Lake Macdonald Dam Improvement Project

Quarterly Compliance
and Monitoring
Summary Report for
the Coordinator-
General

ENV-REP-00002 LMDIP Quarterly Compliance Monitoring Report for

Period 1: 1 January – 31 December 2025

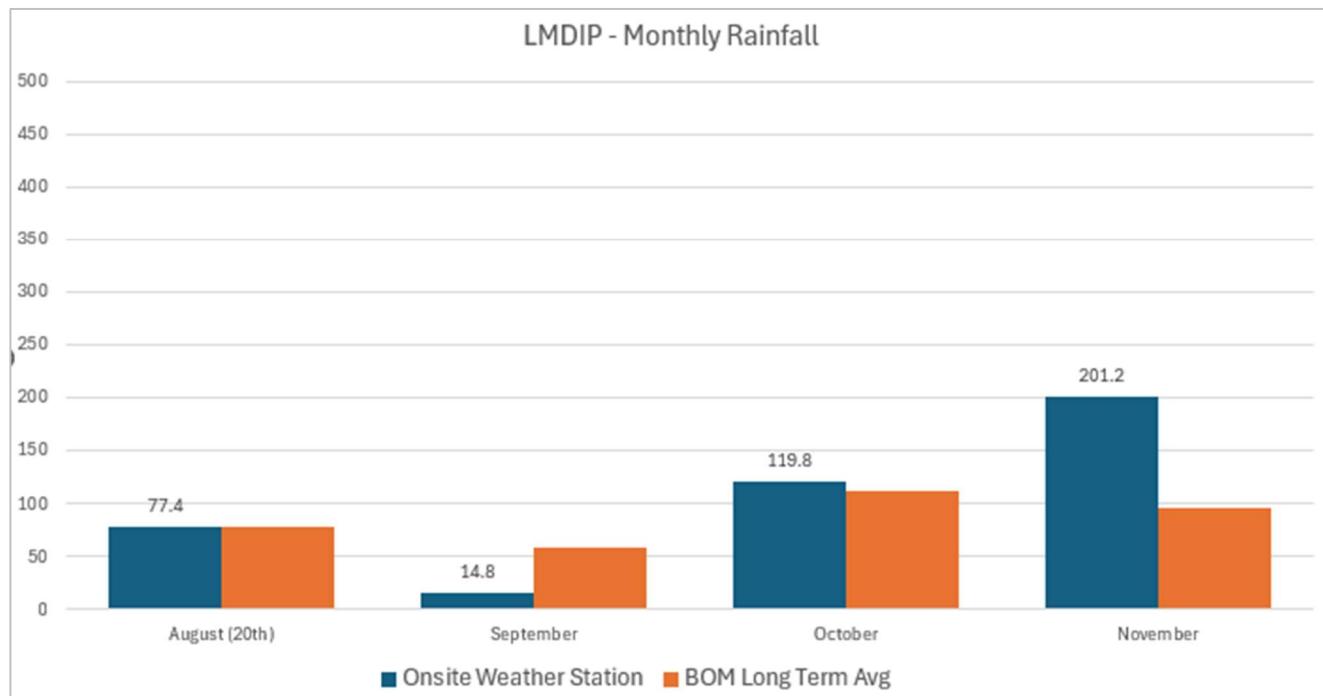
Figure 1: LMDIP Rainfall compared to the Tewantin long term average.

Rainfall observed on site was below the BOM average for September and above for October and November 2025. Several storm events were experienced onsite in November, leading to intense rainfall events, however the site was well prepared and remained compliant during all events, Refer to Figure 1.

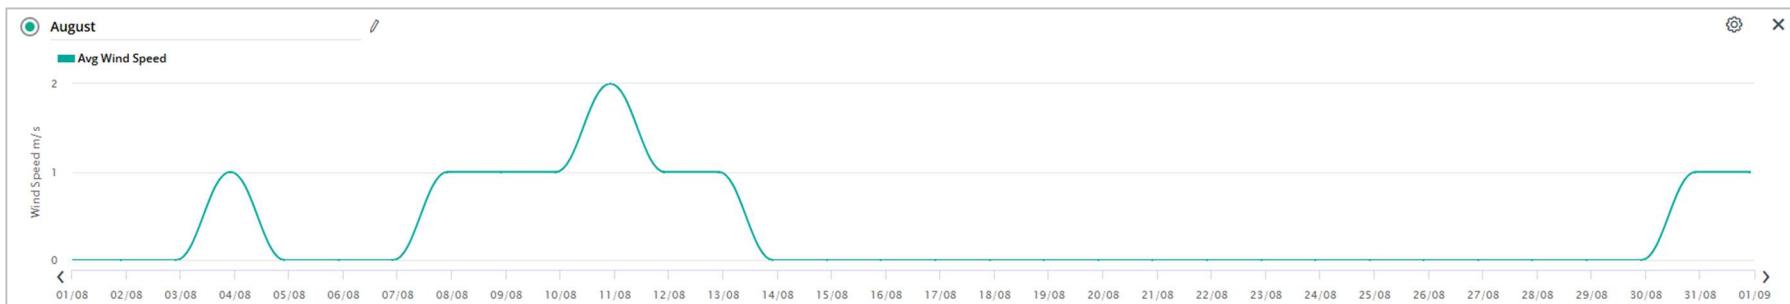
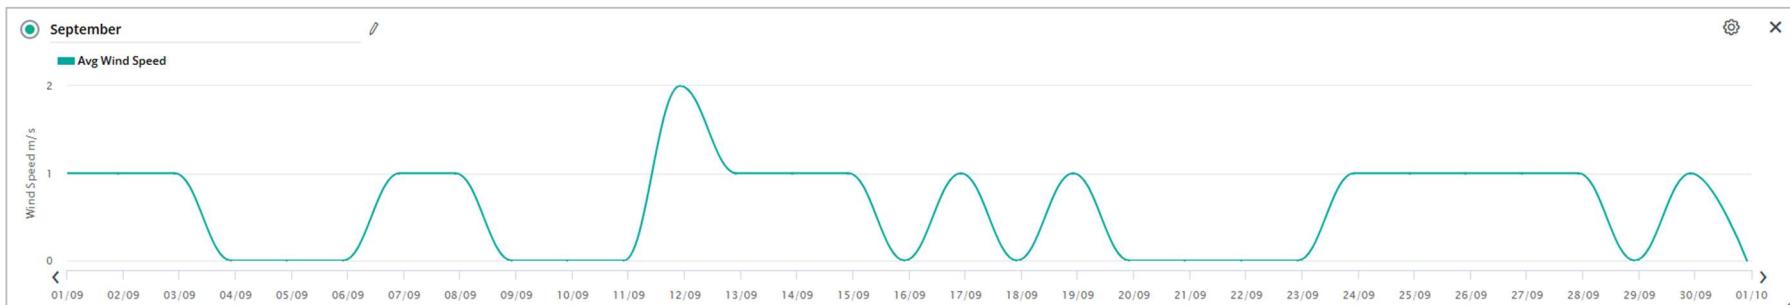
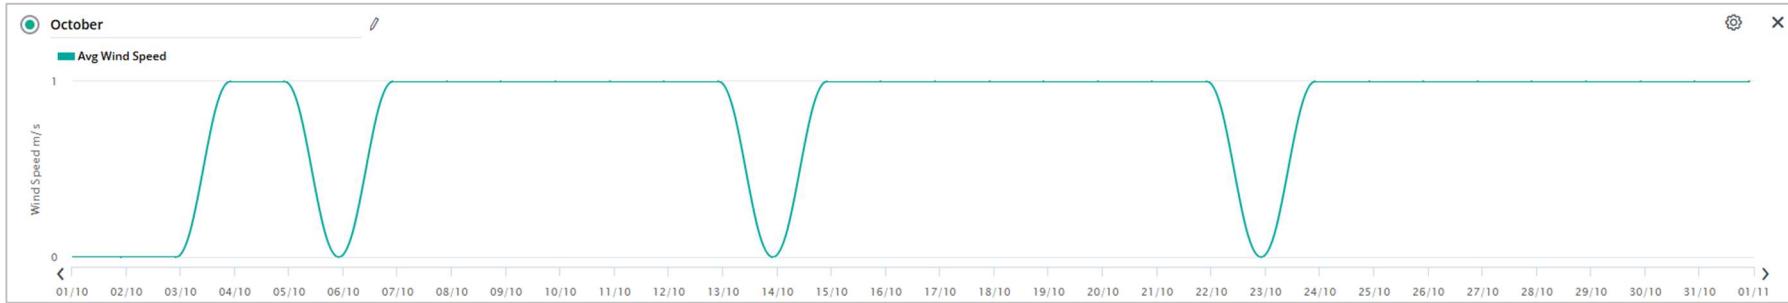
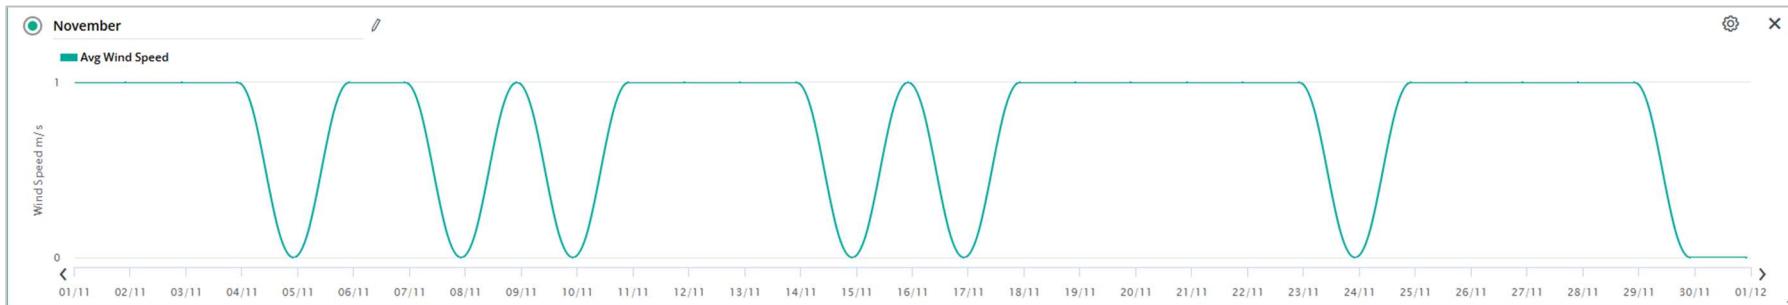
Figure 3: LMDIP average wind speed

Windspeed and direction recorded during the period continued to be unremarkable with average daily windspeeds ranging between 0-2m/s with a predominant North to North-westerly direction. Refer to Figure 3 for average wind speed and Figure 4 for direction.

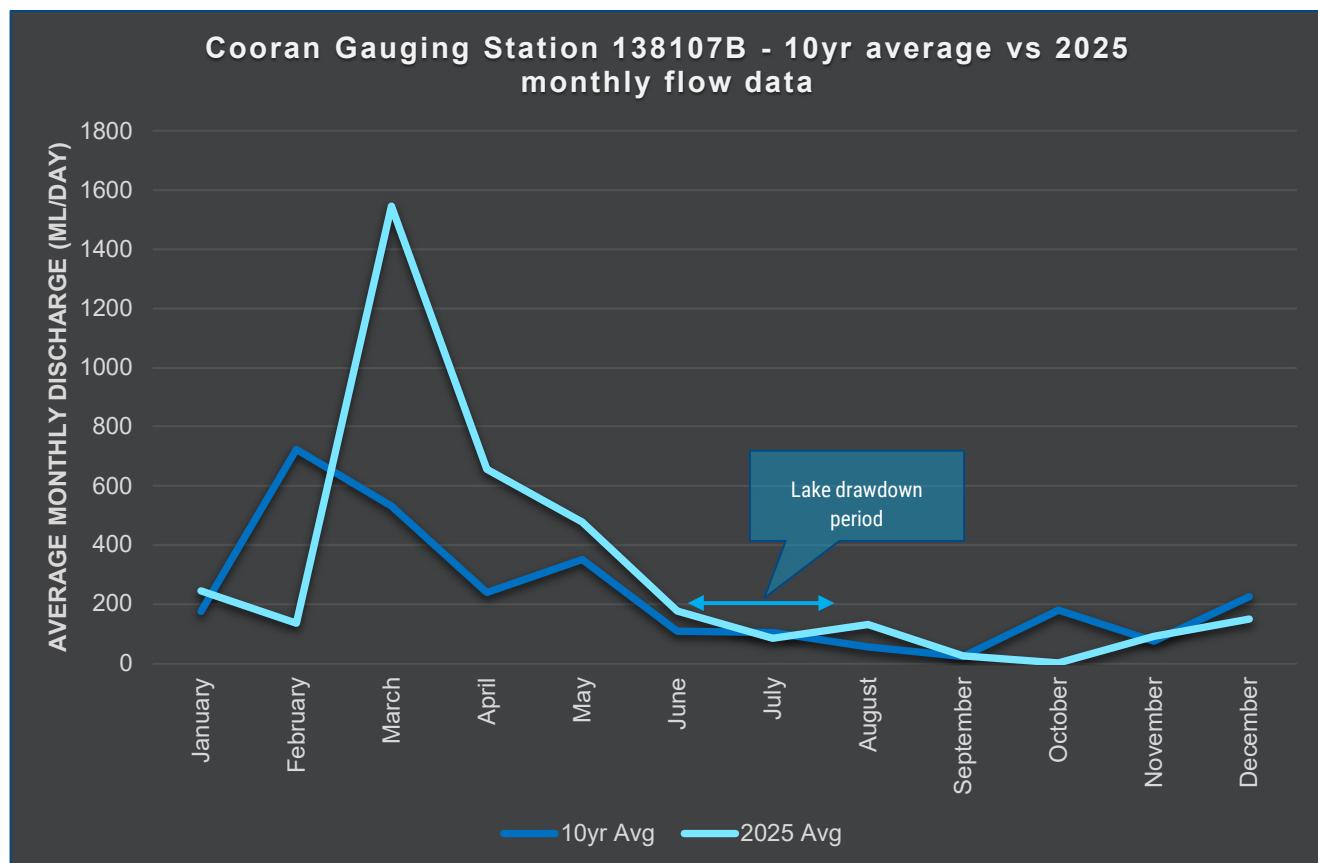
Figure 5: Comparing monthly average flows against the 10yr average

LMDIP regularly monitor the gauging station along Six Mile Creek at Cooran (138107B) to ensure flow regimes remain comparable to what's considered normal. Figure 5 shows the average monthly flows throughout 2025 compared to the 10yr average. A lack of rain in October resulted in minimal flows being available to send downstream. Environmental flows are always maintained as per the Lake Macdonald Water License.

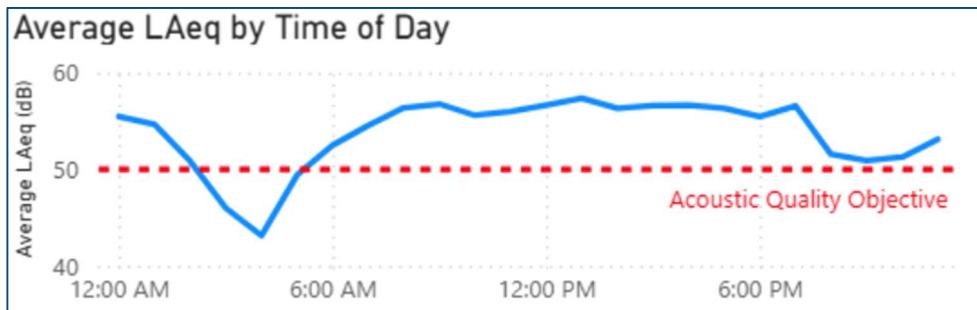
Figure 10: Average LA_{eq} - 1hr by time of day (Monday to Sunday 24-hour period)

Figure 10 indicates that noise throughout the day with the exception of between 2am and 5am is above the 50 dBA objectives. This includes almost 9 hours a day outside construction hours. Below in Figure 11 noise levels on average are less than 10dBA above targets and less than 5 dBA above baseline noise levels (55dBA). Attended noise monitoring has determined that a large portion of this is derived from non-project related traffic.

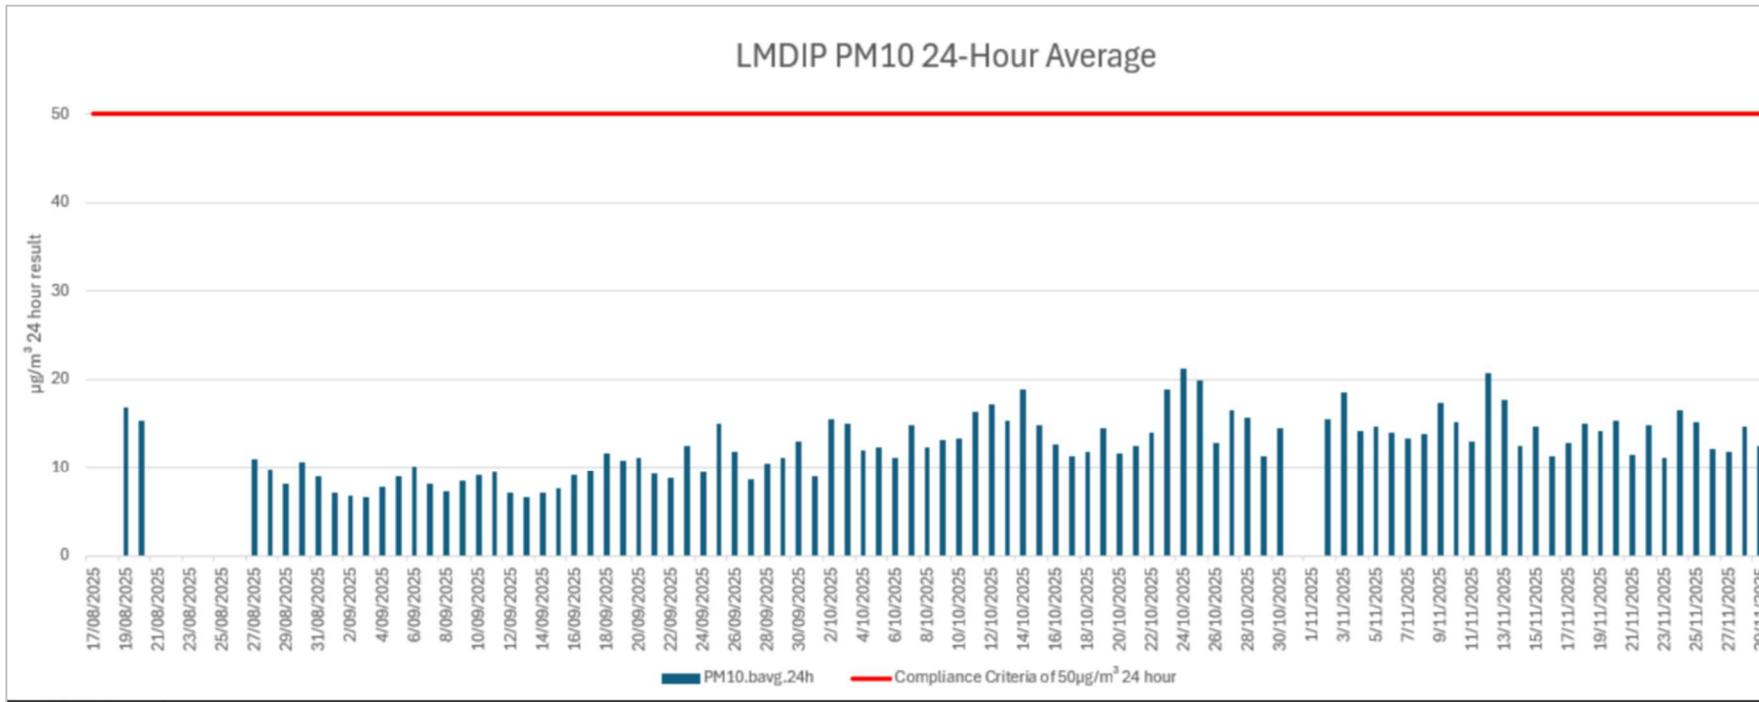
**Figure 15: LMDIP PM10 24 Hour Average**

The data in Figure 15, demonstrates no exceedances in this reporting period with all data captured well below the 50 $\mu\text{g}/\text{m}^3$ 24-hour criteria. There were a few days in August, where data was not recorded which was due to a connectivity issue and the connection to the recording platform cloud dropped out, this is of no impact to the overall results.
