Lake Macdonald Dam Improvement Project

Quarterly Compliance
and Monitoring
Summary Report for
the Coordinator-
General

Document Number: LMDIP-10000-GNL-ENV-REP-00003 LMDIP Quarterly Compliance Monitoring Report for the Coordinator General

Reporting period: 1 December 2025 – 28 February 2026

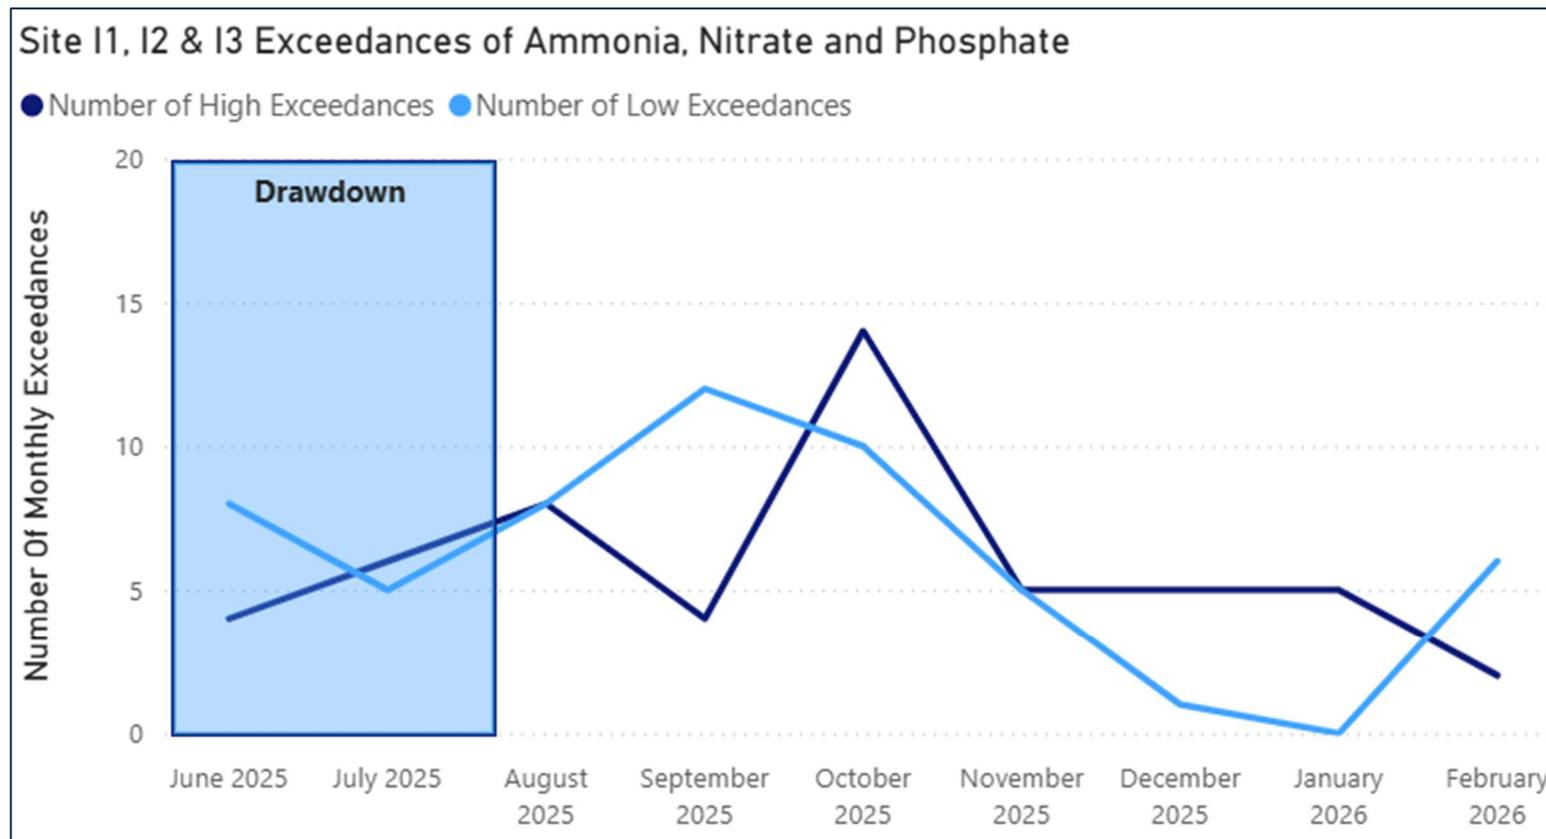
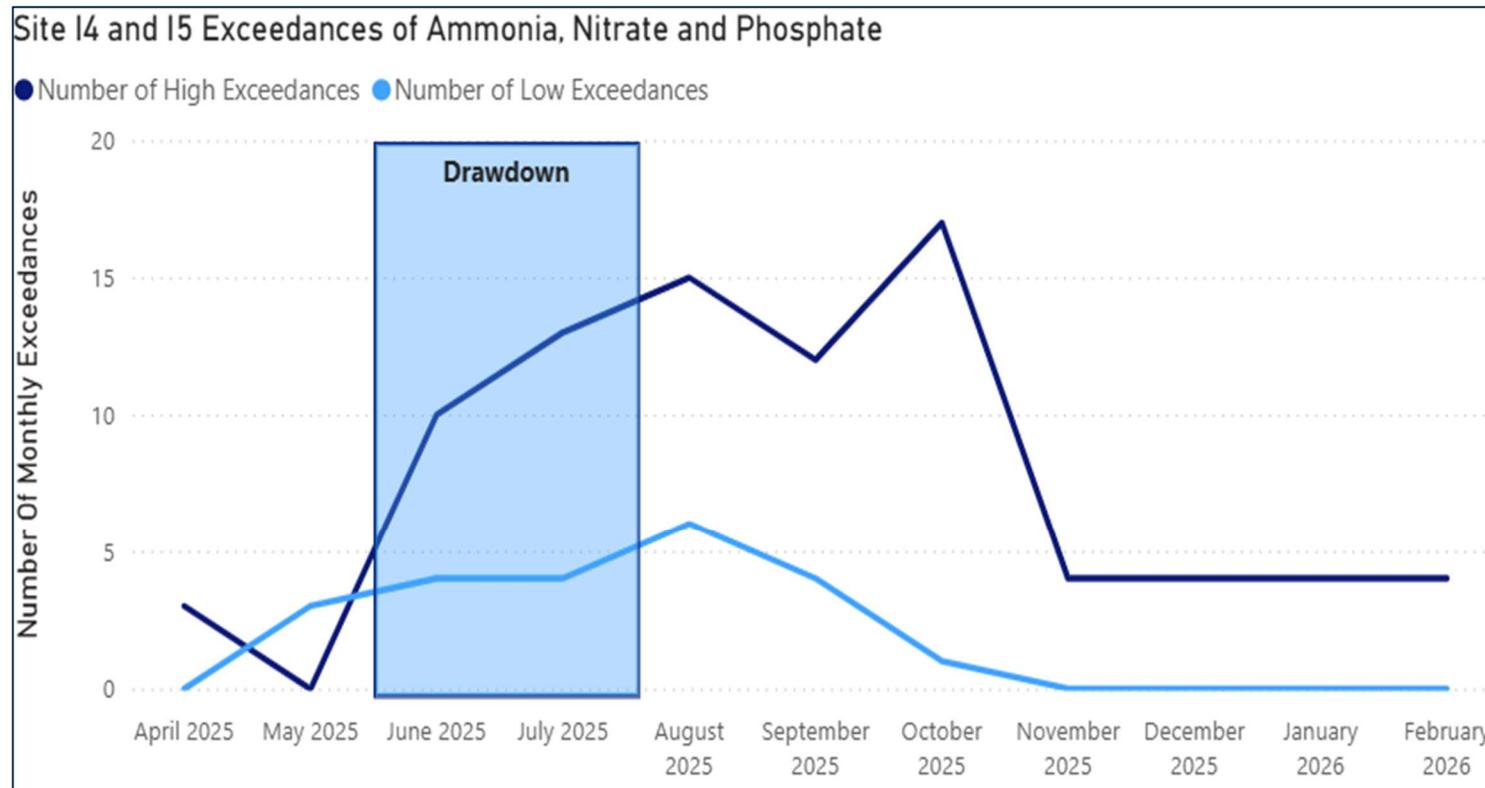
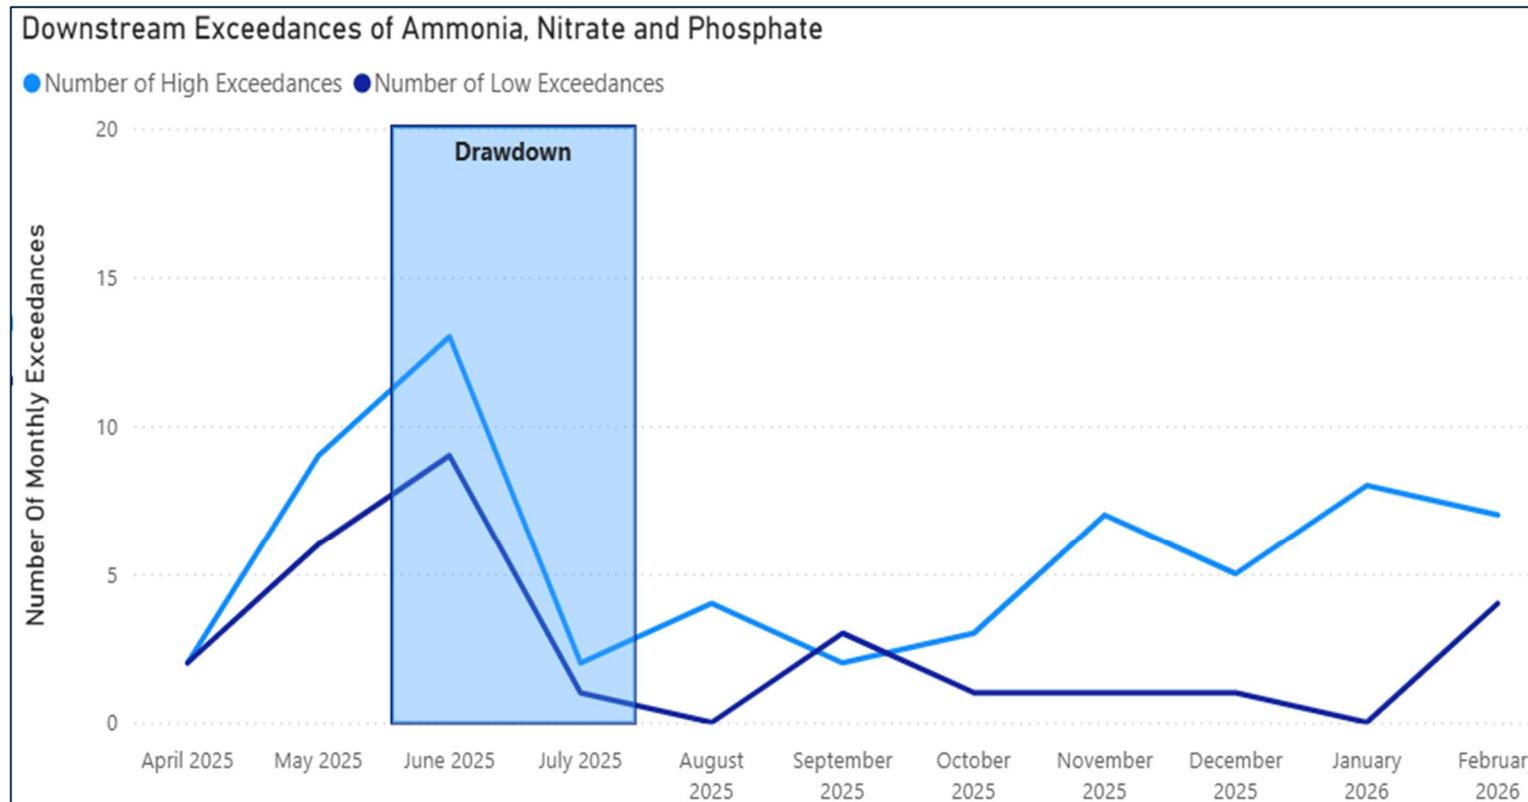
Figures 8, 9 and 10 display the historical inclusive water quality trends at all monitoring locations. These graphs show the number of times the high and low trigger values were exceeded each month since the project began.

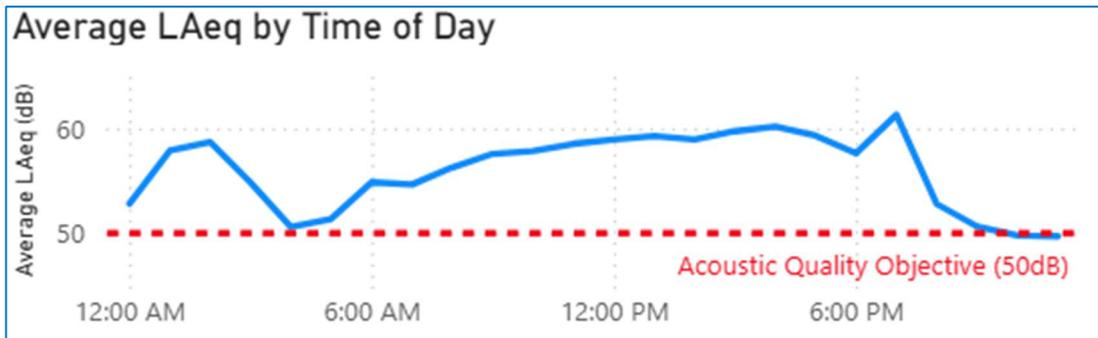
Figure 15: Average LA_{eq} - 1hr by time of day (Monday to Sunday 24-hour period)

Figure 15 indicates that the noise throughout the day with the exception of between 2am and 5am is above the 50 dBA objectives. This includes almost 12 hours a day outside construction hours. Below in Figure 11 noise levels on average are less than 10dBA above targets and less than 5 dBA above baseline noise levels (55dBA). Attended noise monitoring has determined that a large portion of this is derived from non-project related traffic. It was noted that on average the highest noise levels (61dBA LA_{eq}) were recorded at 7pm when no construction activities were occurring. The reviewed audio recorded by the noise loggers highlighted that the cause of these exceedances was usually attributable to cicada's as well as the infrequent spikes caused by storm events.

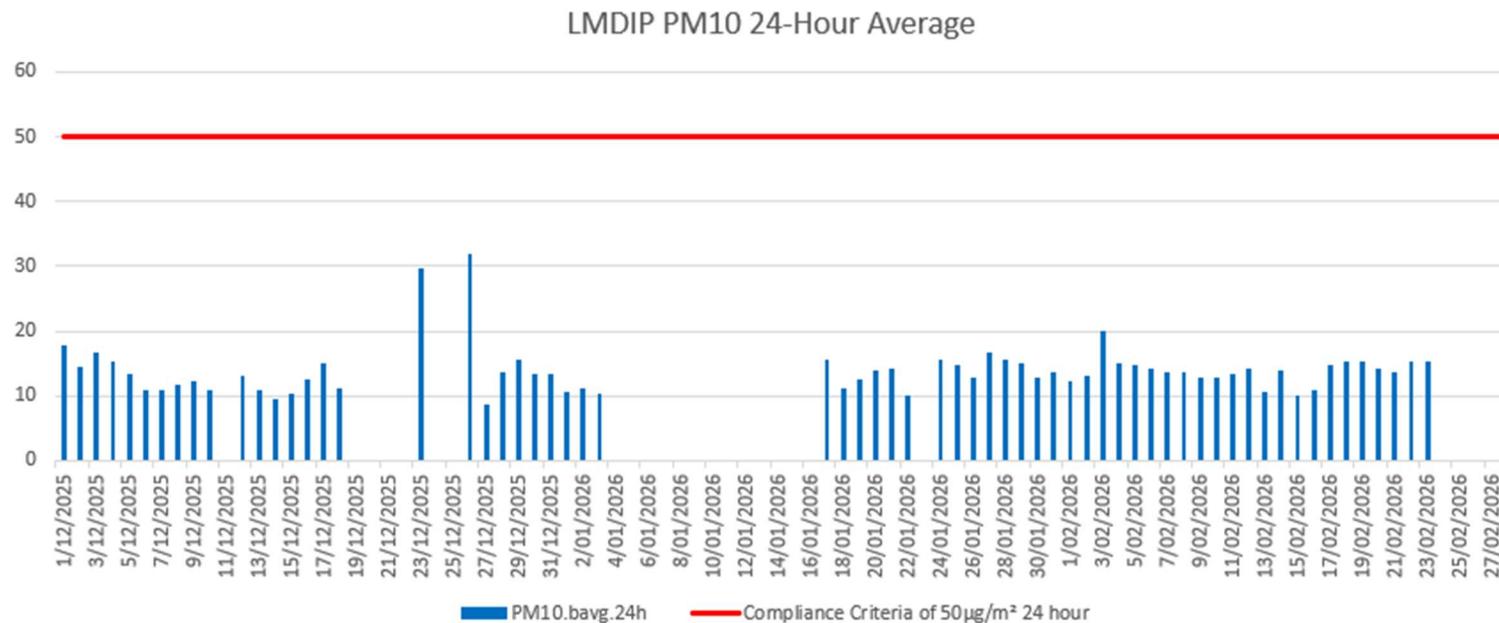
Figure 20: LMDIP PM10 24 Hour Average

The data collected in Figure 20, demonstrates no exceedances in this reporting period with all data captured well below the 50µg/m³ 24-hour criteria, The two spike events were during site shutdown and attributed to thunderstorm events.
