Flora & Fauna (Dewatering)
Management Plan

Lake Macdonald (Six Mile Creek) Dam Improvement Project

Client Reference No. 05327
Prepared for: Seqwater
22 April 2025

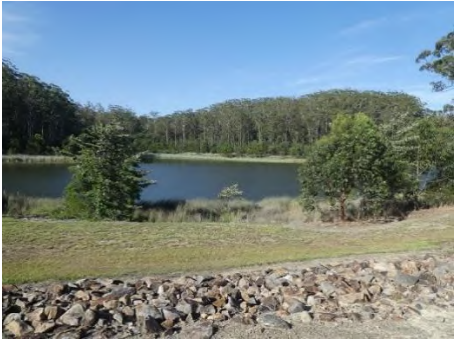
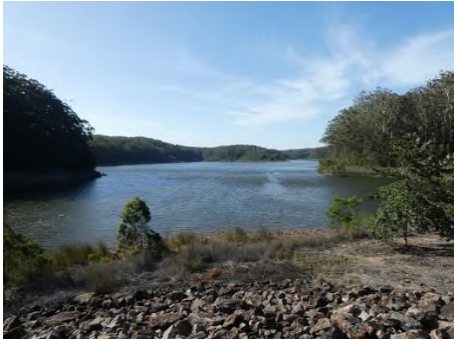
| Site 1 – Cooloolabin Dam 21/11/2019 | Co-ordinates - UTM 56 J E 488246 N 7062855 |

| <p>General comments A large body of water which meets the requirements for releasing fish that have been stocked into Lake Macdonald for recreational purposes that are not EVNT species (i.e. Australian bass, golden perch, southern saratoga).</p> | |

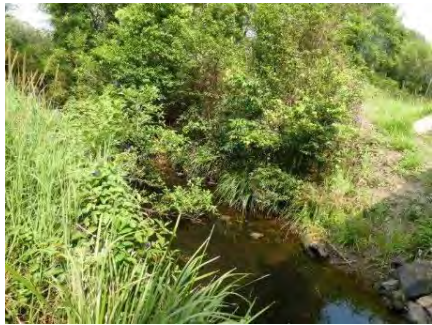
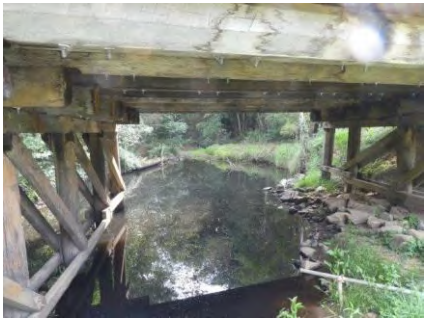
| Site 2 – Six Mile Creek (east branch) 21/11/2019 | Co-ordinates - UTM 56 J E 490171 N 7080092 |

| <p>General comments Two mid-sized pools present. Potentially capacity to relocate a small number of aquatic fauna. Would require high flow to allow movement out of the reach for further relocation of aquatic fauna. Short drive from Lake Macdonald and good access.</p> | |

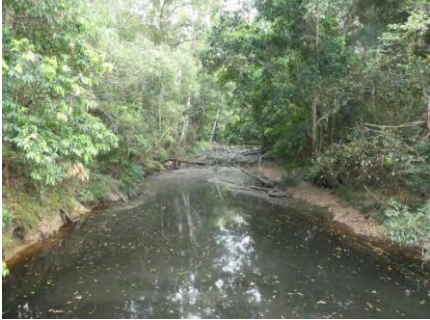
| Site 3 – Six Mile Creek 21/11/2019 | Co-ordinates - UTM 56 J E 489157 N 7086491 |

| <p>General comments A large pool, relatively steep banks and deep water. No boat launch and difficult to sample effectively. Likely to be able to take a small number of aquatic fauna.</p> | |

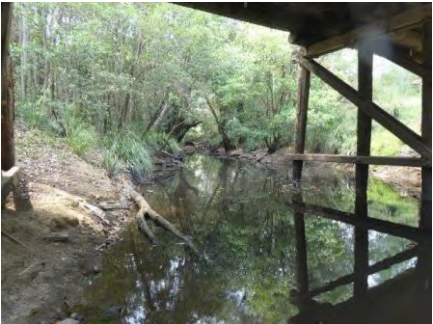
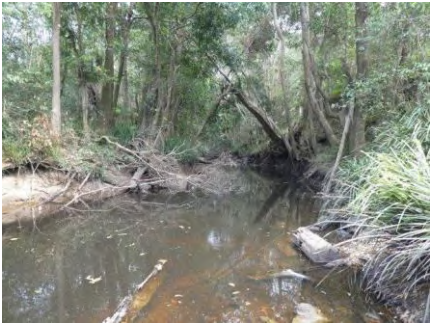
| Site 4 – Six Mile Creek 21/11/2019 | Co-ordinates - UTM 56 J E 484959 N 7086511 |

| General comments A series of smaller pools which have potential capacity to relocate a small number of aquatic fauna. No large pools noted immediately adjacent to the reach so potentially less room for aquatic fauna to move into adjacent habitat. May be able to take a small number of aquatic fauna. | |

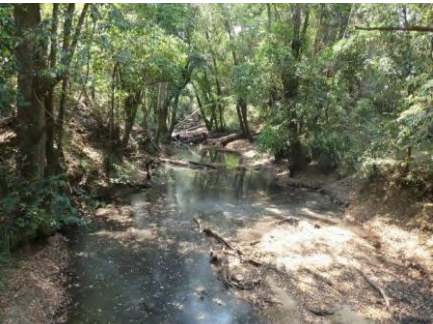
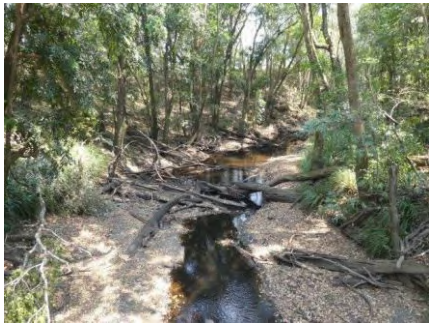
| Site 5 – Six Mile Creek 21/11/2019 | Co-ordinates - UTM 56 J E 478420 N 7089063 |

| General comments Several mid-sized pools throughout the reach. Potential capacity to relocate a small number of aquatic fauna. Would require high flow to allow movement out of the reach for further relocation of aquatic fauna. | |

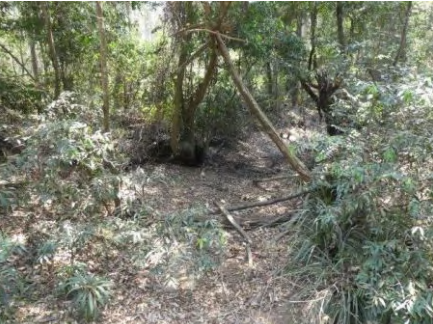
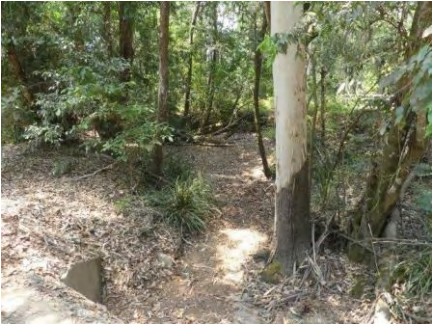
| Site 6 – Dingo Creek 21/11/2019 | Co-ordinates - UTM 56 J E 477795 N 7090114 |

| General comments Dry site, unlikely to hold water for more than a short period of time after rainfall. | |

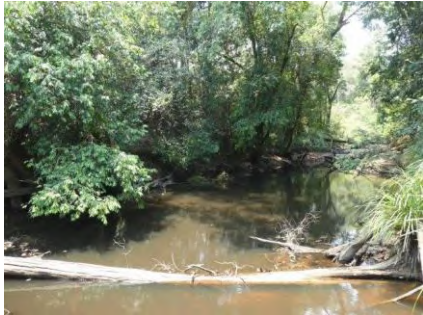
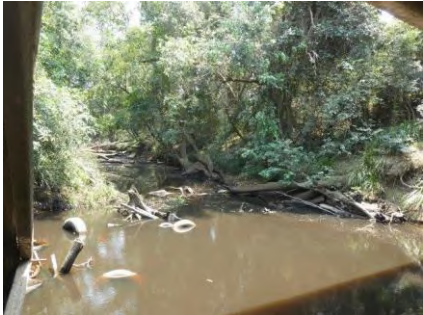
| Site 7 – Six Mile Creek 21/11/2019 | <u>Co-ordinates - UTM 56J</u> E 475960 N 7092575 |

| <u>General comments</u> An apparently deep pool at the site and at least one more adjacent to the reach. Reasonable habitat but some difficulties with site access due to steep banks. May be able to take a small number of aquatic fauna. | |

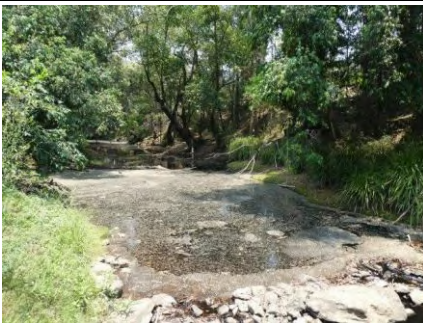
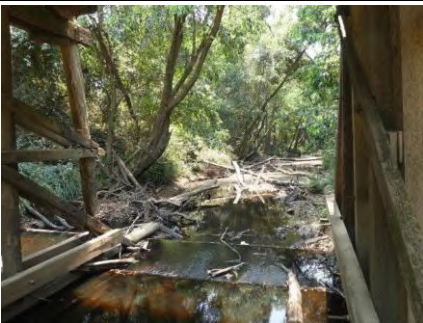
| Site 8 – Six Mile Creek 21/11/2019 | <u>Co-ordinates - UTM 56 J</u> E 473905 N 7095985 |

| <u>General comments</u> Several large and apparently deep pools with potential capacity to relocate several aquatic fauna individuals. Good parking but relatively steep banks and deep water. No boat launch. | |

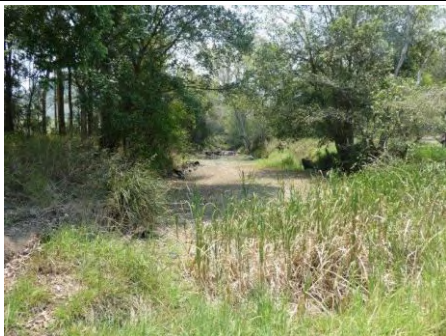
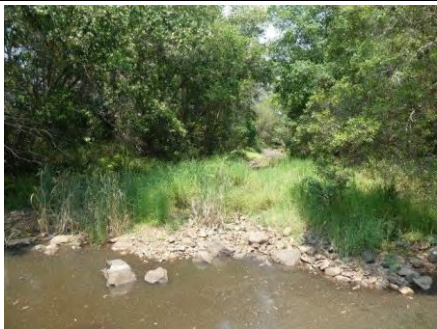
| Site 9 – Woondum Creek 21/11/2019 | <u>Co-ordinates - UTM 56 J</u> E 476900 N 7095458 |

| <u>General comments</u> Largely dry. Pool below the causeway likely a result of scoring from the causeway. | |

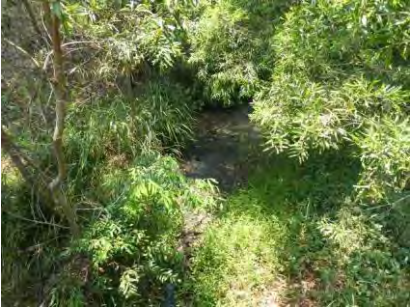
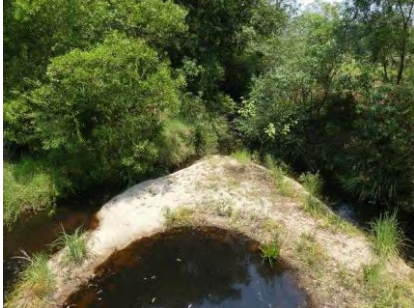
| Site 10 – Sandy Creek 21/11/2019 | Co-ordinates - UTM 56J E 477010 N 7094516 |

| General comments Largely dry. A small pool below the bridge likely a result of scoring from the bridge. | |

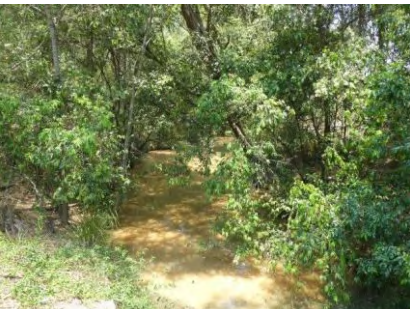
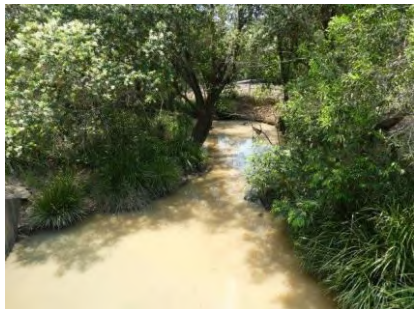
| Site 11 – Traveston Creek 21/11/2019 | Co-ordinates - UTM 56 J E 472061 N 7088401 |

| General comments Water quality poor; low dissolved oxygen, high turbidity and conductivity. | |

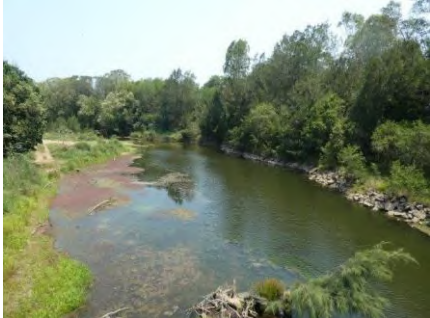
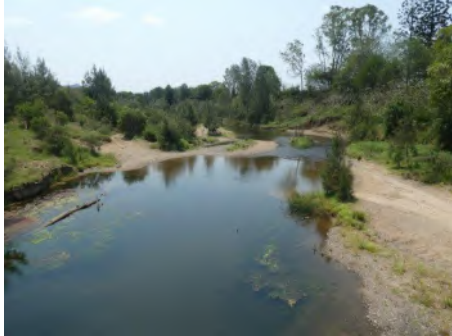
| Site 12 – Mary River 21/11/2019 | Co-ordinates - UTM 56 J E 470262 N 7087513 |

| General comments Good site access and safe launch. Popular spot for local people to swim and take dogs for swims. Concern the high public usage might encourage angling for released Mary River Cod from observers. | |

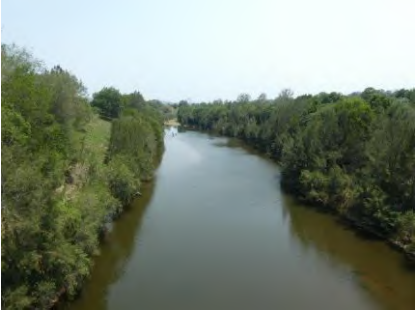
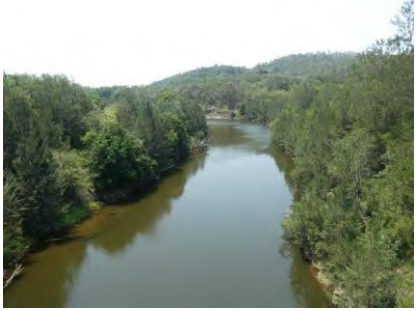
| Site 13 – Mary River 21/11/2019 | Co-ordinates - UTM 56J E 471772 N 7086344 |

| General comments Inaccessible without private property access. | |

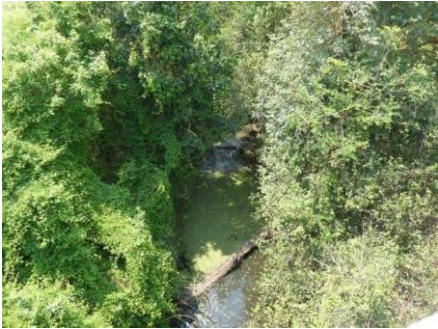
| Site 14 – Kandanga Creek 21/11/2019 | Co-ordinates - UTM 56 J E 469082 N 7082218 |

| General comments Largely inaccessible due to heavy weed infestation of the riparian zone and private property. | |

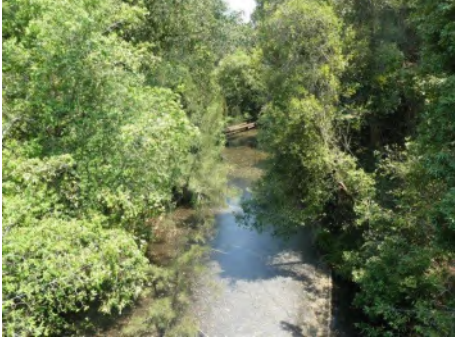
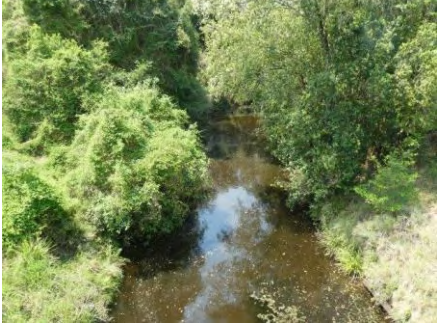
| Site 15 – Kandanga Creek 21/11/2019 | Co-ordinates - UTM 56 J E 470348 N 7084295 |

| General comments Large pools upstream and downstream. Poor parking and site access. | |

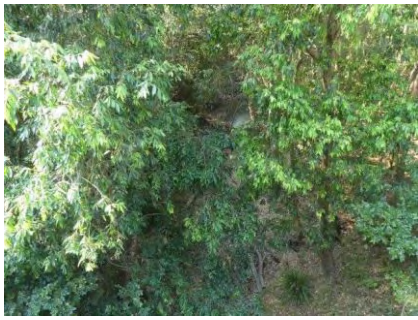
| Site 16 – Coonan-Gibber Creek 21/11/2019 | <u>Co-ordinates - UTM 56J</u> E 472773 N 7075973 |

| <u>General comments</u> Largely dry. A small shallow pool immediately above the road bridge. | |

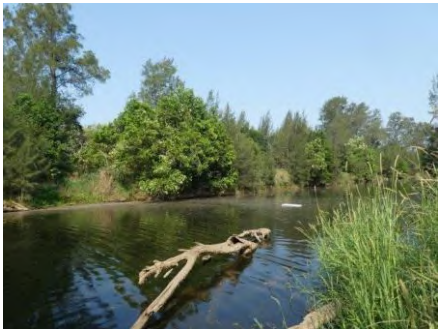
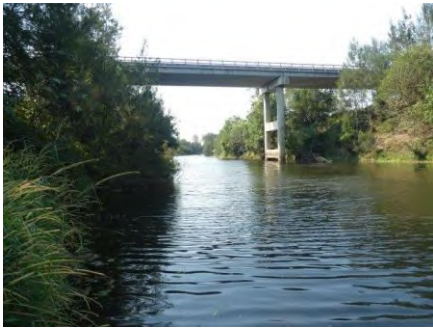
| Site 17 – Mary River 21/11/2019 | <u>Co-ordinates - UTM 56 J</u> E 475087 N 7077293 |

| <u>General comments</u> A large pool at this site. A reasonable footpath provides reasonable point access but the banks are high and the water deep for most of this reach. No boat launching in public access areas. Likely to be able to difficult to sample well under current constraints for capacity or monitoring post relocation. | |

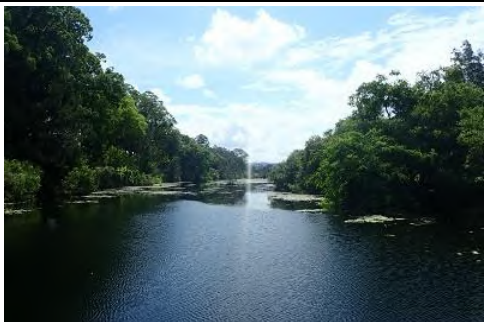
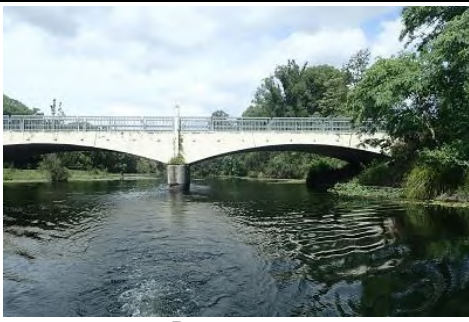
| Site 18 – Yabba Creek 21/11/2019 | <u>Co-ordinates - UTM 56 J</u> E 468073 N 7073451 |

| <u>General comments</u> Excellent site for all criteria. | |

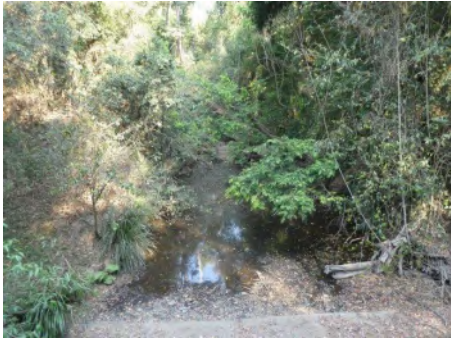
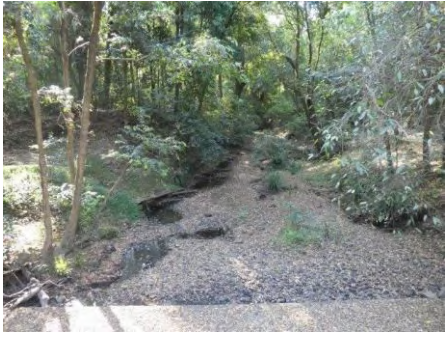
| Site 19 – Belli Creek 21/11/2019 | Co-ordinates - UTM 56J E 477931 N 7070724 |

| General comments Not flowing some remnant pools present. Potential capacity to relocate a small number of aquatic fauna individuals under better flow conditions. | |

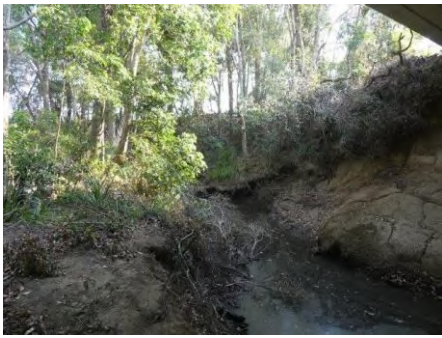
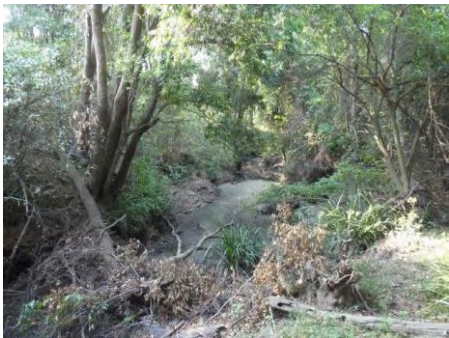
| Site 20 – Belli Creek 21/11/2019 | Co-ordinates - UTM 56 J E 481121 N 7067673 |

| General comments Not flowing, some small remnant pools present with poor water quality. Poor access and unsafe access. | |

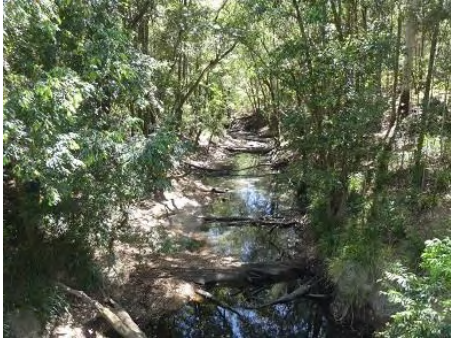
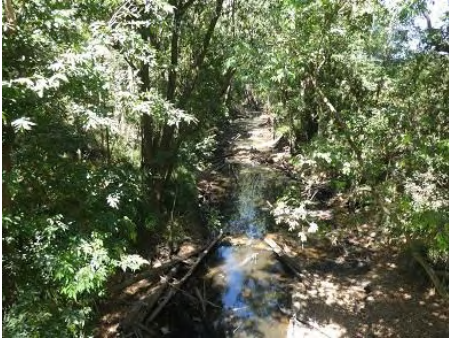
| Site 21 – Six Mile Creek 4/12/2019 | Co-ordinates - UTM 56 J E 480968 N 7087762 |

| General comments Several small to mid-sized pools throughout the reach. Potentially capacity to relocate a small number of aquatic fauna under flow conditions. Would require high flow to allow movement out of the reach for further relocation of aquatic fauna. Short drive good and good access. | |

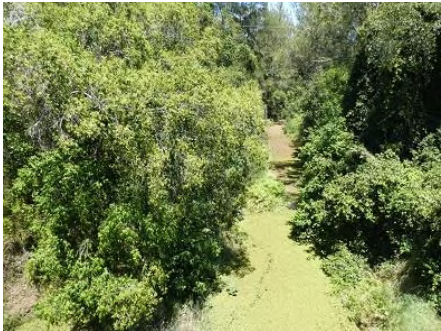
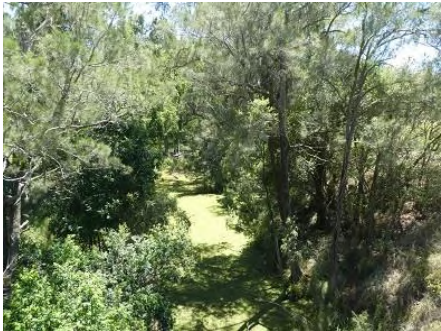
| Site 22 – Amamoor Creek 4/12/2019 | <u>Co-ordinates - UTM 56J</u> E 468572 N 7088012 |

| <u>General comments</u> Poor parking for a car with a trailer. Poor access from the road to the creek. | |

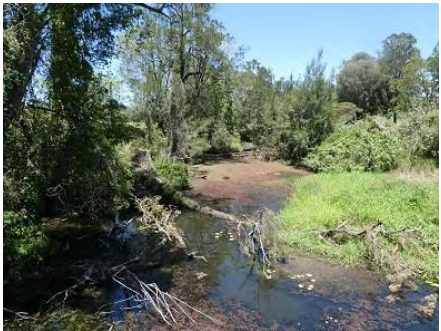
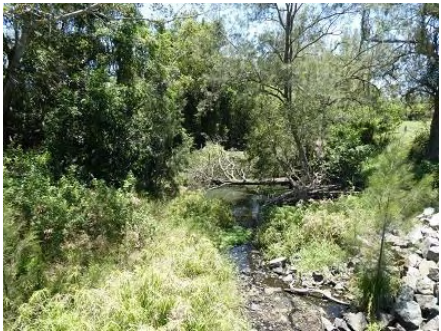
| Site 24 – Amamoor Creek 4/12/2019 | <u>Co-ordinates - UTM 56 J</u> E 467321 N 7086336 |

| <u>General comments</u> Not flowing, some small remnant pools present with poor water quality. Good parking and reasonable access. Potential capacity to relocate a small number of aquatic fauna individuals under better flow conditions. | |

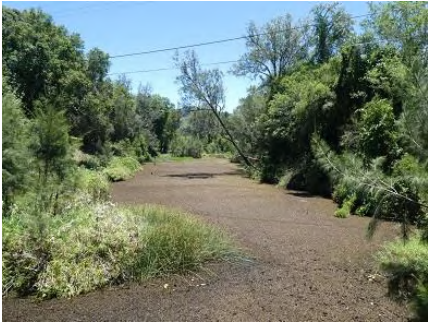
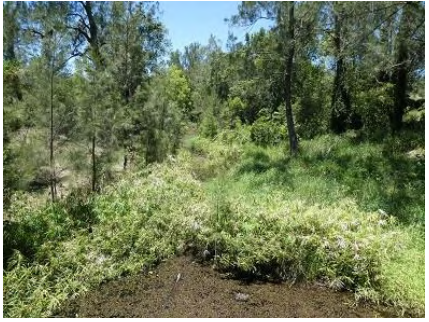
| Site 25 – Amamoor Creek 4/12/2019 | Co-ordinates - UTM 56 J E 466202 N 7085823 |

| <p>General comments Good point access but private property making access for aquatic ecosystem assessment difficult. Potential capacity to relocate a small number of aquatic fauna individuals under better flow conditions.</p> | |

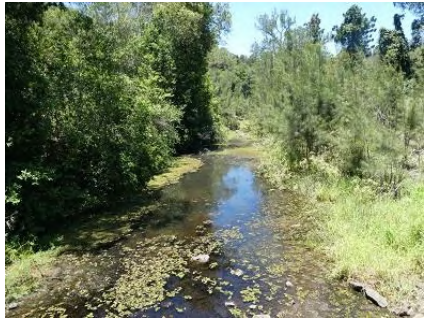
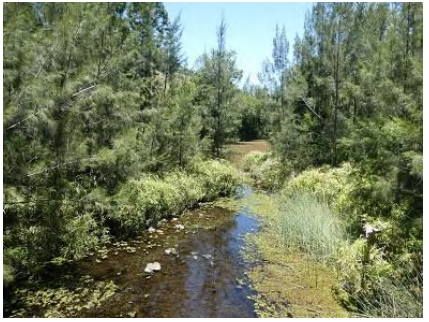
| Site 26 – Amamoor Creek 4/12/2019 | Co-ordinates - UTM 56J E 465197 N 7085152 |

| <p>General comments Not flowing some remnant pools present. Potential capacity to relocate several aquatic fauna individuals under better flow conditions.</p> | |

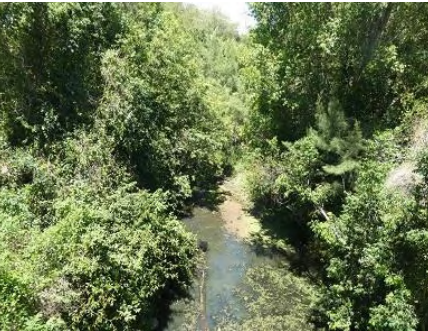
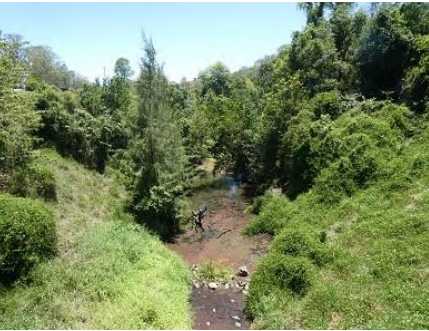
| Site 27 – Kandanga Creek 4/12/2019 | Co-ordinates - UTM 56 J E 467746 N 7081573 |

| <p>General comments Not flowing, some small remnant pools present with poor water quality. Poor access largely excludes this site.</p> | |

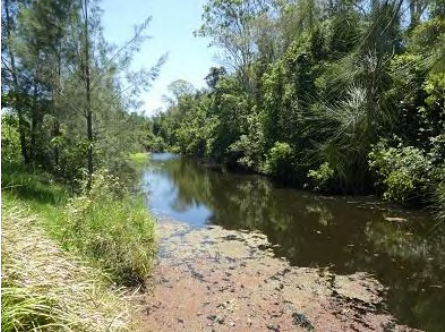
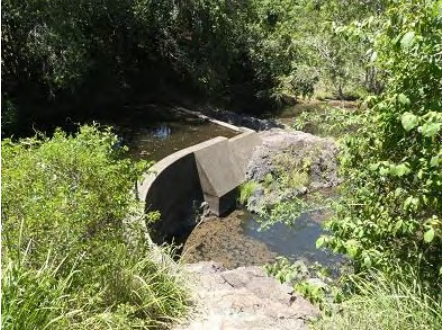
| <p>Site 28 – Kandanga Creek Weir 4/12/2019</p> | <p><u>Co-ordinates - UTM 56J</u> E 467372 N 7081138</p> |

| <p><u>General comments</u> A large pool formed by the Kandanga Weir.</p> | |

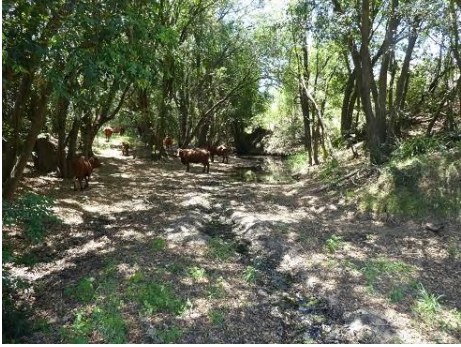
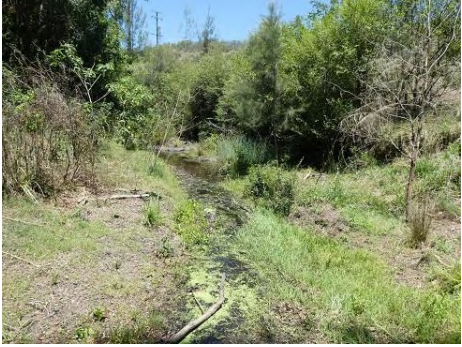
| <p>Site 29 – Kandanga Creek 4/12/2019</p> | <p><u>Co-ordinates - UTM 56J</u> E 466818 N 7080555</p> |

| <p><u>General comments</u> Some small remnant pools. Unlikely to have any larger pools even under better flow conditions.</p> | |

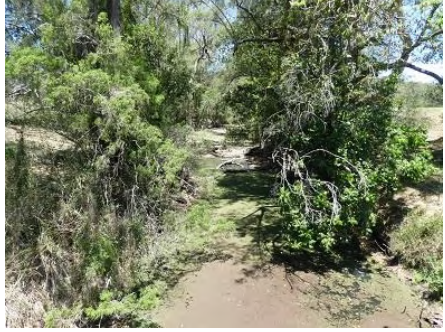
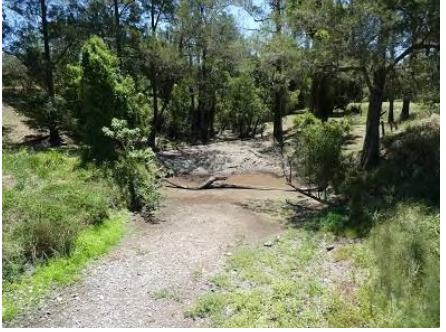
| <p>Site 30 – Kandanga Creek 4/12/2019</p> | <p><u>Co-ordinates - UTM 56 J</u> E 464458 N 7081131</p> |

| <p><u>General comments</u> Site largely dry.</p> | |

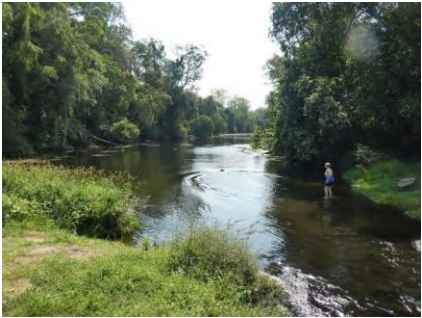
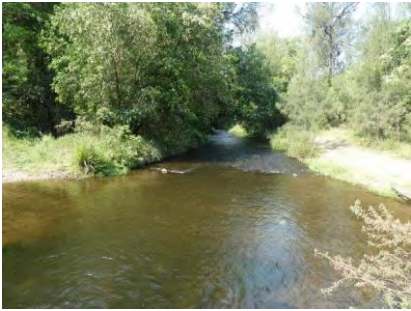
| Site 31 – Yabba Creek 4/12/2019 | Co-ordinates - UTM 56 J E 462860 N 7069961 |

| General comments Excellent site for all criteria. | |

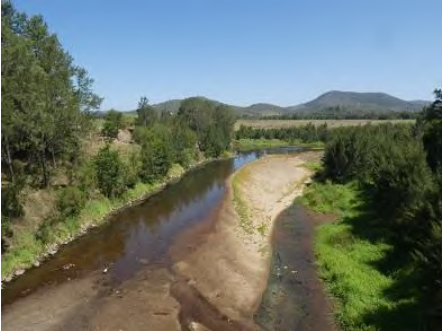
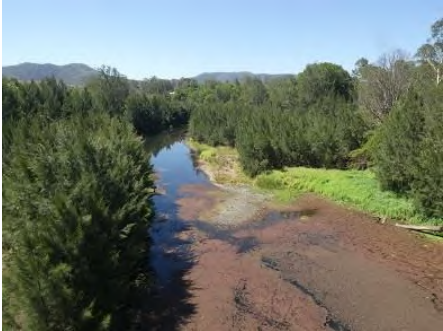
| Site 32 – Mary River 4/12/2019 | Co-ordinates - UTM 56J E 473589 N 7059185 |

| General comments Poor access to site due to private property. Larger pools absent. | |

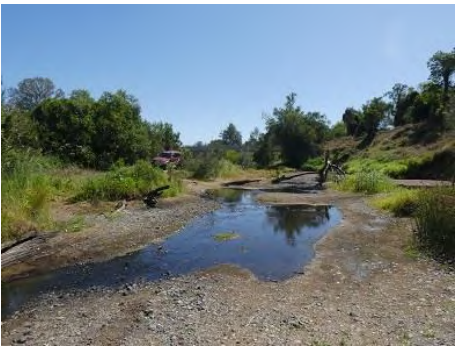
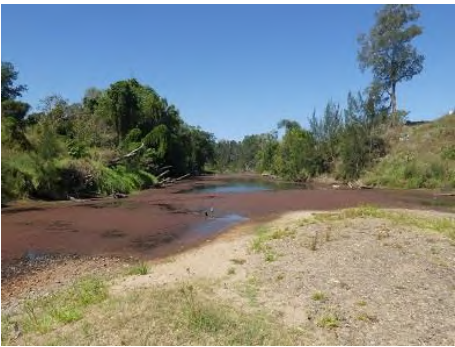
| Site 33 – Mary River 4/12/2019 | Co-ordinates - UTM 56 J E 475676 N 7063772 |

| General comments Not flowing, some small remnant pools present. Potential capacity to relocate a small number of aquatic fauna individuals under better flow conditions. Good parking but the road is heavily used by trucks going to and from the stone quarry, often driving very fast. Access on and off the road considered a potential hazard. | |

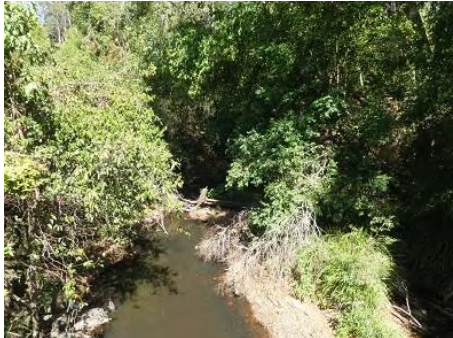
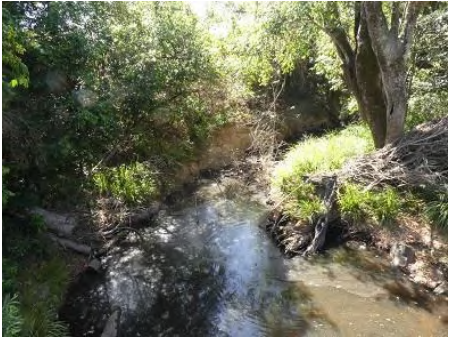
| Site 34 – Belli Creek 4/12/2019 | Co-ordinates - UTM 56 J E 482278 N 7065872 |

| General comments Small to mid-sized pools but a relatively small creek with poor aquatic fauna relocation potential. | |

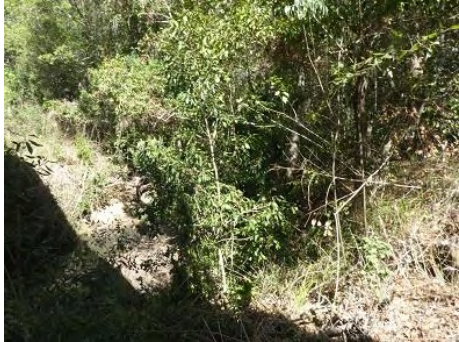
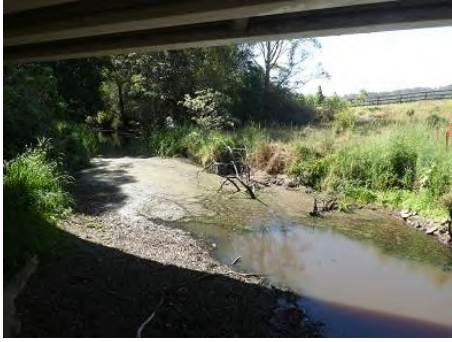
| Site 35 – Belli Creek 4/12/2019 | Co-ordinates - UTM 56J E 486382 N 7069060 |

| General comments Small to mid-sized pools but a relatively small creek with poor aquatic fauna relocation potential. | |

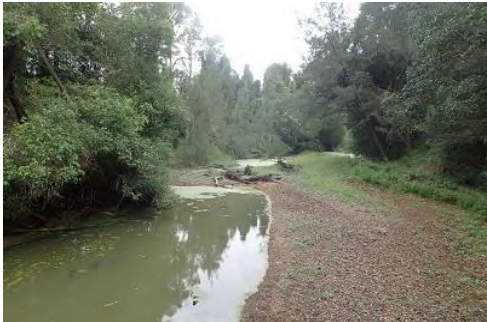
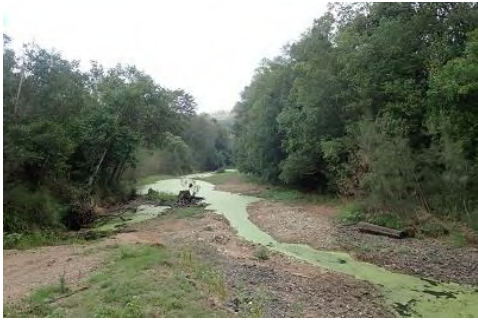
| Site 36 – Mary River 4/12/2019 | Co-ordinates - UTM 56J E 474590 N 7067494 |

| General comments Some mid-sized pools adjacent but at the site the channel is largely infilled. Potential capacity to relocate a small number of aquatic fauna individuals under better flow conditions. | |

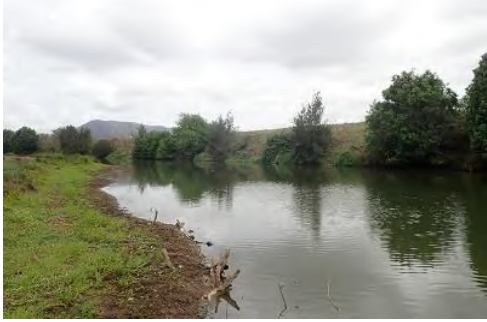
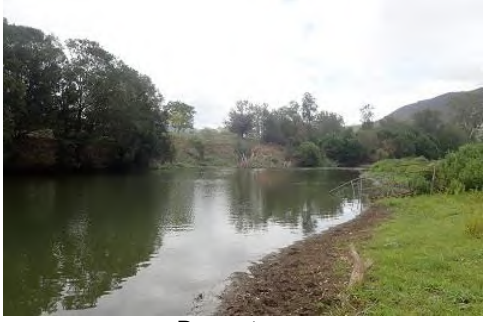
| <p>Site 37 – Mary River 4/12/2019</p> | <p><u>Co-ordinates - UTM 56J</u> E 476475 N 7061738</p> |

| <p><u>General comments</u> Excellent site for all criteria. Access to relocation site through private property but the landowner is amenable to allowing access.</p> | |

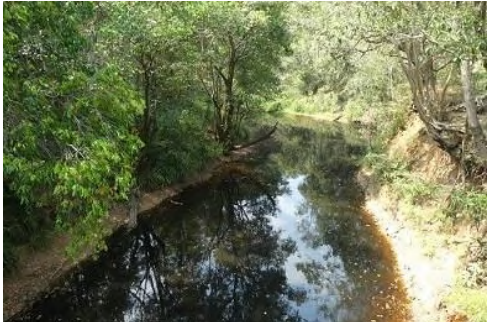
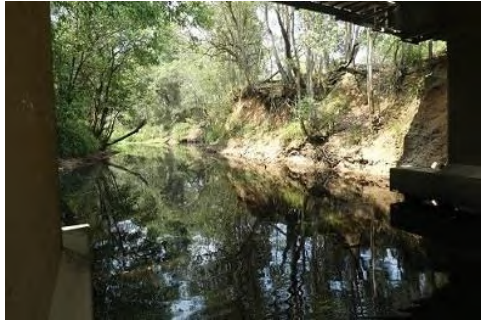
| <p>Site 38 – Six Mile Creek 4/12/2019</p> | <p><u>Co-ordinates - UTM 56J</u> E 482533 N 7087217</p> |

| <p><u>General comments</u> A large pool at the site and some mid-sized pools adjacent. Poor access to the water.</p> | |

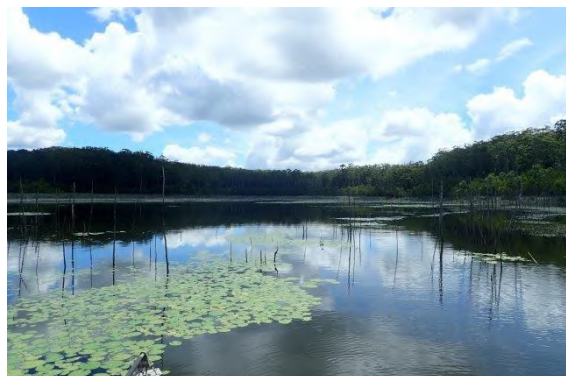
| Site 1 - 15/01/2020 Cooloolabin Dam | | Co-ordinates - UTM 56 J E 488246 N 7062855 | | | |

| A large body of water with a low abundance of large bodied fish and similar aquatic macrophyte assemblages to Lake Macdonald. Capacity to take a large number of fish. | | | | | |

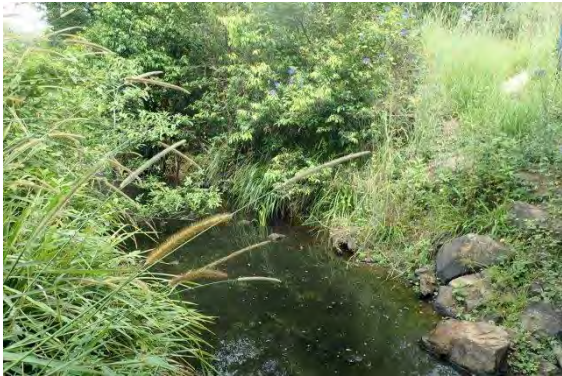
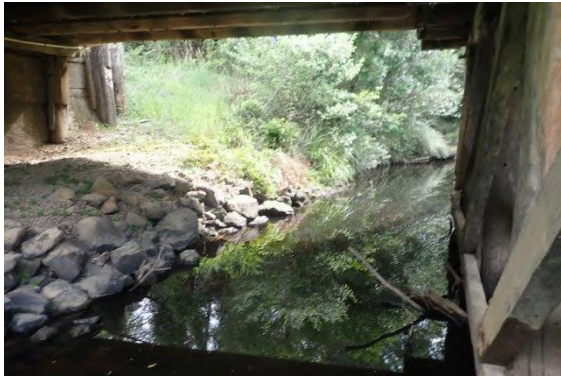
| Site 2 - 17/01/2020 Six Mile Creek | | Co-ordinates - UTM 56 J E 490171 N 7080092 | | | |

| Close to Lake Macdonald. Small to intermediate sized pools that may be suitable for a small number of saw-shelled and broad-shelled turtles. | | | | | |

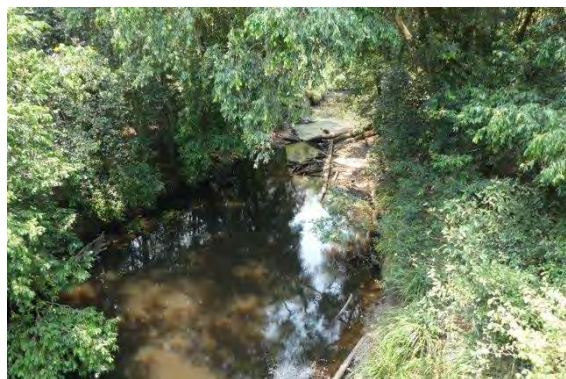
| Site 7 - 17/01/2020 Six Mile Creek | | Co-ordinates - UTM 56J E 475960 N 7092575 | | | |

| Site 7 - 17/01/2020 Six Mile Creek | | Co-ordinates - UTM 56J E 475960 N 7092575 | | | |
|--|---|--|---|---|---|
| Steep boulder banks and deep water from edge. Point access under the road bridge. No macroinvertebrate or fish sampling. Cathedral traps left overnight for turtles, none caught. May be suitable for a small number of saw-shelled and broad-shelled turtles. | | | | | |

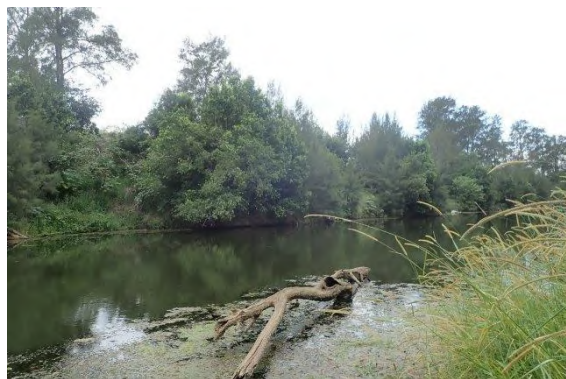
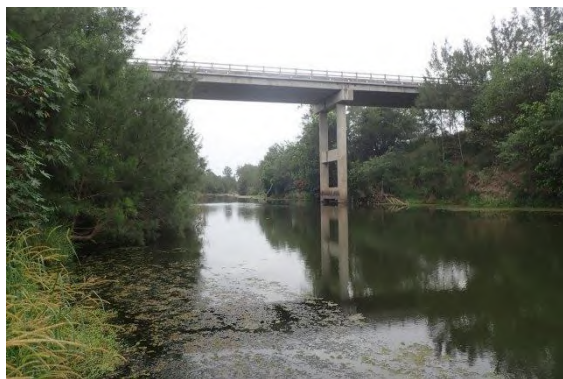
| Site 17 - 14/01/2020 Mary River | | Co-ordinates - UTM 56 J E 475087 N 7077293 | | | |

| Site 17 - 14/01/2020 Mary River | | Co-ordinates - UTM 56 J E 475087 N 7077293 | | | |
|---|---|--|---|---|---|
| Single point of bank access and steep banks with deep water for the rest of the reach. Unsafe to sample from the bank and no suitable boat launches available. Deep large pool. While sampling not easily conducted likely to have similar assemblages of macroinvertebrates and fish as the other large pools on the Mary River (sites 12, 37). Hence some capacity for relocation of aquatic fauna from Lake Macdonald. | | | | | |

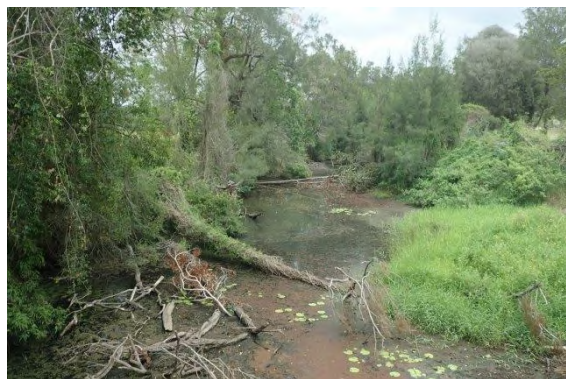
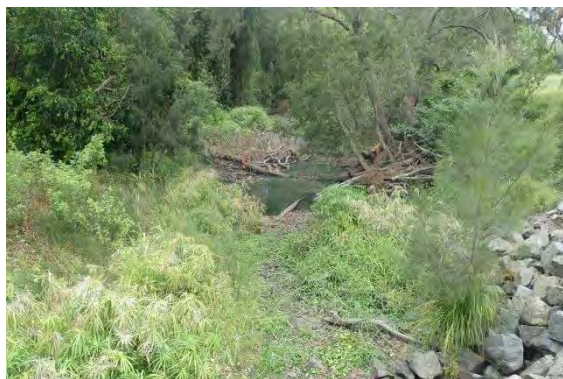
| Site 24 - 14/01/2020 Amamoor Creek | | Co-ordinates - UTM 56 J E 467321 N 7086336 | | |

| Site 24 - 14/01/2020 Amamoor Creek | | Co-ordinates - UTM 56 J E 467321 N 7086336 | | |
|---|---|--|---|---|
| No macroinvertebrate or fish sampling undertaken due to water quality and high turbidity suggesting any sampling could adversely impact on existing conditions and health of aquatic biota. Suggest sampling under better conditions prior to any potential relocation. | | | | |

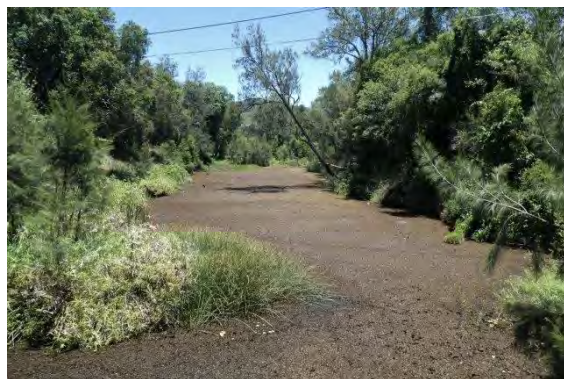
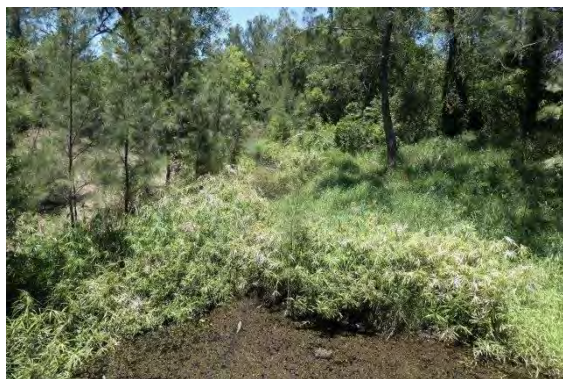
| Site 25 - 14/01/2020 Amamoor Creek | | Co-ordinates - UTM 56 J E 466202 N 7085823 | | | |

| General comments No macroinvertebrate or fish sampling undertaken due to water quality and high coverage of floating macrophytes suggesting any sampling could adversely impact on existing conditions and health of aquatic biota. Suggest sampling under better conditions prior to any potential relocation. | | | | | |

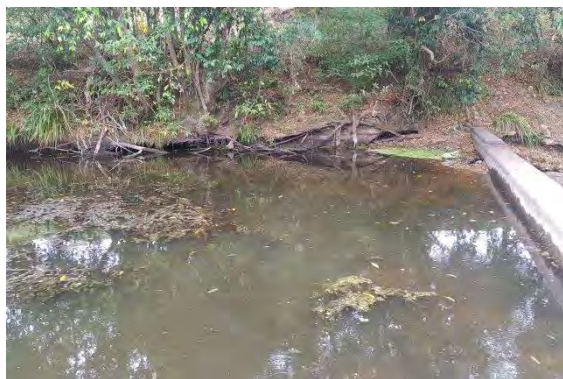
| Site 28 - 13/01/2020 Kandanga Creek Weir | | Co-ordinates - UTM 56J E 467372 N 7081138 | | | |

| Site 28 - 13/01/2020 Kandanga Creek Weir | | Co-ordinates - UTM 56J E 467372 N 7081138 | | | |
|--|---|--|---|---|---|
| No macroinvertebrate or fish sampling undertaken due to water quality and high turbidity suggesting any sampling could adversely impact on existing conditions and health of aquatic biota. Australian smelt noted as gasping at the water surface with some mortalities also noted. Suggest sampling under better conditions prior to any potential relocation. | | | | | |
