Flora and Fauna (Dewatering)  
Management Plan

# Lake Macdonald (Six Mile Creek) Dam Improvement Project

Client Reference No. 05327  
Prepared for: Seqwater  
1 June 2026

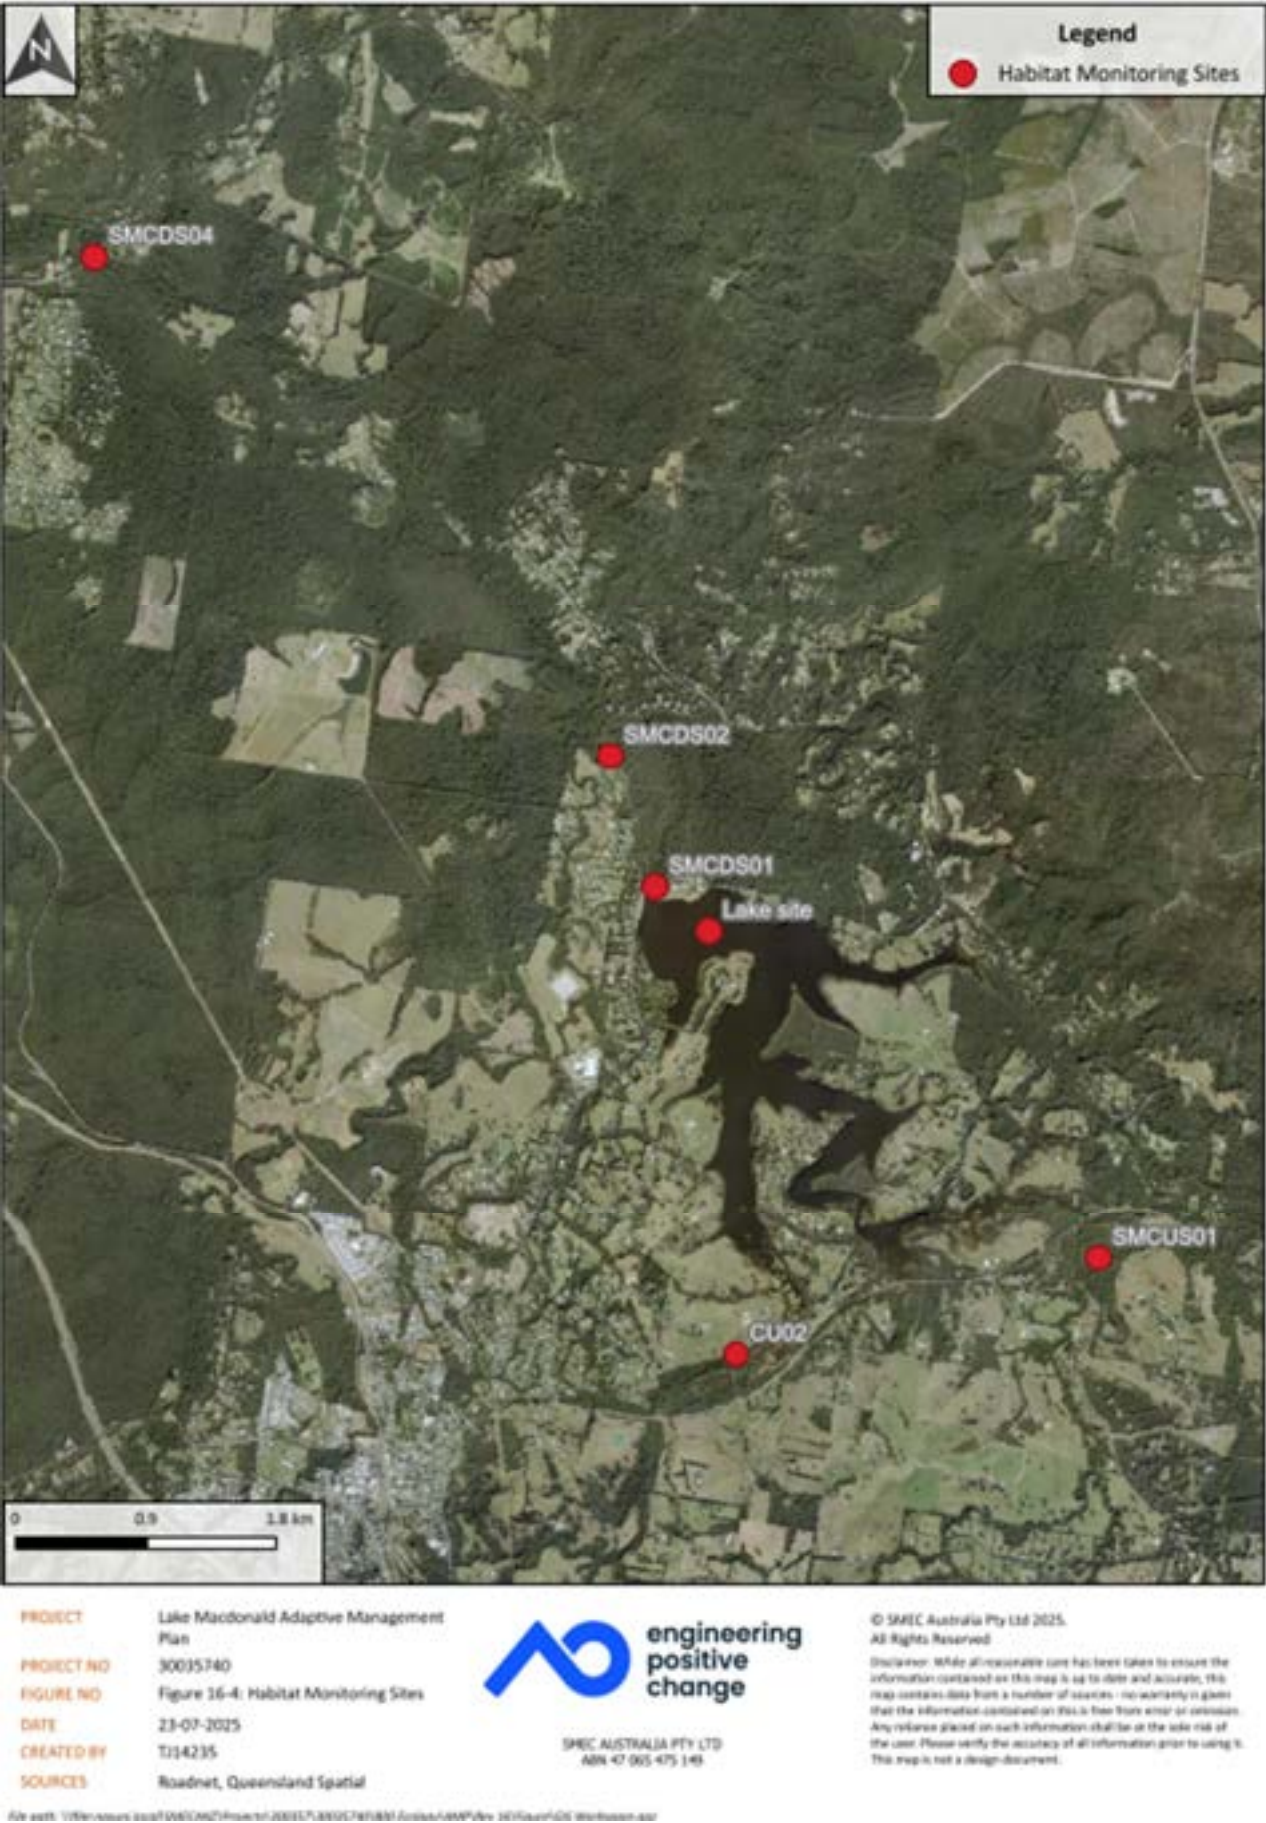
Figure 16-4 Habitat monitoring sites

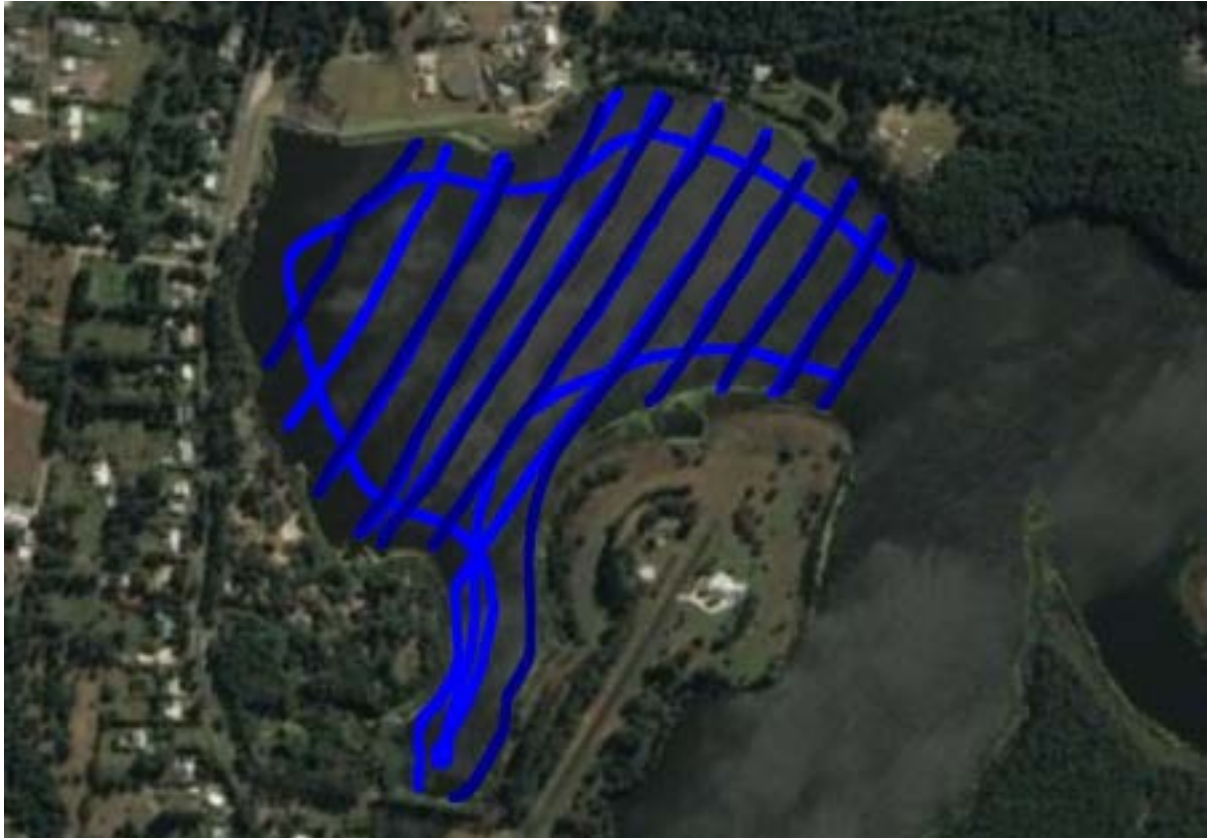
Figure 4. Typical survey transect pattern used in each zone recorded in the internal gps unit in the head unit of the DT-X.
