Northern Pipeline Interconnector 2 (NPI2)

Annual Compliance Report 2023

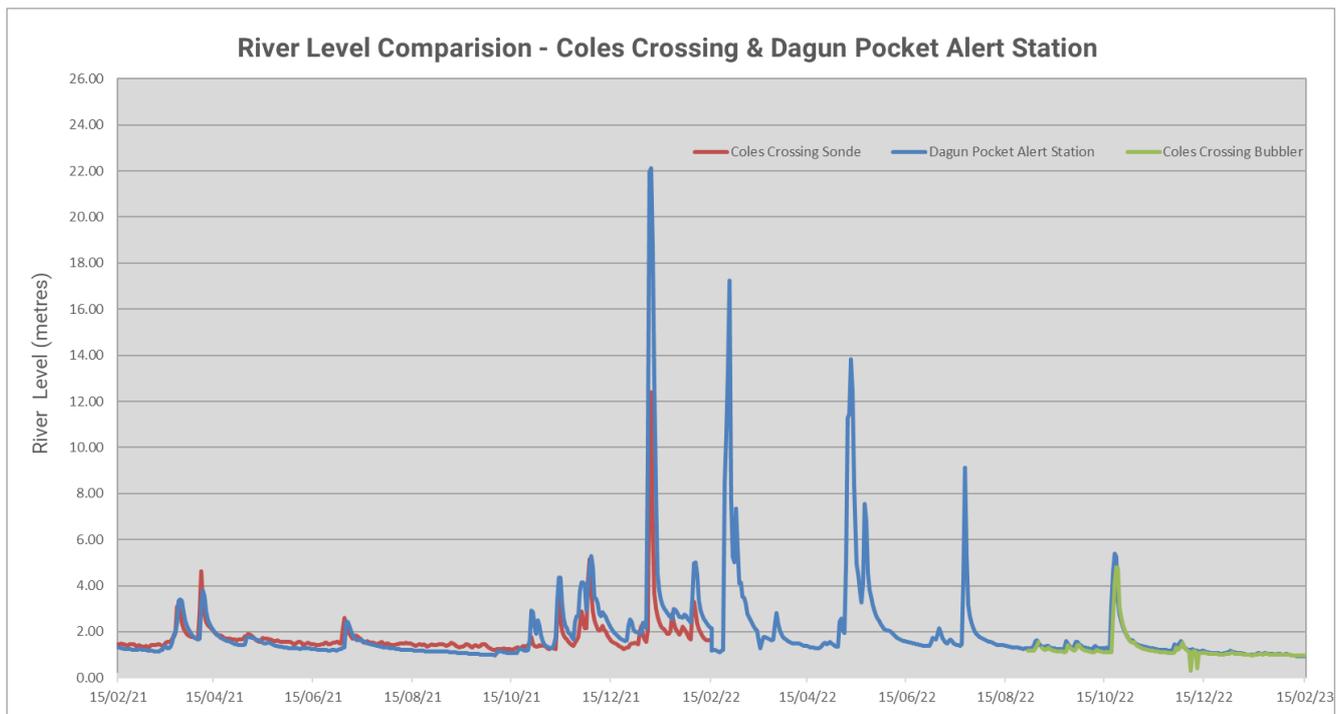
Figure 1 - Two-year comparison of river level data between Coles Crossing and Dagon Pocket 15/02/2021 – 15/02/2023

As mentioned above, the data collected using the Exo Sonde is not as accurate as data collected through a hydrometric instrument, the data has been analysed and adjusted based on historical bathymetric survey data. Figure 3 below demonstrates the comparison of the adjusted water level data from the Coles Crossing Exo Sonde and data from the closest hydrometric station which is Dagon Pocket Alert Station (8.5km downstream of Coles Crossing). This comparison supports the close statistical alignment between the adjusted Exo Sonde and Dagon Pocket – although it should be noted that the Mary River at Dagon Pocket is much wider than at Coles Crossing. Figure 3 also includes new data from the Coles Crossing bubbler. Due to the aforementioned flooding and subsequent project delays, there is a data gap for water level data at Coles Crossing from 15 February 2022, until 30 August 2022 when the level differential pressure sensor (bubbler) was commissioned.

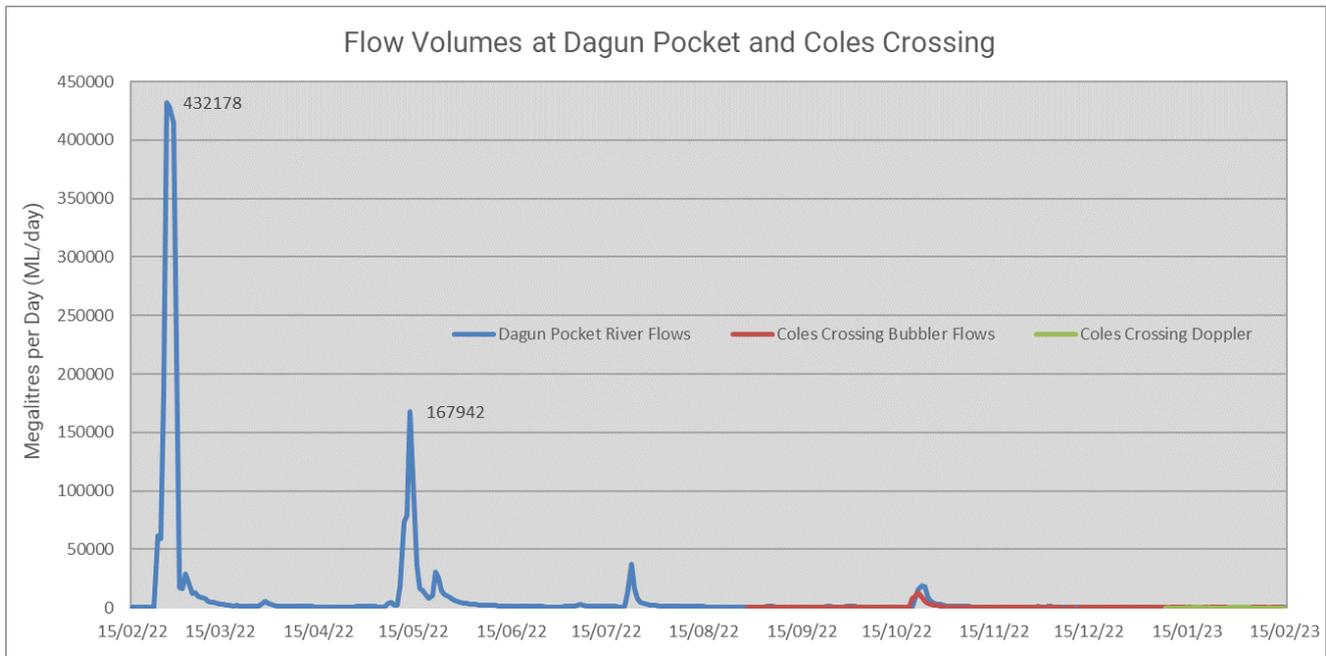
Figure 2 - River flow data between Coles Crossing and Dagon Pocket

Daily flow data obtained from the Dagon Pocket Alert Station and the Coles Crossing bubbler have been illustrated in Figure 2 below. Flood events in late-February and April-May resulted in peaks flows of 432,178 ML/day and 167,942 ML/day respectively.

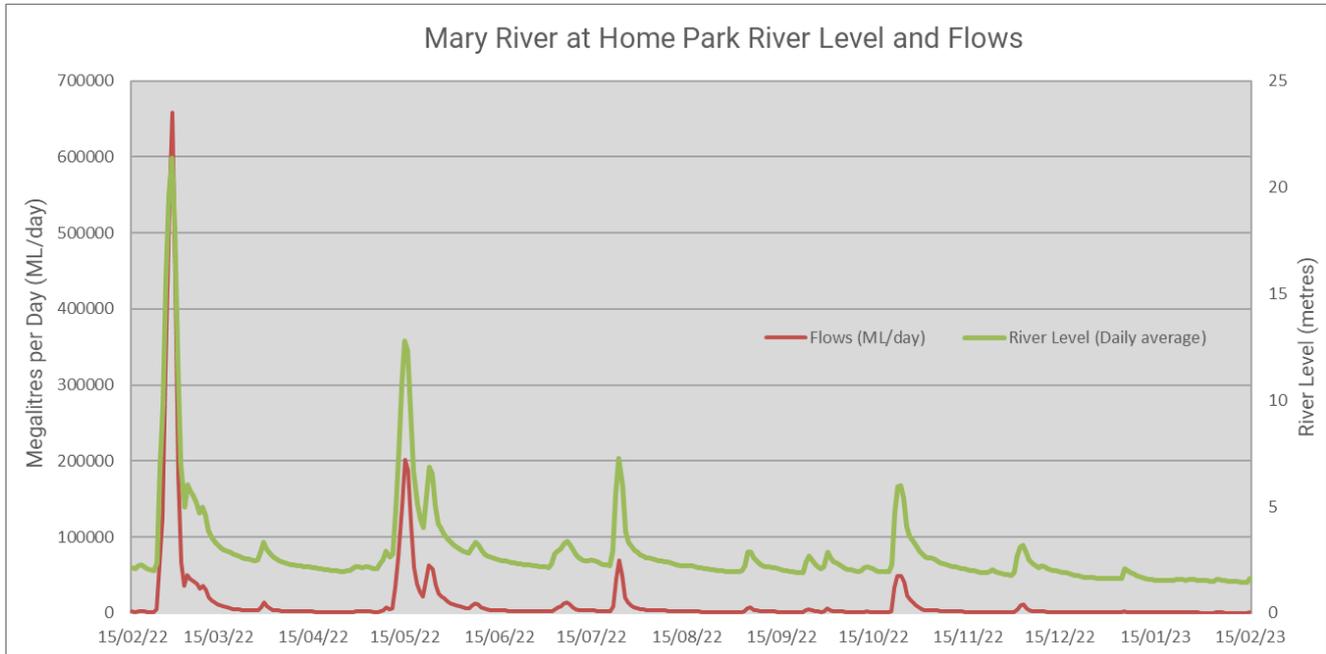
Figure 3 – Daily river flow volumes and height data at Home Park gauging station

EPBC Condition 4 (Condition 4c item ii) Compliance Status – Non-compliant due to partial data gaps at Coles Crossing during the monitoring period from 15 February 2022 and 29 August 2022. Interim monitoring data and indicative flows from Dagon Pocket have analysed to enable an evaluation of operations to achieve the intent of the monitoring program.

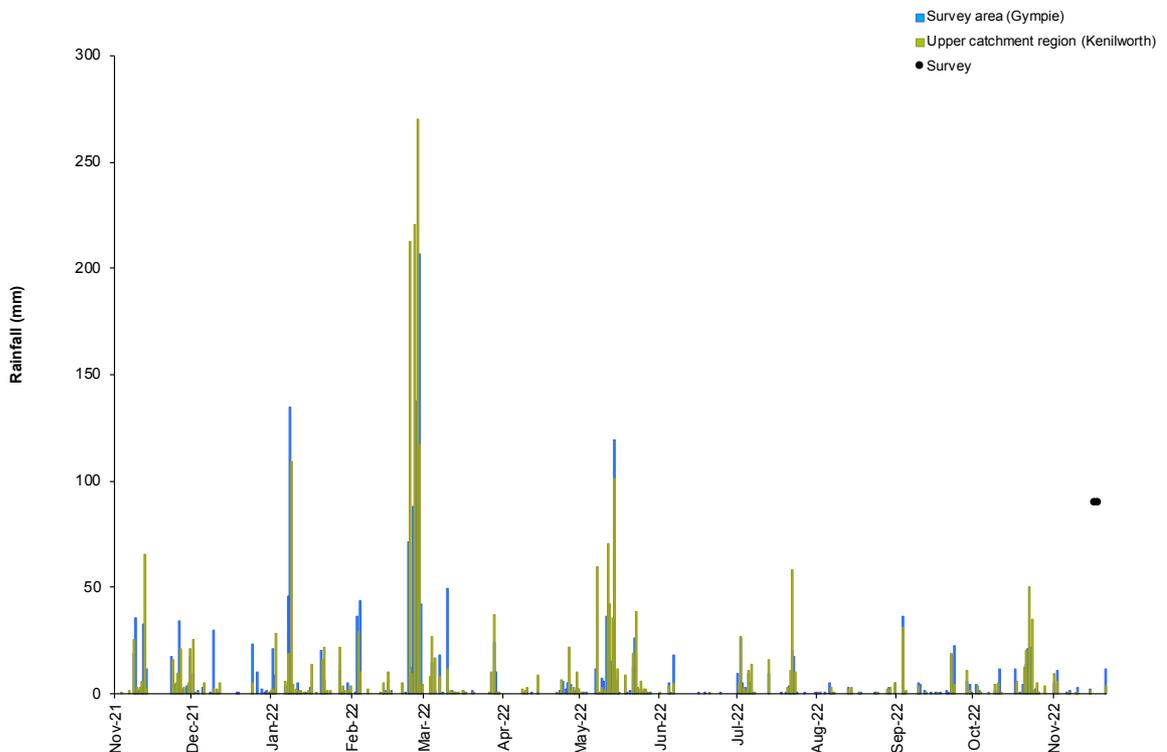
Figure 3.1 Total daily rainfall twelve months prior to the November 2022 survey in the survey area (Gympie) and upper catchment (Kenilworth) (BOM 2022).

There was no notable rainfall in early to mid-November 2022, prior to the survey, and limited rainfall immediately before the survey (Figure 3.1). There were seven relatively large rainfall events (i.e. > 30 mm) in the upper catchment in the 12 months prior to the survey: November 2021, January 2022, February 2022, March 2022, two in May 2022, and July 2022. The late February rainfall events were very high. Rainfall over the past 12 months was above the long-term average recorded at both Kenilworth and Gympie (Figure 3.2), with the exception of December 2021, and March, April, June, August and November 2022 at both Kenilworth and Gympie.

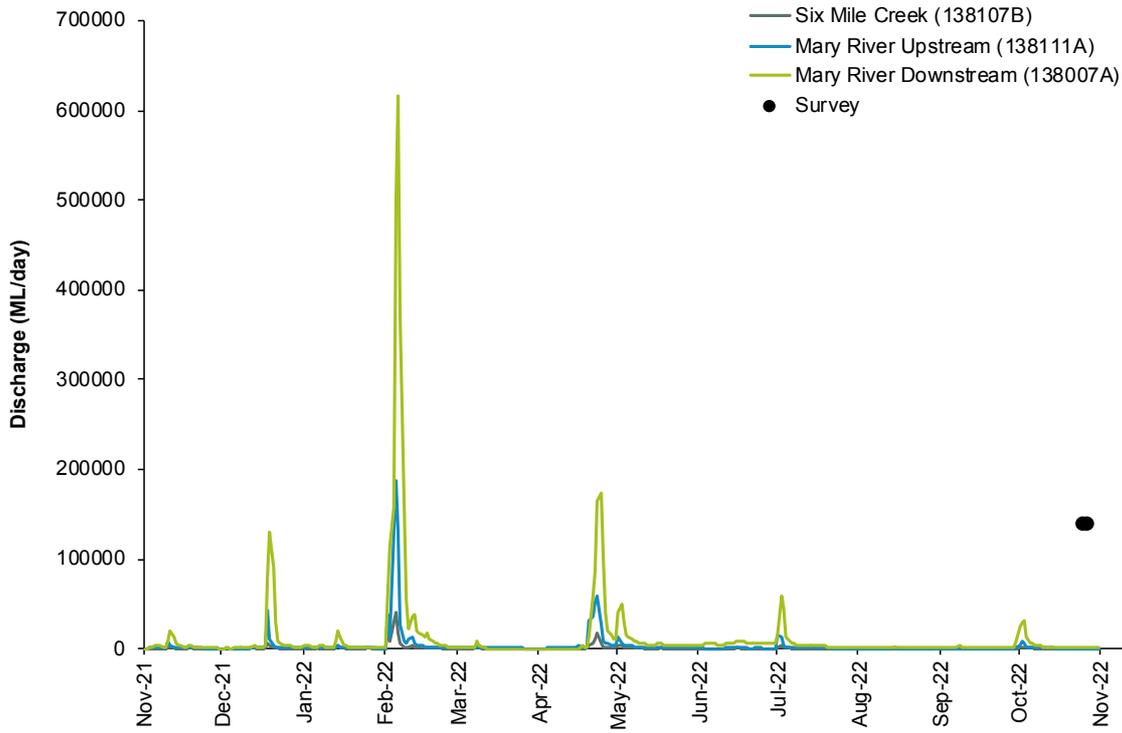
Figure 3.3 Mean daily discharge recorded at stream flow monitoring stations on Six Mile Creek and Mary River (Queensland Government 2022).

Flow and water levels in the Mary River and Six Mile Creek were generally moderate, except in January, February, May and July 2022 where there were brief high to very high flow events (Figure 3.3 and Figure 3.4). In the Mary River in 2022, the maximum recorded high flow event (i.e. 615,862 ML/day) was recorded in February. This event (on 27 February), and the second and third highest events (on 26 and 28 February respectively) were the three highest recorded Mary River flow events since surveys commenced in 2013. Of the ten highest Mary River Flow events recorded since surveys commenced in 2013, nine of them occurred in 2022.

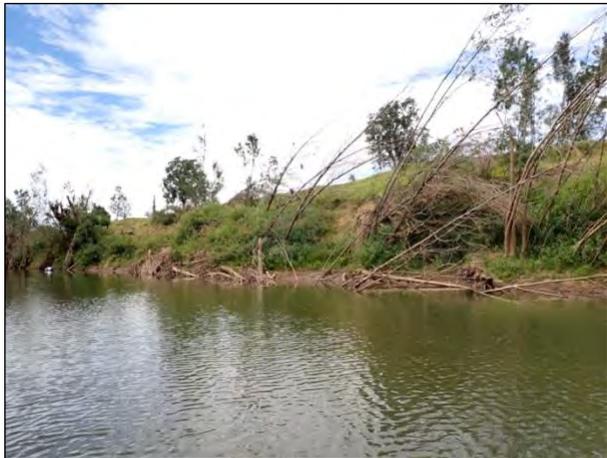
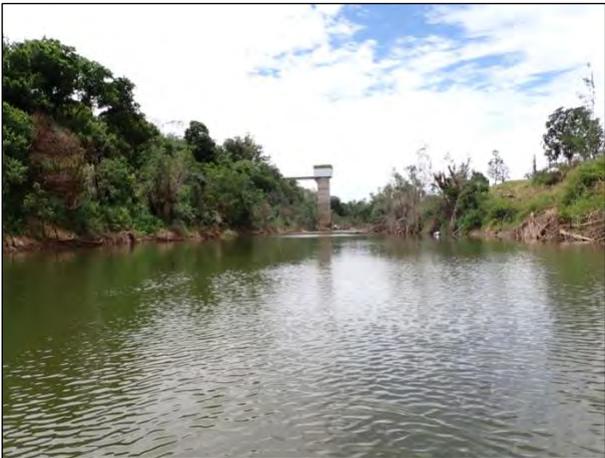
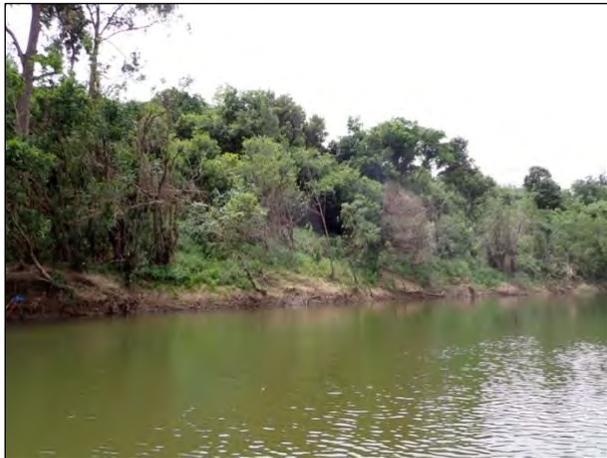
Site MR1

Right bank at mid-site		Upstream at mid-site		Left bank at mid-site	
Water Quality		Flow Conditions			
Temperature (°C)	25.7	Flow habitats present	Connected in-channel pool		
Conductivity (µS/cm)	315.6	Water level	Moderate (at watermark)		
Turbidity (NTU)	7.78	Recent high flow	Yes		
Dissolved oxygen (mg/L)	7.83	Flow	Upstream	Mid-site	Downstream
Dissolved oxygen (% sat)	96.5	Depth (m)	3.3	2.7	1.8
pH	6.43	Width (m)	39	41	35
		Velocity (m/s)	0.07	0.091	0.149

Land Use	Grazing		
Left bank:	Pump station	Right bank:	Grazing
Overall disturbance:	Moderate		
Bank Assessment			
Left Bank		Right Bank	
Bank material:	Sand, clay	Bank material:	Sand, clay
Bank height:	5 m	Bank height:	5 m
Bank slope:	Steep	Bank slope:	Steep
Bank shape:	Concave	Bank shape:	Concave
Vegetation cover:	Moderate	Vegetation cover:	Moderate
Vegetation type:	Grass, shrubs and trees	Vegetation type:	Grass, shrubs and trees
Shading of river:	5%	Shading of river:	5%
Trailing bank vegetation:	5%	Trailing bank vegetation:	5%
Erosion Assessment			
Left Bank		Right Bank	
Erosion:	Moderate	Erosion:	Moderate
Stability:	Moderate	Stability:	Moderate
Disturbances:	Weeds, cleared vegetation	Disturbances:	Weeds, cleared vegetation, access tracks
Bed Assessment			
Substrate material:	Gravel, sand and silt/clay		
Bed stability rating:	Bed stable	Sediment deposits:	Silt

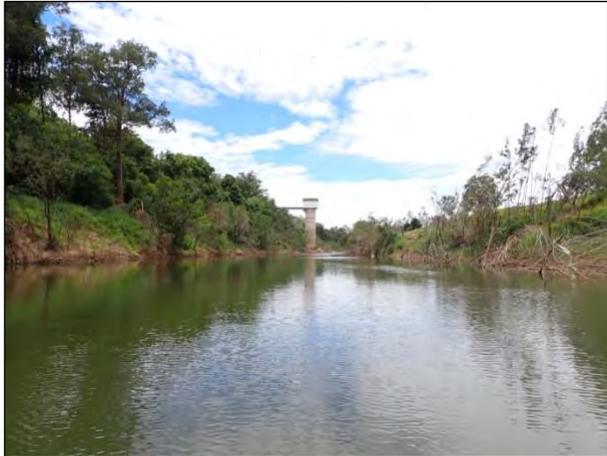
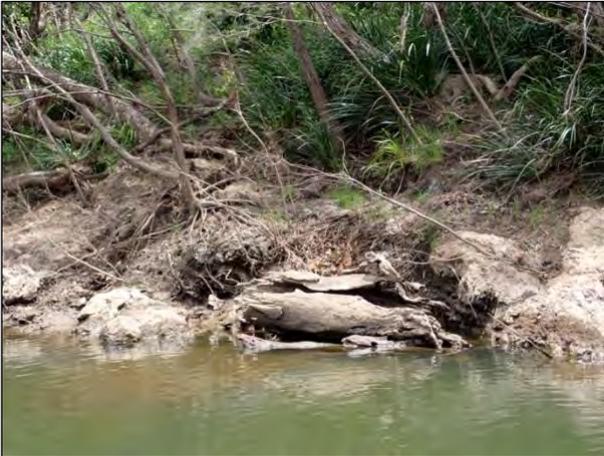
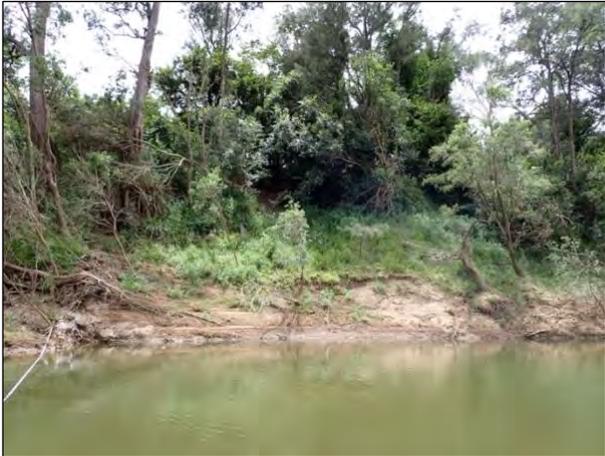
Table B.2 Site MR1 – habitat assessment for MNES species

Connected pool with slow flow		Logs suitable for basking	
Erosion of sandy nesting banks			
Habitat	Present / Absent	Habitat	Present / Absent
Isolated pools	Absent	Individual log (diameter >250mm)	Present
Connected pools	Present	Individual branch (diameter <300mm)	Present
Riffle	Absent	Branch pile <50% dense (diameter <300mm)	Present
Run	Absent	Branch pile >50% dense (diameter <300mm)	Present
Aquatic vegetation	Absent	Log jam <50% dense (diameter >300mm)	Present
Turtle basking spots	Present	Log jam >50% dense (diameter >300mm)	Absent
Turtle nesting habitat	Absent	Terrestrial leaves and twigs	Present – sparse
Submerged boulders / rock crevices	Absent

MNES Species Habitat	
Overall suitability	Suitable
Comments:	Patches of potentially suitable habitat for Mary River cod, White-Throated Snapping turtles, Mary River turtles and Australian Lungfish were scattered throughout the site. Pools were deep to 3 m. Some banks were moderately shaded and contained large woody debris. Turtle basking spots were present in limited numbers, while turtle nesting habitat and submerged boulders and rock crevices were absent at MR1. Aquatic vegetation was absent.

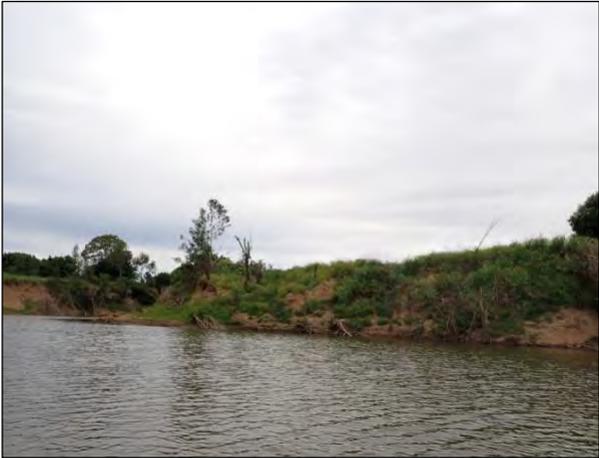
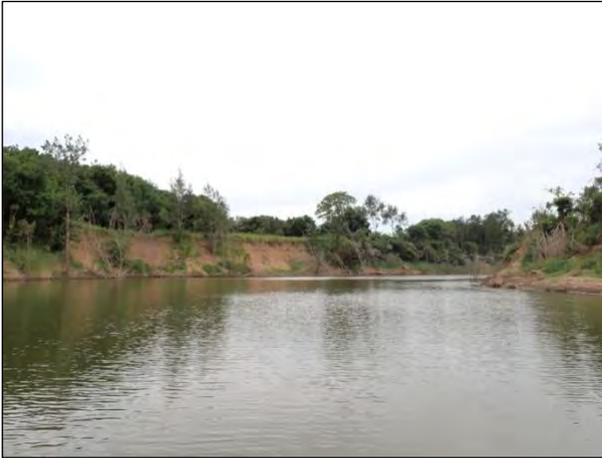
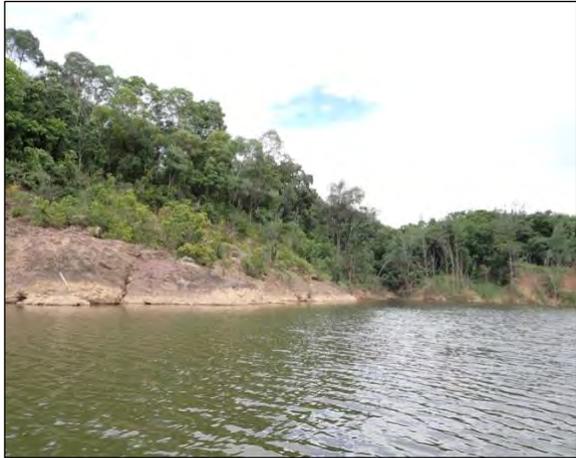
Site MR2

Right bank at mid-site		Upstream at mid-site		Left bank at mid-site	
Water Quality		Flow Conditions			
Temperature (°C)	25.96	Flow habitats present	Connected in-channel pool		
Conductivity (µS/cm)	338.5	Water level	Moderate (at watermark)		
Turbidity (NTU)	11.1	Recent high flow	Yes		
Dissolved oxygen (mg/L)	8.94	Flow	Upstream	Mid-site	Downstream
Dissolved oxygen (% sat)	110.7	Depth (m)	3.4	5	3
pH	7.72	Width (m)	57	33	60
		Velocity (m/s)	0.06	0.085	0.072

Land Use	Grazing land		
Left bank:	Grazing	Right bank:	Grazing
Overall disturbance:	High		
Bank Assessment			
Left Bank		Right Bank	
Bank material:	Boulder, cobble, sand	Bank material:	Cobble, sand, silt/clay
Bank height:	8 m	Bank height:	10 m
Bank slope:	Steep	Bank slope:	Steep
Bank shape:	Convex	Bank shape:	Convex
Vegetation cover:	Moderate	Vegetation cover:	Moderate
Vegetation type:	Grass, shrubs, trees	Vegetation type:	Grass
Shading of river:	5%	Shading of river:	10%
Trailing bank vegetation:	5%	Trailing bank vegetation:	25%
Erosion Assessment			
Left Bank		Right Bank	
Erosion:	Moderate	Erosion:	Moderate
Stability:	Moderate	Stability:	Moderate
Disturbances:	Erosion	Disturbances:	Erosion, weeds, cleared vegetation
Bed Assessment			
Substrate material:	Pebble, gravel, sand and silt/clay		
Bed stability rating:	Bed stable	Sediment deposits:	Sand

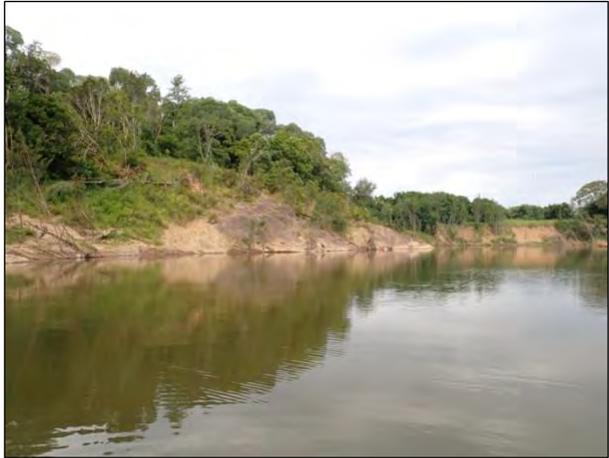
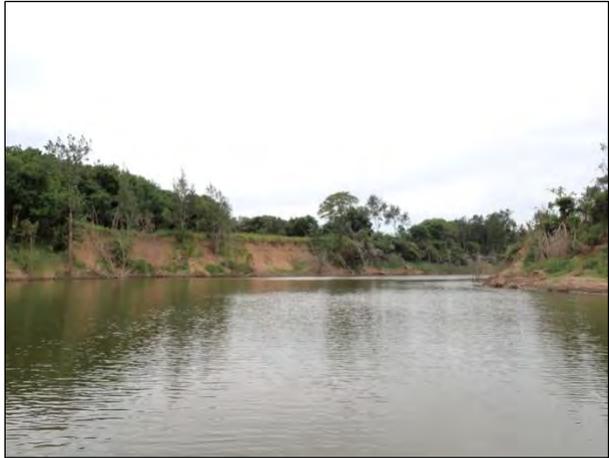
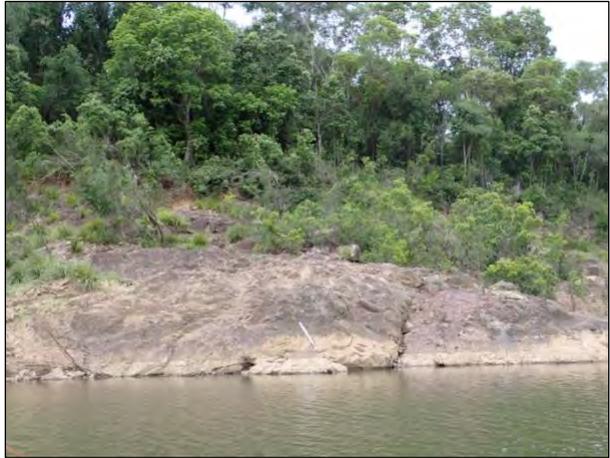
Table B.5 MR2 – habitat assessment for MNES species.

Eroded sandy/pebble banks		Connected pool with slow flow

Rocky banks			
Habitat	Present / Absent	Habitat	Present / Absent
Isolated pools	Absent	Individual log (diameter >250mm)	Present
Connected pools	Present	Individual branch (diameter <300mm)	Present
Riffle	Absent	Branch pile <50% dense (diameter <300mm)	Absent
Run	Absent	Branch pile >50% dense (diameter <300mm)	Absent
Aquatic vegetation	Absent	Log jam <50% dense (diameter >300mm)	Absent
Turtle basking spots	Absent	Log jam >50% dense (diameter >300mm)	Absent
Turtle nesting habitat	Present	Terrestrial leaves and twigs	Present – sparse
Submerged boulders / rock crevices	Present

MNES Species Habitat.	
Overall suitability	Suitable
Comments:	Patches of potentially suitable habitat for Mary River turtles and White-Throated Snapping turtles were observed, however basking locations were largely absent and turtle nesting habitats were eroded. Deep pools (>4 m) throughout the site provide good habitat for both Australian Lungfish and Mary River cod. Submerged large woody debris provide habitat and shelter. Aquatic plants were not observed at site MR2.

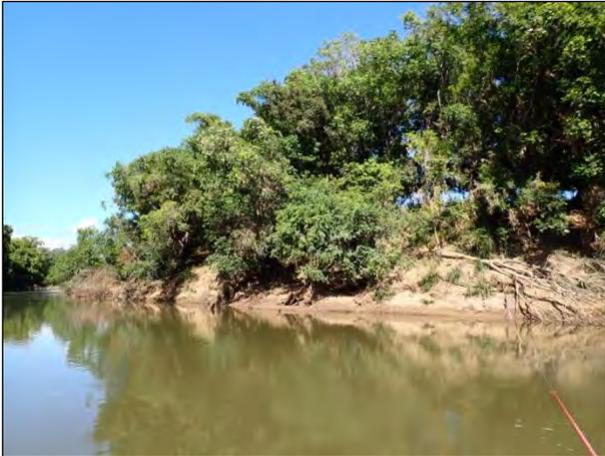
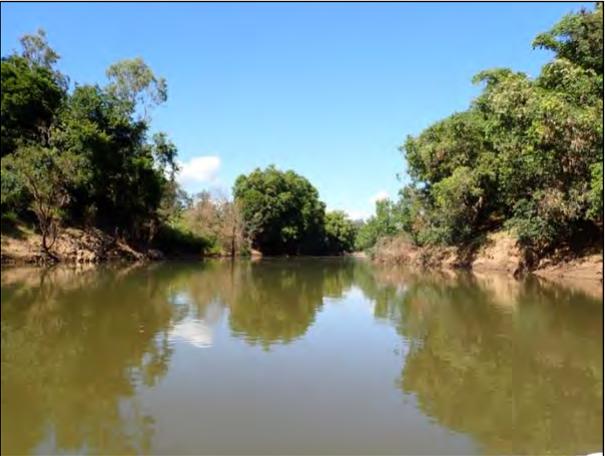
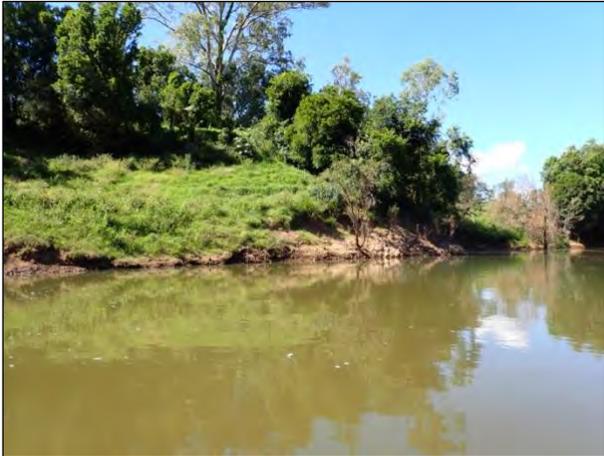
Site MR4

Right bank at mid-site		Upstream at mid-site		Left bank at mid-site	
Water Quality		Flow Conditions			
Temperature (°C)	23.95	Flow habitats present	Connected in-channel pool		
Conductivity (µS/cm)	360.1	Water level	Moderate (at watermark)		
Turbidity (NTU)	12.4	Recent high flow	Yes		
Dissolved oxygen (mg/L)	7.87	Flow	Upstream	Mid-site	Downstream
Dissolved oxygen (% sat)	93.8	Depth (m)	2.3	4	0.7
pH	7.81	Width (m)	26	65	47
		Velocity (m/s)	0.333	0.19	0.19

Land Use	Grazing		
Left bank:	Grazing	Right bank:	Grazing
Overall disturbance:	Very high		
Bank Assessment			
Left Bank		Right Bank	
Bank material:	Silt/clay	Bank material:	Silt/clay
Bank height:	5 m	Bank height:	7 m
Bank slope:	Steep	Bank slope:	Steep
Bank shape:	Convex	Bank shape:	Convex
Vegetation cover:	Some	Vegetation cover:	Moderate
Vegetation type:	Grass, shrubs and trees	Vegetation type:	Grass, shrubs and trees
Shading of river:	5%	Shading of river:	5%
Trailing bank vegetation:	5%	Trailing bank vegetation:	5%
Erosion Assessment			
Left Bank		Right Bank	
Erosion:	Some	Erosion:	Moderate
Stability:	Moderate	Stability:	Moderate
Disturbances:	Weeds, cattle and cleared vegetation	Disturbances:	Weeds, erosion and cleared vegetation
Bed Assessment			
Substrate material:	Pebble, gravel, sand and silt/clay		
Bed stability rating:	Bed stable	Sediment deposits:	Sand and silt

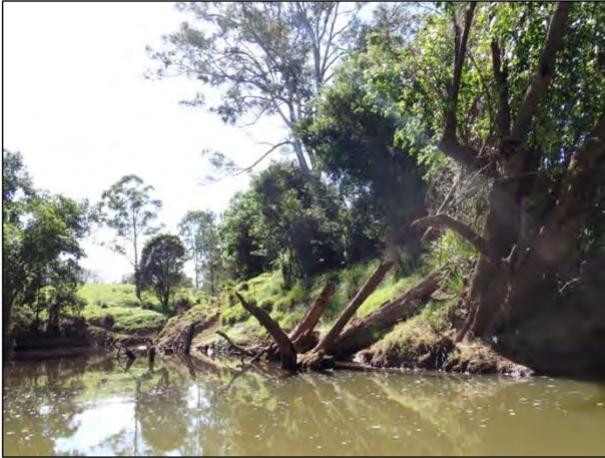
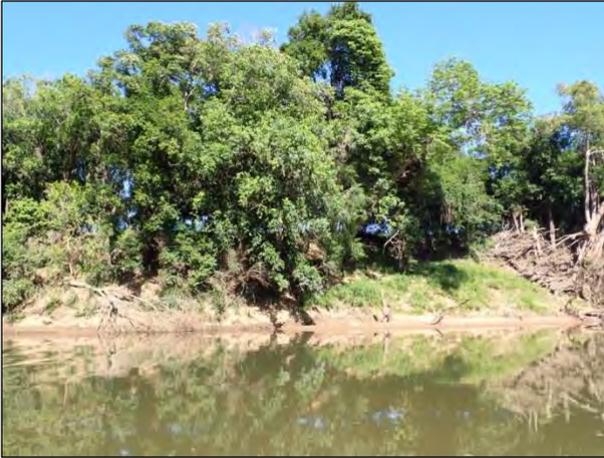
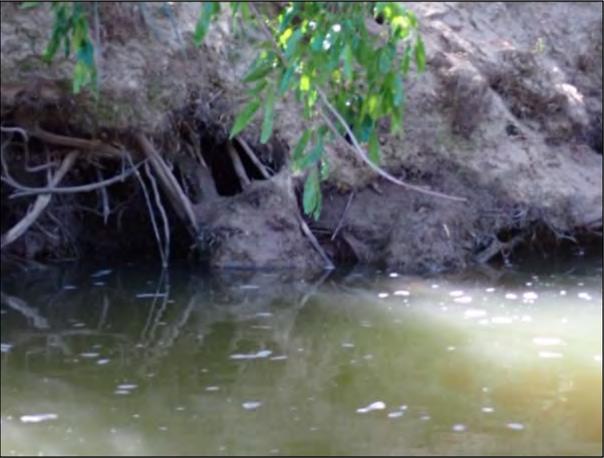
Table B.8 Habitat assessment for MNES species at site MR4.

Logs and woody debris suitable for basking		Sandy bank suitable for nesting

Undercut banks provide habitat	
Habitat	Present / Absent	Habitat	Present / Absent
Isolated pools	Absent	Individual log (diameter >250mm)	Present
Connected pools	Present	Individual branch (diameter <300mm)	Present
Riffle	Absent	Branch pile <50% dense (diameter <300mm)	Present
Run	Absent	Branch pile >50% dense (diameter <300mm)	Present
Aquatic vegetation	Absent	Log jam <50% dense (diameter >300mm)	Present
Turtle basking spots	Present	Log jam >50% dense (diameter >300mm)	Absent
Turtle nesting habitat	Present	Terrestrial leaves and twigs	Present – sparse
Submerged boulders / rock crevices	Present

MNES Species Habitat	
Overall suitability	Suitable
	Suitable habitat for Mary River cod, Australian Lungfish, White-Throated Snapping turtles and Mary River turtles was scattered through the site. Deep pools (>4 m) were present throughout the site during the 2022 survey. Most deep pools contained large woody debris. Turtle basking spots were present in the form of exposed logs. Sandy banks suitable for nesting habitat were present. No aquatic vegetation was observed at site.

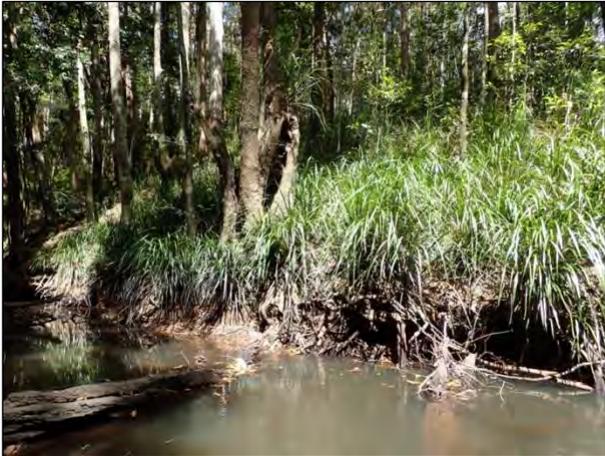
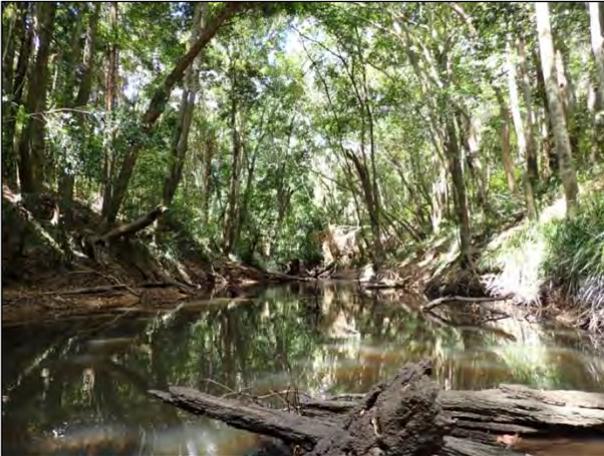
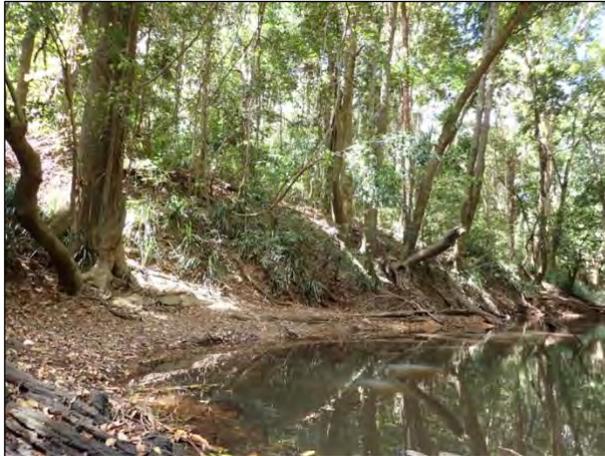
Site SMC4

Right bank at mid-site		Upstream at mid-site		Left bank at mid-site	
Water Quality		Flow Conditions			
Temperature (°C)	20.69	Flow habitats present	Connected in-channel pool, riffle, run		
Conductivity (µS/cm)	170.2	Water level	Moderate (at watermark)		
Turbidity (NTU)	11	Recent high flow	Yes		
Dissolved oxygen (mg/L)	5.95	Flow	Upstream	Mid-site	Downstream
Dissolved oxygen (% sat)	67	Depth (m)	0.5	0.8	0.6
pH	6.98	Width (m)	8.5	9.5	10
		Velocity (m/s)	0.165	0.291	0.125

Land Use	Grazing		
Left bank:	Grazing	Right bank:	Grazing
Overall disturbance:	High		
Bank Assessment			
Left Bank		Right Bank	
Bank material:	Sand and silt/clay	Bank material:	Sand and silt/clay
Bank height:	3 m	Bank height:	3 m
Bank slope:	Steep	Bank slope:	Moderate - steep
Bank shape:	Concave	Bank shape:	Convex
Vegetation cover:	Moderate	Vegetation cover:	Extensive
Vegetation type:	Shrubs (<i>Lomandra</i> sp.) and trees	Vegetation type:	Shrubs (<i>Lomandra</i> sp.) and trees
Shading of river:	25%	Shading of river:	25%
Trailing bank vegetation:	5%	Trailing bank vegetation:	5%
Erosion Assessment			
Left Bank		Right Bank	
Erosion:	Some	Erosion:	Moderate
Stability:	Moderate	Stability:	Moderate
Disturbances:	Roads (bridge)	Disturbances:	Roads (bridge)
Bed Assessment			
Substrate material:	Gravel, sand, silt/clay		
Bed stability rating:	Bed stable	Sediment deposits:	Sand and silt

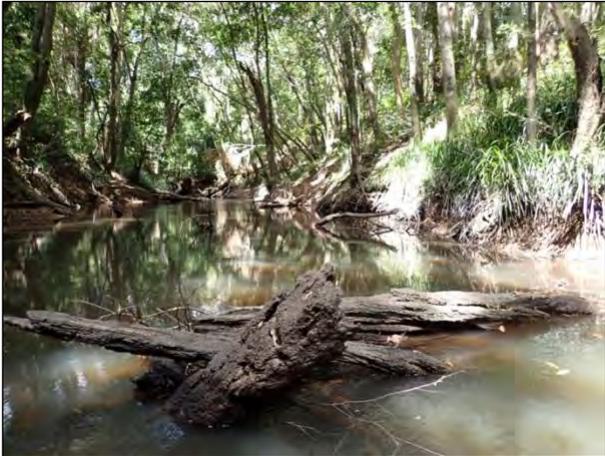
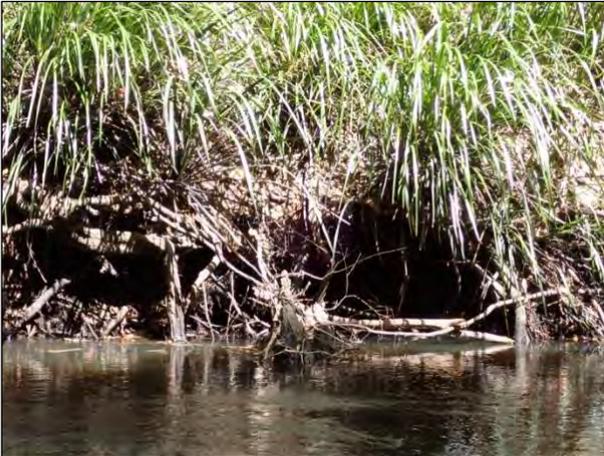
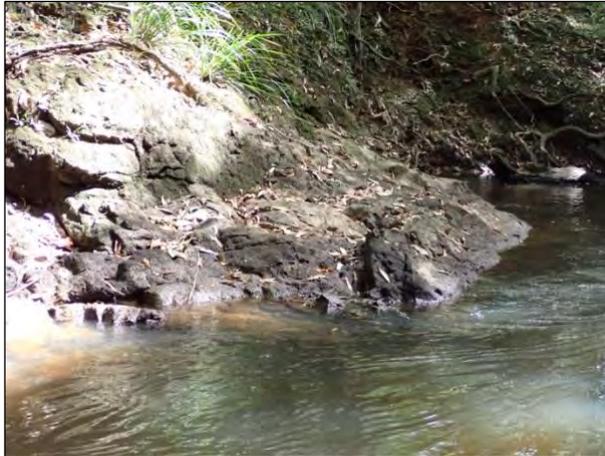
Table B.11 Site SMC4 – habitat assessment for MNES species.

Woody debris provides basking spot		Undercut banks provide habitat

Sandy bank provides nesting habitat	
Habitat	Present / Absent	Habitat	Present / Absent
Isolated pools	Absent	Individual log (diameter >250mm)	Present
Connected pools	Present	Individual branch (diameter <300mm)	Present
Riffle	Present	Branch pile <50% dense (diameter <300mm)	Present
Run	Present	Branch pile >50% dense (diameter <300mm)	Present
Aquatic vegetation	Absent (none in-stream)	Log jam <50% dense (diameter >300mm)	Present
Turtle basking spots	Present	Log jam >50% dense (diameter >300mm)	Present
Turtle nesting habitat	Present	Terrestrial leaves and twigs	Present – dense
Submerged boulders / rock crevices	Absent

MNES Species Habitat	
Overall suitability	Suitable for White-Throated Snapping turtles and Mary River turtles, potentially suitable for juvenile Mary River cod, not suitable for Australian Lungfish.
Comments:	Moderately shaded, shallow pools (<1 m) throughout the majority of the reach. Submerged woody debris was present across the site, providing potential habitat for juvenile Mary River cod. No suitable habitat for the Australian Lungfish was present. The presence of flowing water in shallow riffles and a sandy substrate provide habitat that is suitable for White-Throated Snapping turtles and Mary River turtles, in addition to sandy nesting habitat on the banks. Woody debris provided turtle basking spots.

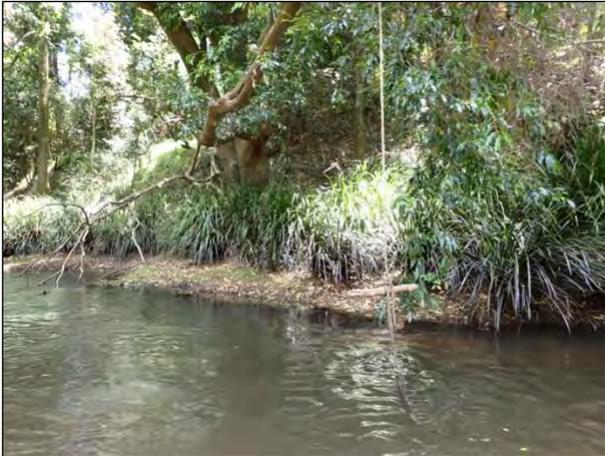
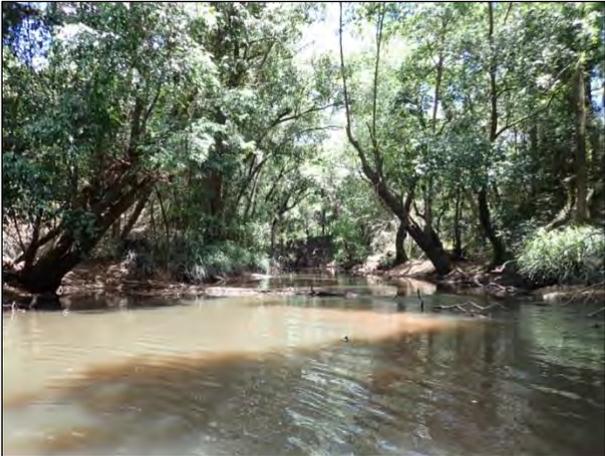
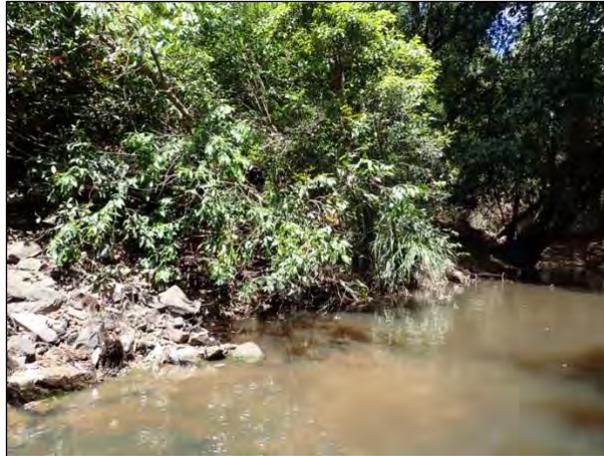
Site SMC5

Right bank at mid-site		Upstream at mid-site		Left bank at mid-site	
Water Quality		Flow Conditions			
Temperature (°C)	22.8	Flow habitats present	Connected in-channel pool, riffle, run		
Conductivity (µS/cm)	189.3	Water level	Moderate (at watermark)		
Turbidity (NTU)	11.1	Recent high flow	Yes		
Dissolved oxygen (mg/L)	5.9	Flow	Upstream	Mid-site	Downstream
Dissolved oxygen (% sat)	69.2	Depth (m)	0.9	0.5	0.5
pH	8.1	Width (m)	8	9	13.5
		Velocity (m/s)	0.174	0.145	0.326

Land Use	Grazing		
Left bank:	Grazing	Right bank:	Grazing
Overall disturbance:	Moderate to low		
Bank Assessment			
Left Bank		Right Bank	
Bank material:	Sand and silt/clay	Bank material:	Sand
Bank height:	6 m	Bank height:	6 m
Bank slope:	Steep	Bank slope:	Steep
Bank shape:	Stepped	Bank shape:	Stepped
Vegetation cover:	Moderate	Vegetation cover:	Moderate
Vegetation type:	Trees, shrubs (<i>Lomandra</i> sp.), grasses	Vegetation type:	Trees, shrubs (<i>Lomandra</i> sp.), grasses
Shading of river:	50%	Shading of river:	50%
Trailing bank vegetation:	5%	Trailing bank vegetation:	5%
Erosion Assessment			
Left Bank		Right Bank	
Erosion:	Some	Erosion:	Some
Stability:	Moderate	Stability:	Moderate
Disturbances:	Access tracks, erosion, road	Disturbances:	Access tracks, erosion, road
Bed Assessment			
Substrate material:	Cobble, pebble, gravel, sand, silt/clay		
Bed stability rating:	Bed stable	Sediment deposits:	Sand

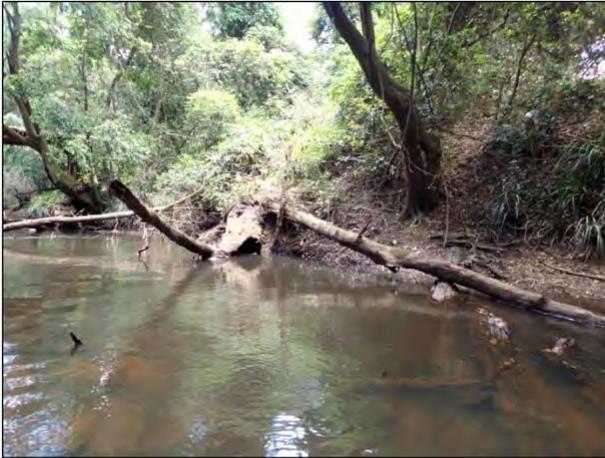
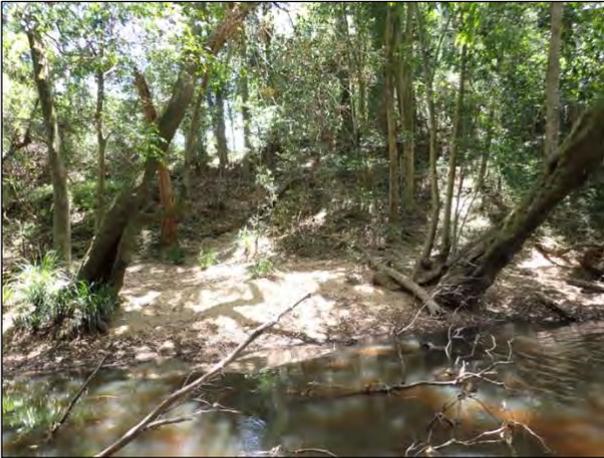
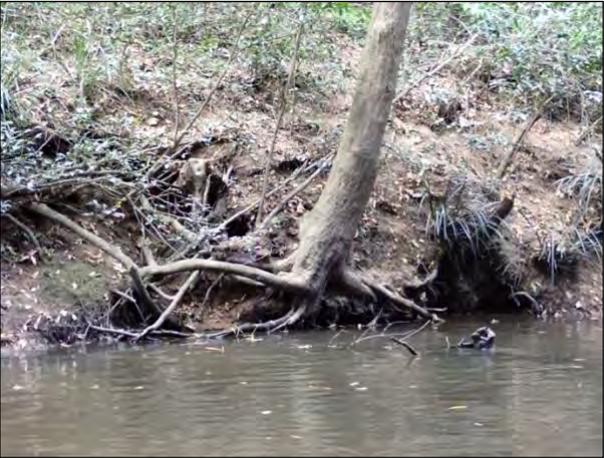
Table B.14 Site SMC5 – habitat assessment for MNES species.

Logs provide basking habitat		Sandy banks provide nesting habitat	
Undercut banks provide habitat			
Habitat	Present / Absent	Habitat	Present / Absent
Isolated pools	Absent	Individual log (diameter >250mm)	Present
Connected pools	Present	Individual branch (diameter <300mm)	Present
Riffle	Present	Branch pile <50% dense (diameter <300mm)	Present
Run	Present	Branch pile >50% dense (diameter <300mm)	Present
Aquatic vegetation	Absent	Log jam <50% dense (diameter >300mm)	Present
Turtle basking spots	Present	Log jam >50% dense (diameter >300mm)	Present
Turtle nesting habitat	Present	Terrestrial leaves and twigs	Present – Dense
Submerged boulders / rock crevices	Present		
Overall suitability	Potential for Mary River cod, White-Throated Snapping turtle and Mary River turtle, unsuitable for Australian Lungfish.
