Flora & Fauna (Dewatering)
Management Plan

Lake Macdonald (Six Mile Creek) Dam Improvement Project

Client Reference No. 05327
Prepared for: Seqwater
18 August 2025

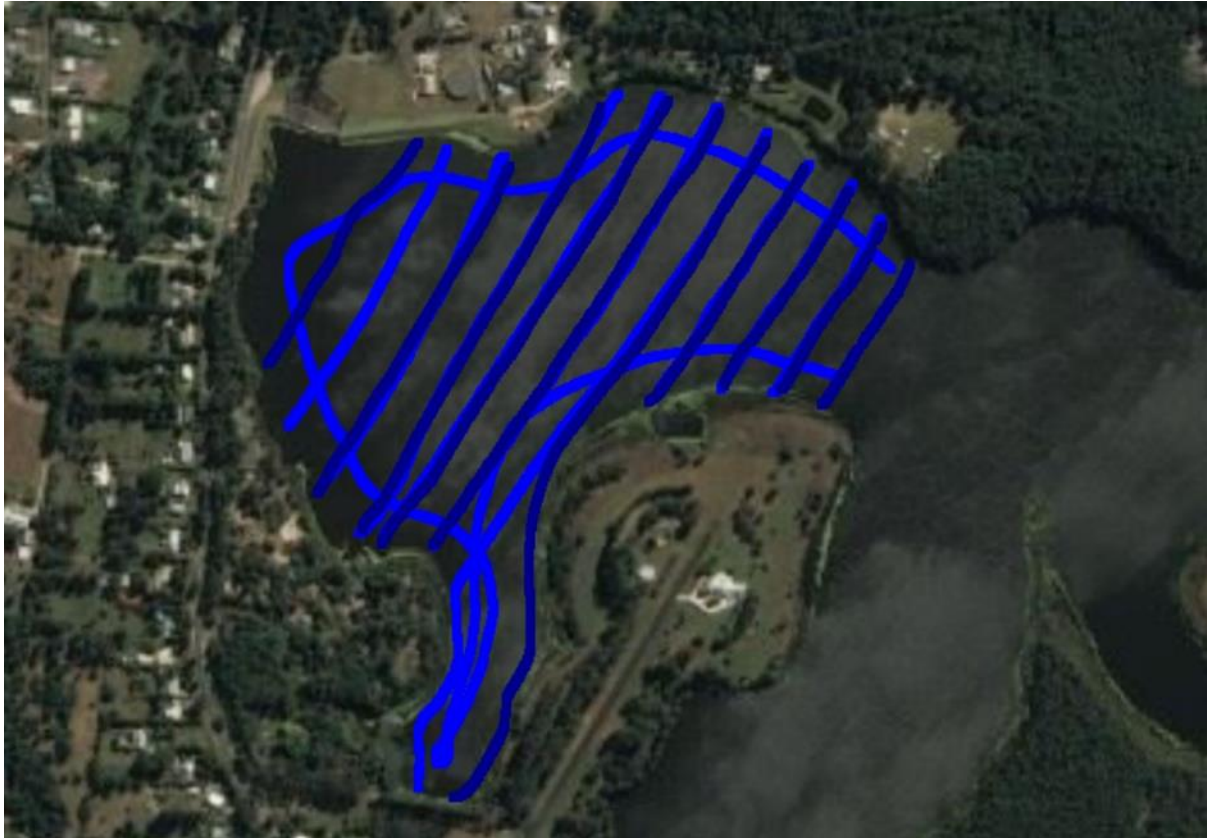
Figure 4. Typical survey transect pattern used in each zone recorded in the internal gps unit in the head unit of the DT-X.
