# Lake Macdonald Dam Improvement Project

Quarterly Compliance and Monitoring Summary Report for the Coordinator-General

JH Document Number: 7225-JHG-REP-SQ-001[A] LMDIP Quarterly Compliance Monitoring Report for the Coordinator General

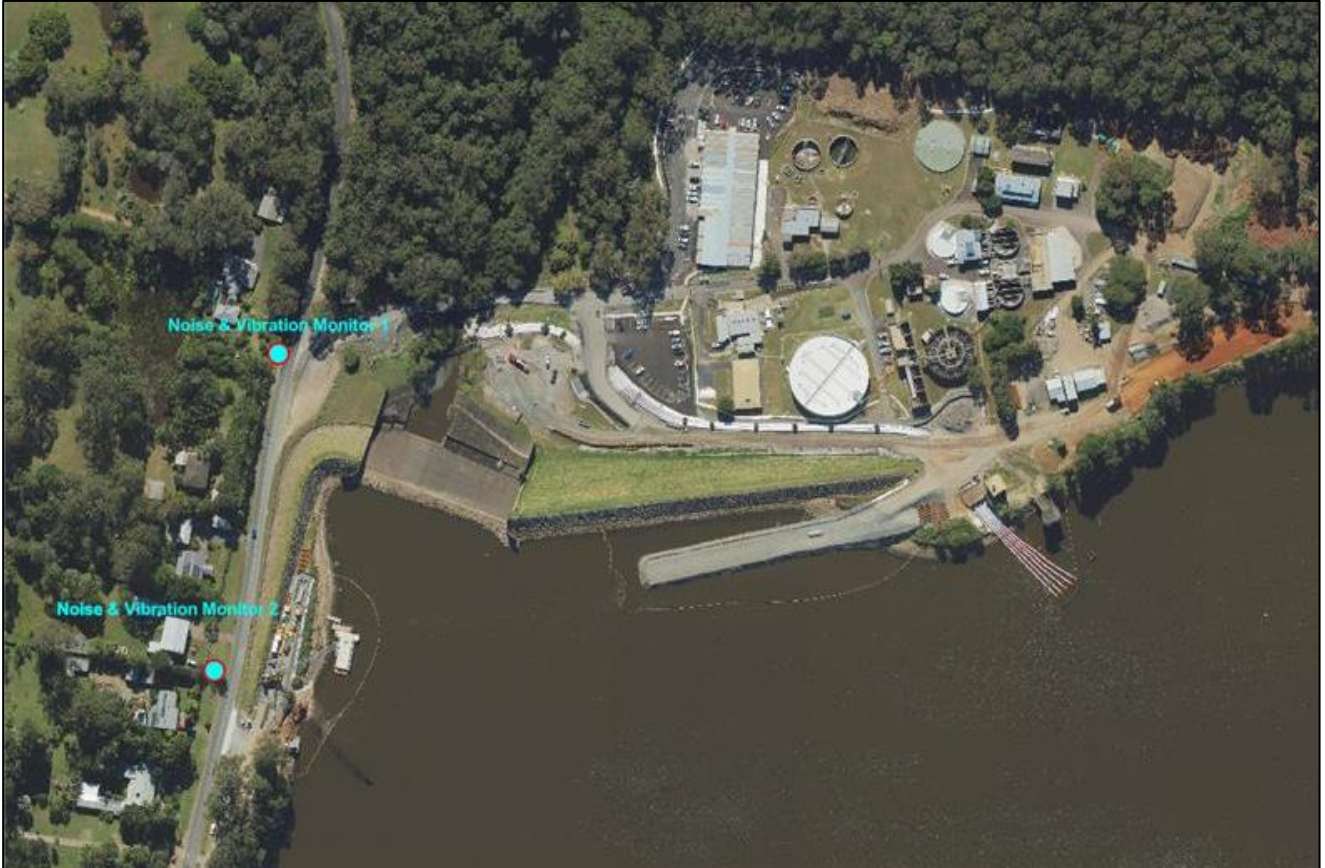
Figure 2: Noise and Vibration Monitoring Locations

Ideally monitoring for compliance would occur 1m from the façade of the affected receiver, however the project does not have access to any such locations. Consequently, N&V1 and N&V2 have been located adjacent to Lake Macdonald Drive where access and security for the monitoring equipment is available. As a result, the monitoring data collected is significantly influenced by road traffic that is (in the majority ~97.5%) not construction related.

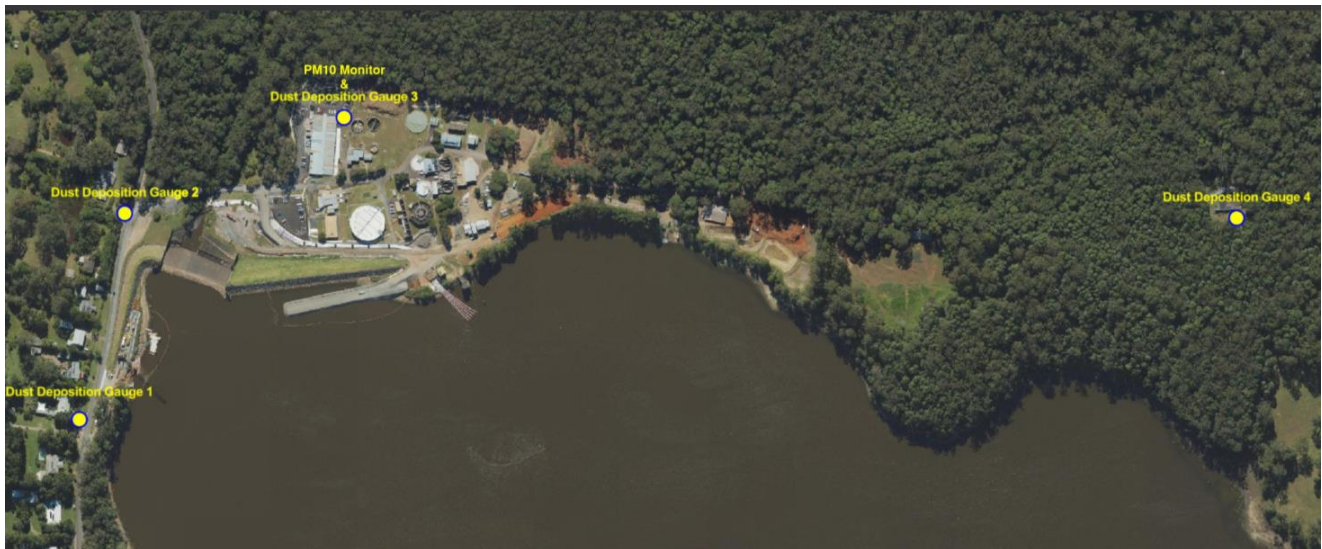
Figure 3: Air Quality Monitoring Locations, (including PM10 Monitor)

Air quality has been monitored throughout the period via dust deposition gauges and 1 real-time PM10 monitor at the locations as shown in Figure 3.

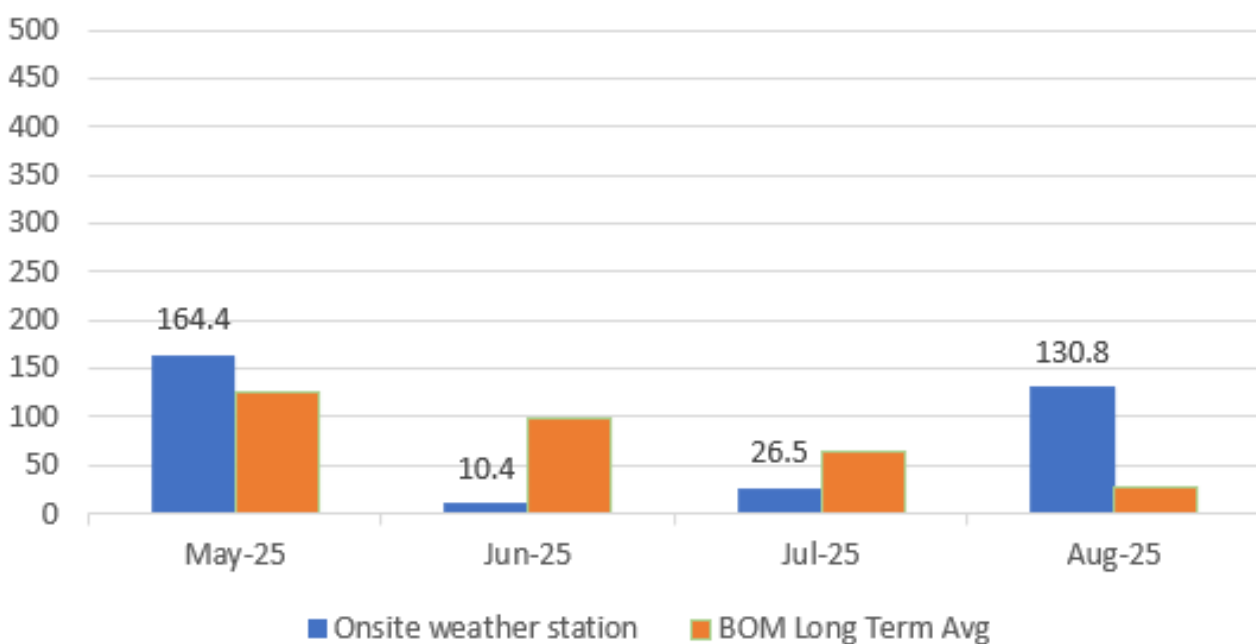
### LMDIP - Monthly Rainfall

Rainfall observed on site was elevated in May, low in June and July and highly elevated in August
