# **Lake Macdonald Dam Improvement Project**

Quarterly Compliance  
and Monitoring  
Summary Report for  
the Coordinator-  
General

Reporting period: 1 June 2026 – 31 August 2026

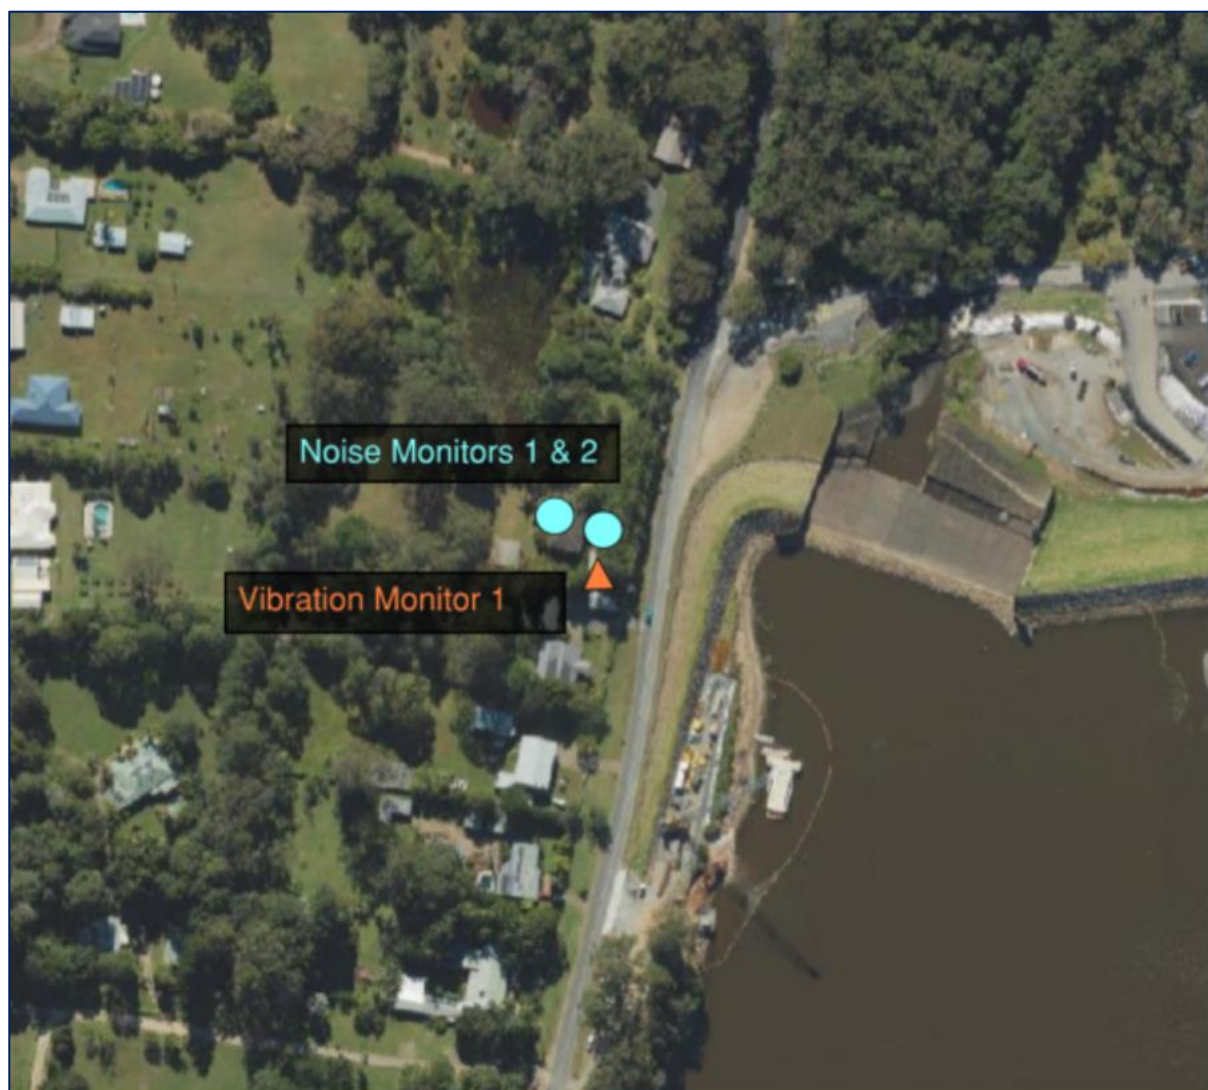
**Figure 14: Noise and Vibration Monitoring Location**

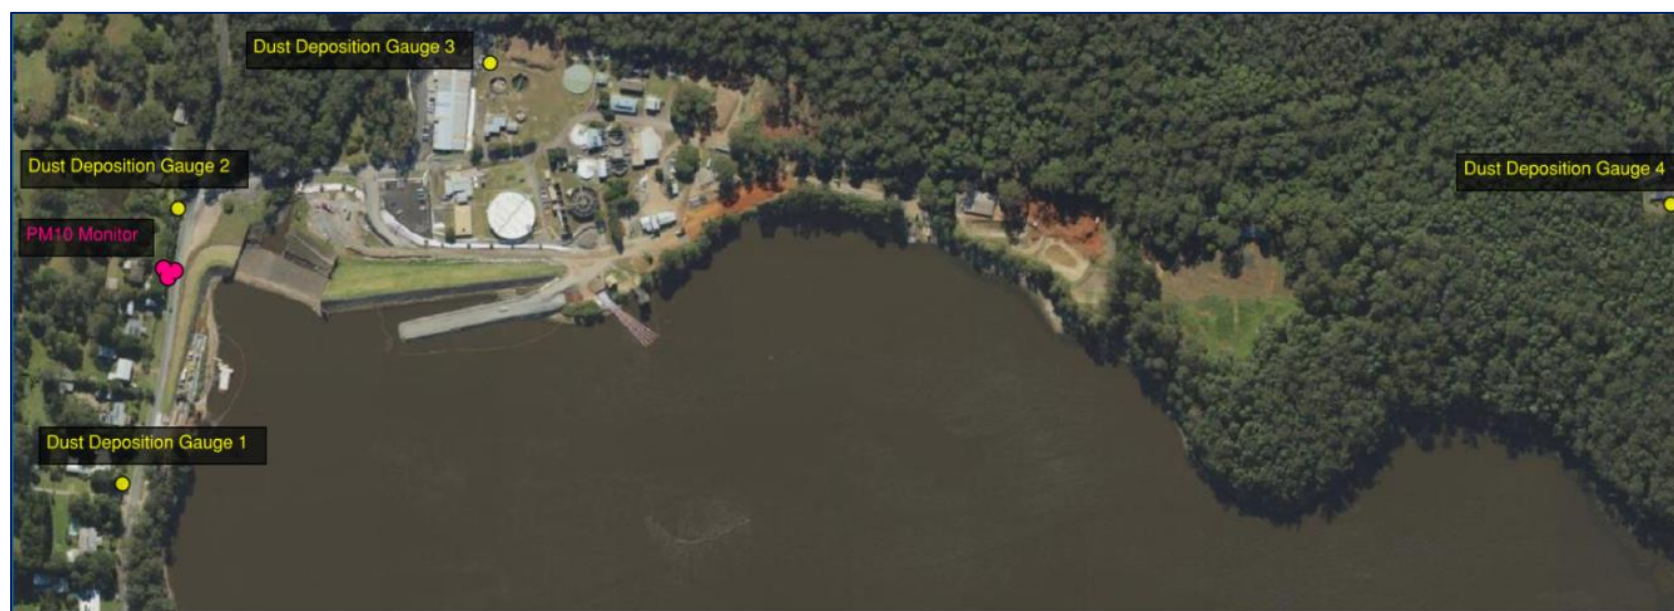
Air quality has been monitored throughout the period via dust deposition gauges and a real-time PM<sub>10</sub> monitor at the locations shown in Figure 17. No exceedances were observed for this quarterly reporting period.

Figure 17: Air Quality Monitoring Locations (including PM10 Monitor)
