Annual Compliance Report Northern Pipeline Interconnector 2

2019 - 2020

15 May 2020

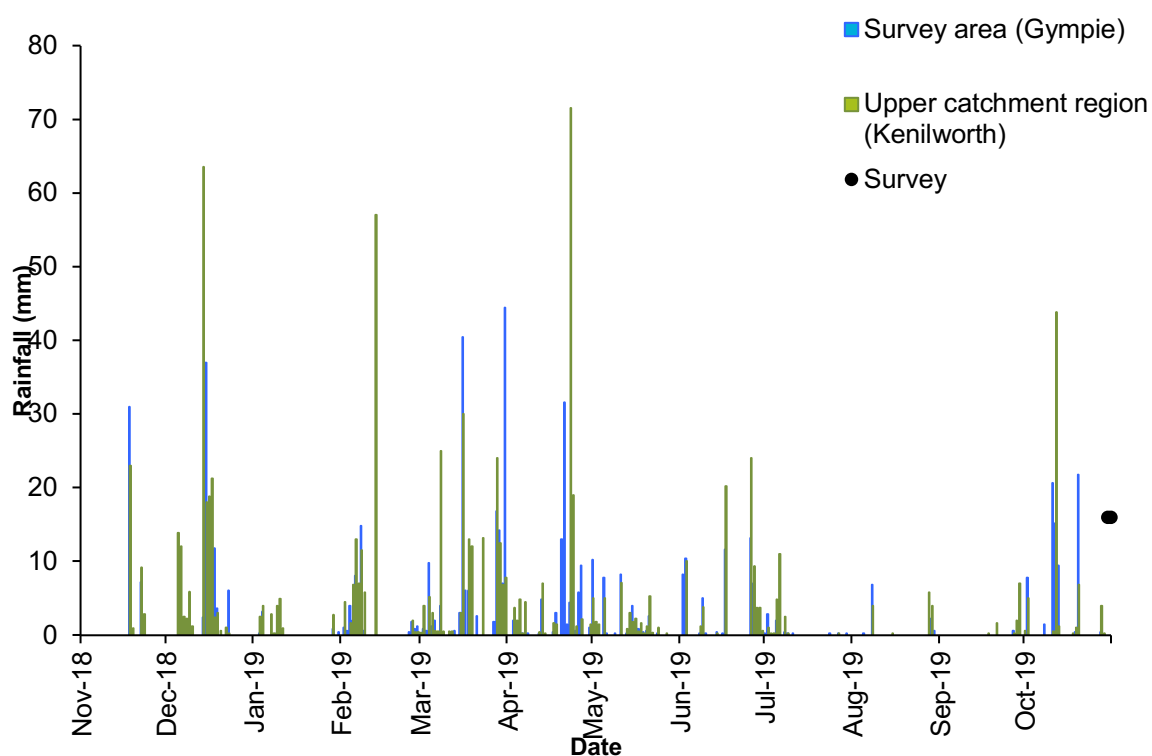
There was notable rainfall in early to mid-October 2019, prior to the survey, but no rainfall immediately before or during the survey (Figure 3.1). There were four relatively large rainfall events in the upper catchment in the 12 months leading up to the survey: December 2018, February 2019, April 2019 and October 2019. However, rainfall over the past 12 months was below the long term average recorded at both Kenilworth and Gympie (Figure 3.2), with the exception of:

Figure 3.1 Total daily rainfall twelve months prior to the October 2019 survey in the survey area (Gympie) and upper catchment (Kenilworth).

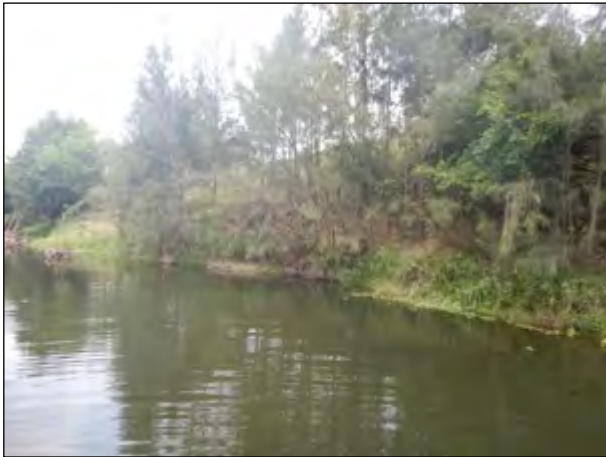
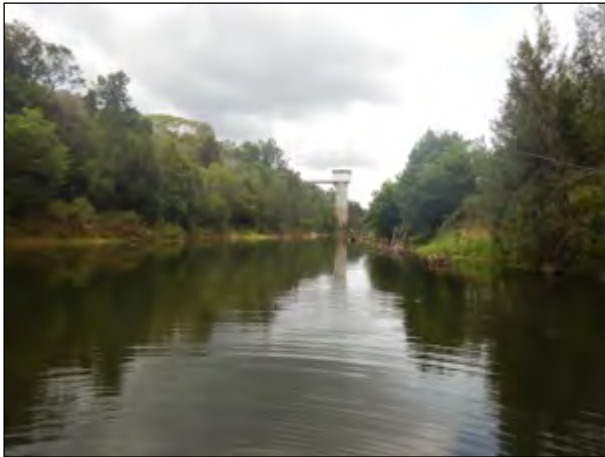
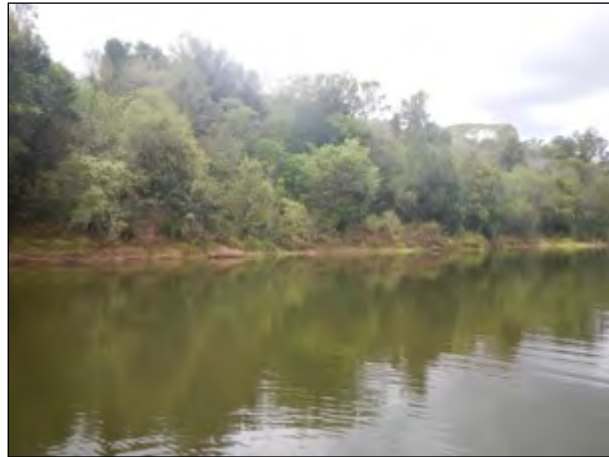
Right bank at mid-siteUpstream at mid-siteLeftt bank at mid-site

Land Use		Grazing land with native forest remnants throughout entire reach	
Left bank:	Grazing; cropping	Right bank:	Grazing; cropping
Overall disturbance:	low		
Bank Assessment			
Left Bank		Right Bank	
Bank material:	Silt / sand	Bank material:	Silt /sand
Bank height:	6 m	Bank height:	10 m
Bank slope:	steep	Bank slope:	Steep
Bank shape:	Convex/concave	Bank shape:	Convex
Vegetation cover:	Moderate	Vegetation cover:	Moderate
Vegetation type:	trees	Vegetation type:	trees
Shading of river:	5%	Shading of river:	5%
Trailing bank vegetation:	5%	Trailing bank vegetation:	5%
Erosion Assessment			
Left Bank		Right Bank	
Erosion:	Some	Erosion:	Some
Stability:	Moderate	Stability:	moderate
Disturbances:	Weeds	Disturbances:	Weeds
Bed Assessment			
Substrate material:	Silt/clay with some sand and pebbles		
Bed stability rating:	Bed stable	Sediment deposits:	Sand

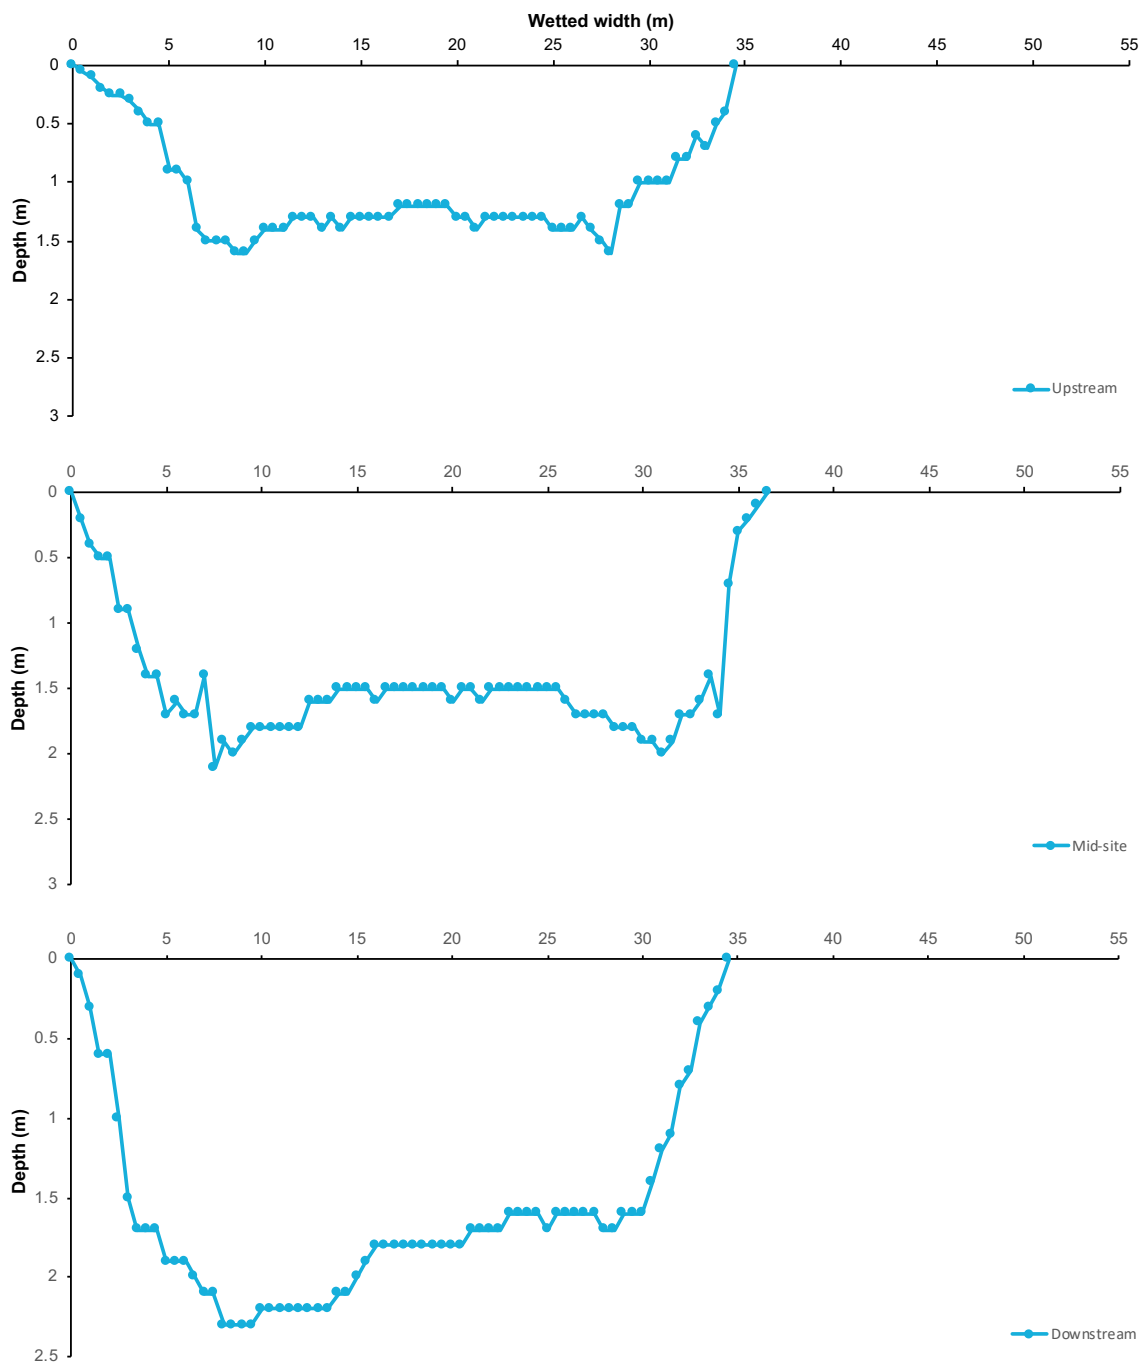
Figure B.1 Site MR1 – channel depth profiles.

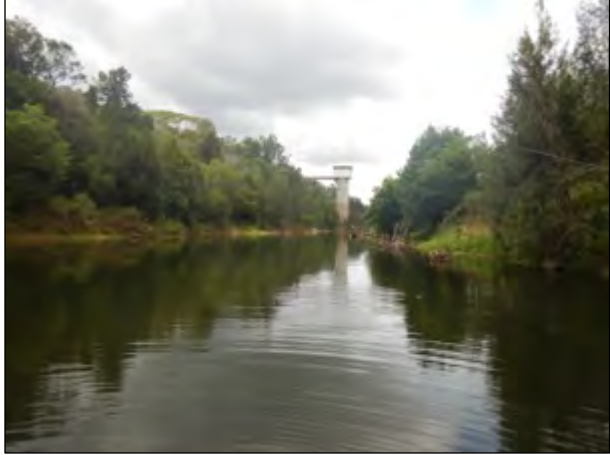
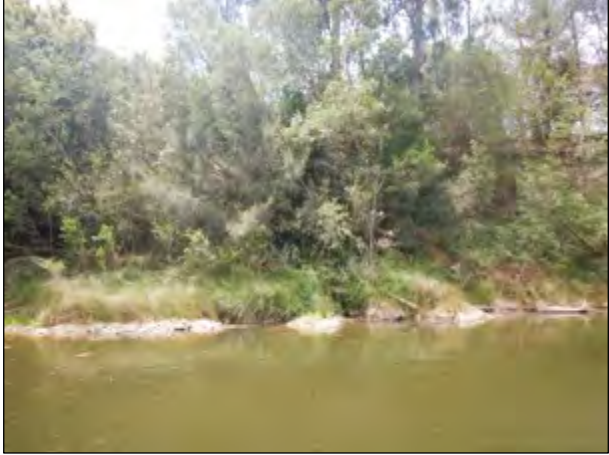
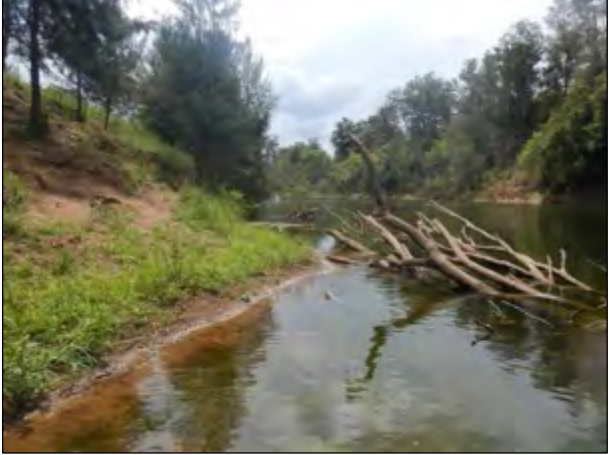
Connected pool with slow flow		Rocks and logs suitable for basking	
Woody debris, suitable for basking			
Habitat	Present / Absent	Habitat	Present / Absent
Isolated pools	Absent	Individual log (diameter >250mm)	Present
Connected pools	Present	Individual branch (diameter <300mm)	Present
Riffle	Absent	Branch pile <50% dense (diameter <300mm)	Absent
Run	Absent	Branch pile >50% dense (diameter <300mm)	Absent
Aquatic vegetation	Present – dense	Log jam <50% dense (diameter >300mm)	Present
Turtle basking spots	Present	Log jam >50% dense (diameter >300mm)	Absent
Turtle nesting habitat	Absent	Terrestrial leaves and twigs	Present – sparse
Submerged boulders / rock crevices	Present

MNES Species Habitat	
Overall suitability	Suitable
Comments:	Patches of suitable habitat for Mary River cod, white-throated snapping turtles and Mary River turtles, and potentially suitable habitat for lungfish, were scattered throughout the site. Pools were deeper than 2 m. Most banks and pools were shaded and contained large woody debris. Turtle basking spots and submerged habitat features were present. Potential nesting habitat was not present at MR1. Aquatic vegetation comprised <i>Juncus</i> sp. (emergent), <i>Cyperus</i> sp. (emergent), <i>Persicaria</i> sp. (emergent) and <i>Hydrilla</i> sp. (submerged).

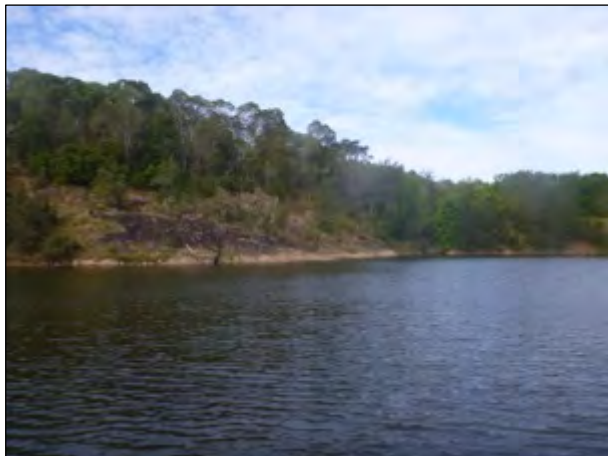
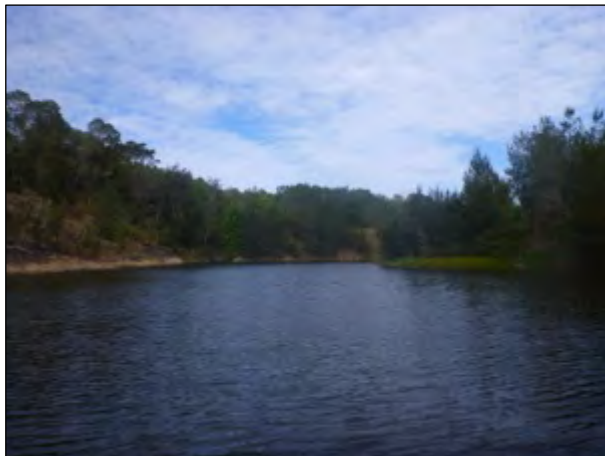
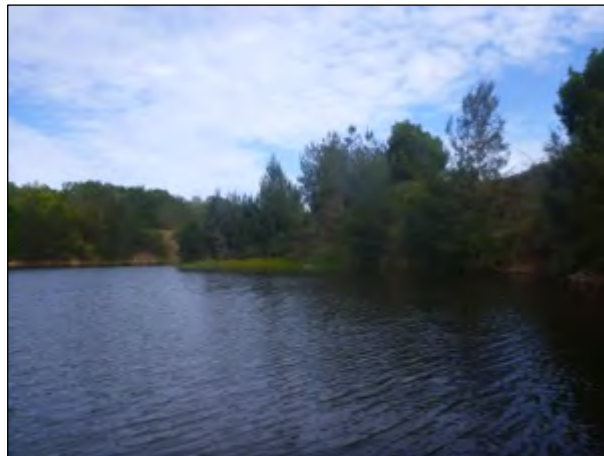
Right bank at mid-site		Upstream at mid-site		Left bank at mid-site	
Water Quality		Flow Conditions			
Temperature (°C)	26.97	Flow habitats present	Connected in-channel pool		
Conductivity (µS/cm)	427	Water level	Moderate (at watermark)		
Turbidity (NTU)	5.48	Recent high flow	No		
Dissolved oxygen (mg/L)	8.8	Flow	Upstream	Mid-site	Downstream
Dissolved oxygen (% sat)	110.8	Depth (m)	3.1	0.5	0.8
pH	7.63	Width (m)	40	45	35
		Velocity (m/s)	0.02	0.004	0

Land Use	Grazing land with native forest remnants		
Left bank:	Grazing	Right bank:	Grazing
Overall disturbance:	Moderate		
Bank Assessment			
Left Bank		Right Bank	
Bank material:	Sand with silt	Bank material:	Bedrock, sand and silt
Bank height:	8 m	Bank height:	10 m
Bank slope:	Moderate	Bank slope:	Moderate - steep
Bank shape:	Stepped	Bank shape:	Convex
Vegetation cover:	Moderate	Vegetation cover:	Some
Vegetation type:	Grass, shrubs, trees	Vegetation type:	Grass, shrubs, trees
Shading of river:	5%	Shading of river:	0%
Trailing bank vegetation:	5%	Trailing bank vegetation:	0%
Erosion Assessment			
Left Bank		Right Bank	
Erosion:	Moderate	Erosion:	Some
Stability:	Moderate	Stability:	Moderate - high
Disturbances:	Erosion, weeds, veg. clearing, cattle and access tracks	Disturbances:	Weeds, high erosion ~10m from water and cattle
Bed Assessment			
Substrate material:	Bedrock, sand and silt/clay		
Bed stability rating:	Bed stable	Sediment deposits:	Silt and sand

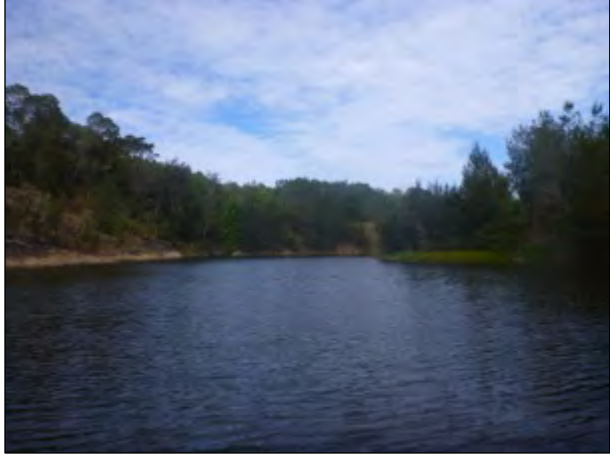
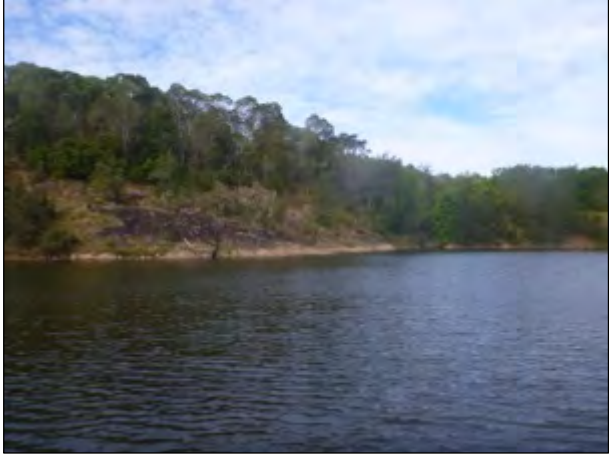
Deep continuous pools with slow flow		Exposed bedrock suitable for basking	
Habitat	Present / Absent	Habitat	Present / Absent
Isolated pools	Absent	Individual log (diameter >250mm)	Present
Connected pools	Present	Individual branch (diameter <300mm)	Present
Riffle	Absent	Branch pile <50% dense (diameter <300mm)	Absent
Run	Absent	Branch pile >50% dense (diameter <300mm)	Absent
Aquatic vegetation	Present – scattered	Log jam <50% dense (diameter >300mm)	Absent
Turtle basking spots	Present	Log jam >50% dense (diameter >300mm)	Absent
Turtle nesting habitat	Absent	Terrestrial leaves and twigs	Present – scattered
Submerged boulders / rock crevices	Present

MNES Species Habitat	
Overall suitability	Suitable
Comments:	Patches of suitable habitat for Mary River turtles and white-throated snapping turtles, with basking spots and nesting habitat present on left bank. Deep pools (>4 m) throughout the site provide good habitat for both lungfish and Mary River Cod. The pools were characterized by low flow at the time of the survey. Submerged boulders and large woody debris provide habitat and shelter. Some turtle basking spots were present, <i>Persicaria</i> sp., <i>Juncus</i> sp. and <i>Cyperus</i> sp. (emergent aquatic plants), was scattered in shallow water throughout the site.

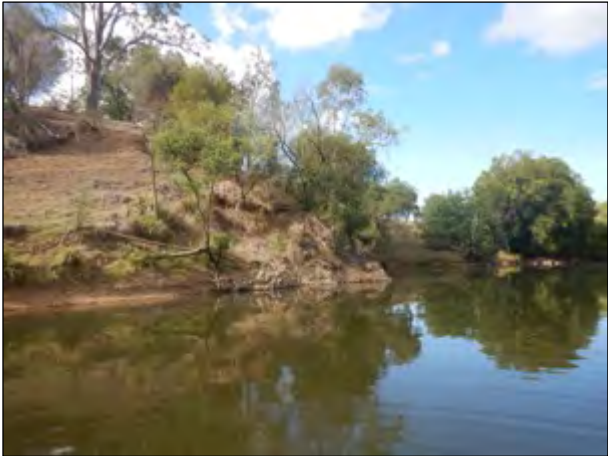
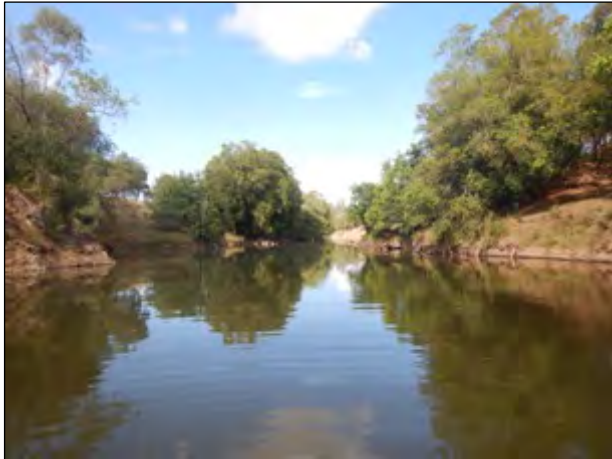
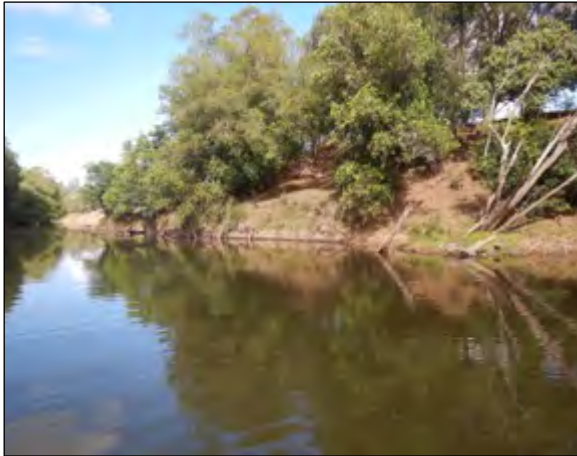
Right bank at mid-siteUpstream at mid-siteLeft bank at mid-site

Land Use	Grazing		
Left bank:	Grazing	Right bank:	Grazing
Overall disturbance:	Moderate		
Bank Assessment			
Left Bank		Right Bank	
Bank material:	Silt, sand	Bank material:	Sand, silt, bedrock
Bank height:	5 m	Bank height:	7 m
Bank slope:	Steep/moderate	Bank slope:	Steep/moderate
Bank shape:	Convex/concave/stepped	Bank shape:	Convex/concave/stepped
Vegetation cover:	Moderate	Vegetation cover:	Some
Vegetation type:	Grass, trees, shrubs	Vegetation type:	Grass, shrubs, trees
Shading of river:	5%	Shading of river:	5%
Trailing bank vegetation:	0%	Trailing bank vegetation:	5%
Erosion Assessment			
Left Bank		Right Bank	
Erosion:	Some	Erosion:	Heavy
Stability:	Moderate	Stability:	Low
Disturbances:	Cattle, erosion, weeds	Disturbances:	Cattle, weeds, erosion (heavily eroded)
Bed Assessment			
Substrate material:	Bedrock, sand and silt / clay (cobbles in shallow areas Downstream)		
Bed stability rating:	Bed stable	Sediment deposits:	Silt / sand

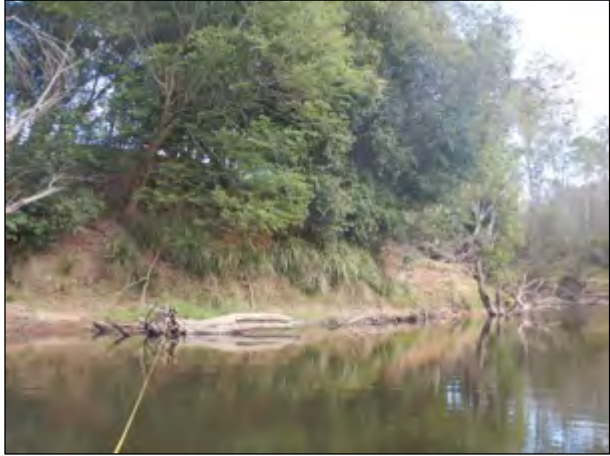
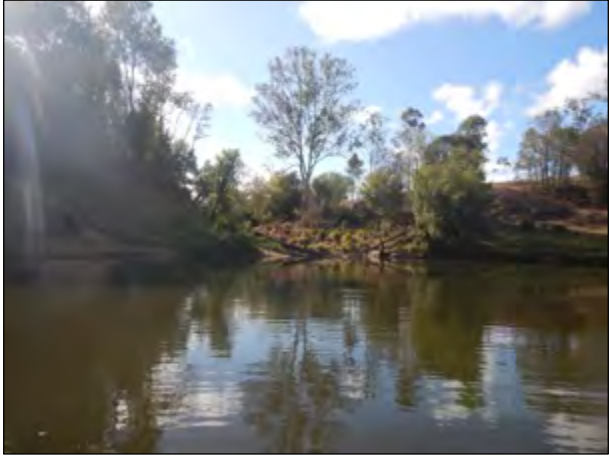
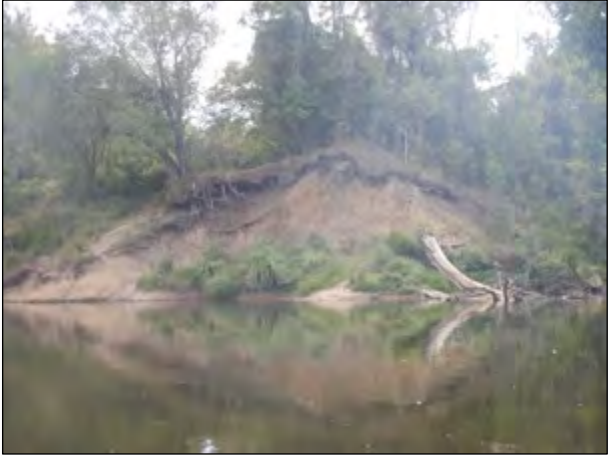
Connected pool with slow flow		Bank erosion present	
Habitat	Present / Absent	Habitat	Present / Absent
Isolated pools	Absent	Individual log (diameter >250mm)	Present
Connected pools	Present	Individual branch (diameter <300mm)	Present
Riffle	Absent	Branch pile <50% dense (diameter <300mm)	Present
Run	Absent	Branch pile >50% dense (diameter <300mm)	Absent
Aquatic vegetation	Present	Log jam <50% dense (diameter >300mm)	Absent
Turtle basking spots	Present	Log jam >50% dense (diameter >300mm)	Absent
Turtle nesting habitat	Absent	Terrestrial leaves and twigs	Present – scattered
Submerged boulders / rock crevices	Present		
Overall suitability	Suitable

MNES Species Habitat	
	Suitable habitat for Mary River cod, lungfish, white-throated snapping turtles and Mary River turtles was scattered through the site. Deep pools (>3 m) were present throughout the site during the 2019 survey. Most deep pools contained large woody debris, with some shading from overhanging vegetation. Turtle basking spots were present in the form of exposed logs that were scattered throughout the site. Aquatic vegetation in emergent form was observed on the banks with <i>Juncus</i> sp. and <i>Lomandra</i> sp. present.

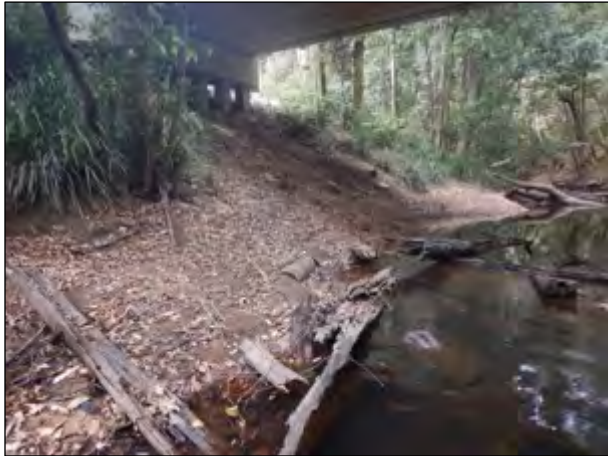
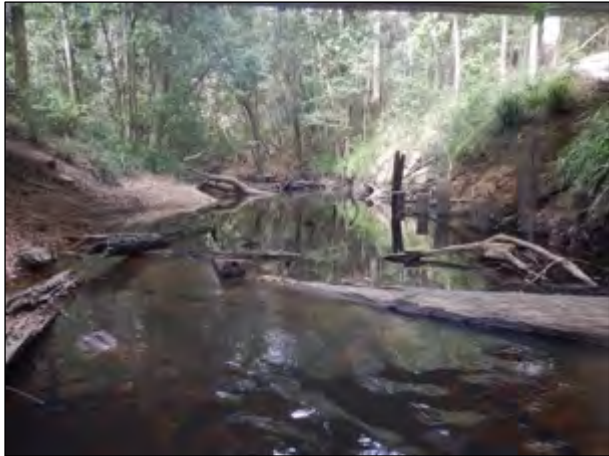
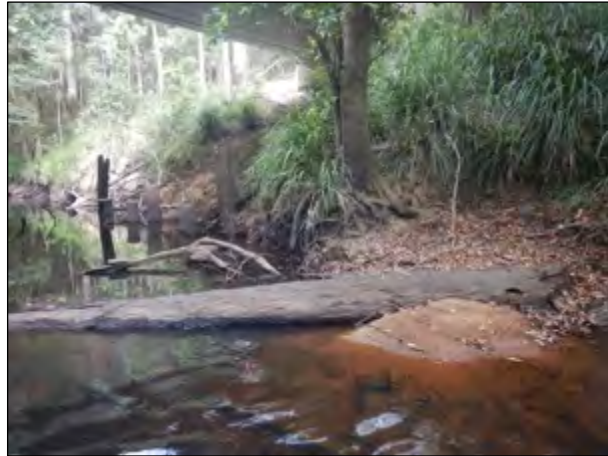
Site SMC5

Right bank at mid-site		Upstream at mid-site		Left bank at mid-site		
Water Quality		Flow Conditions				
Temperature (°C)	21.84	Flow habitats present	Connected in-channel pool, riffle			
Conductivity (µS/cm)	201.6	Water level	Low (below watermark)			
Turbidity (NTU)	5.42	Recent high flow	No			
Dissolved oxygen (mg/L)	3.94	Flow	Upstream	Mid-site	Downstream	
Dissolved oxygen (% sat)	45.1	Depth (m)	0.11	0.3	0.14	
pH	7.65	Width (m)	1.5	6	6	
		Velocity (m/s)	0.3	0.089	0.00

Land Use	Native forest		
Left bank:	Native forest	Right bank:	Native forest
Overall disturbance:	Moderate		
Bank Assessment			
Left Bank		Right Bank	
Bank material:	Sand	Bank material:	Sand
Bank height:	3 m	Bank height:	3 m
Bank slope:	Moderate - steep	Bank slope:	Moderate - steep
Bank shape:	Convex, concave	Bank shape:	Convex, concave
Vegetation cover:	Moderate	Vegetation cover:	Moderate
Vegetation type:	Shrubs, tress	Vegetation type:	Shrubs, trees
Shading of river:	25-50%	Shading of river:	25-50%
Trailing bank vegetation:	5%	Trailing bank vegetation:	5%
Erosion Assessment			
Left Bank		Right Bank	
Erosion:	Some	Erosion:	Some
Stability:	Moderate	Stability:	Moderate
Disturbances:	Erosion, roads	Disturbances:	Erosion, roads
Bed Assessment			
Substrate material:	Sand, silt / clay and gravel		
Bed stability rating:	Bed stable	Sediment deposits:	Sand

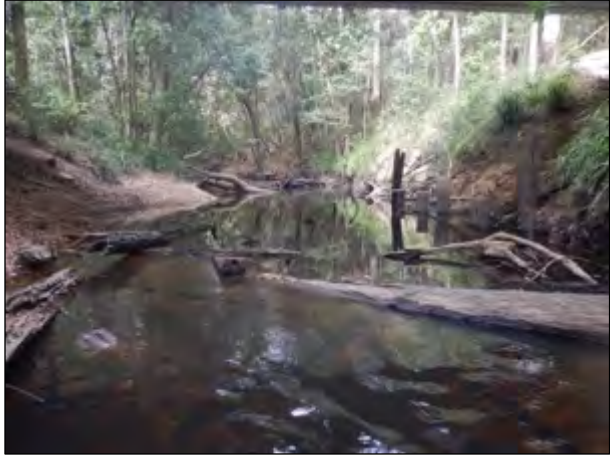
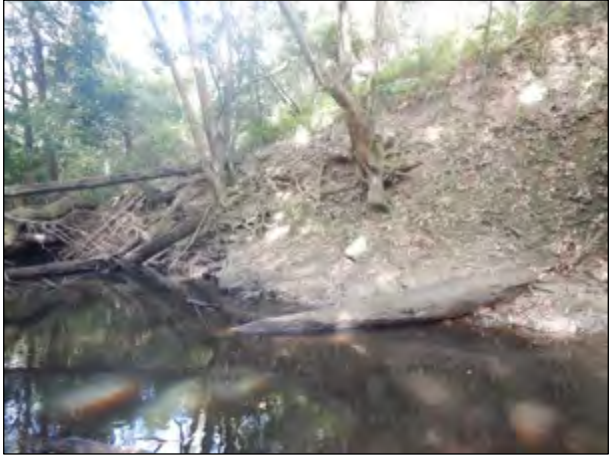
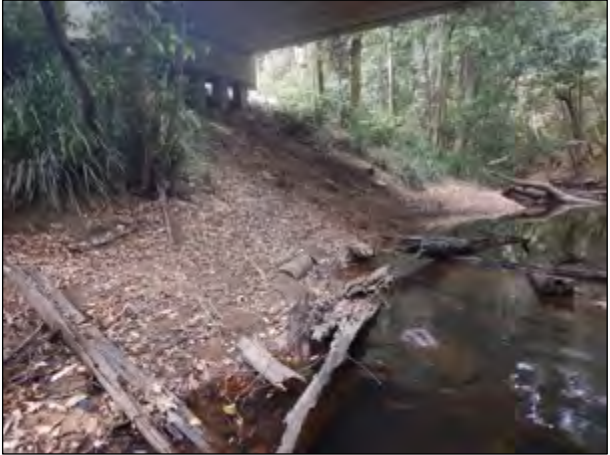
Woody debris provides basking spot		Bedrock on bank provides basking spot	
Sandy bank provides nesting habitat			
Habitat	Present / Absent	Habitat	Present / Absent
Isolated pools	Absent	Individual log (diameter >250mm)	Present
Connected pools	Present	Individual branch (diameter <300mm)	Present
Riffle	Present	Branch pile <50% dense (diameter <300mm)	Present
Run	Absent	Branch pile >50% dense (diameter <300mm)	Present
Aquatic vegetation	Absent	Log jam <50% dense (diameter >300mm)	Present
Turtle basking spots	Present	Log jam >50% dense (diameter >300mm)	Present
Turtle nesting habitat	Present – about 10m suitable	Terrestrial leaves and twigs	Present – dense
Submerged boulders / rock crevices	Absent

MNES Species Habitat	
Overall suitability	Suitable for white-throated snapping turtles and Mary River turtles, potentially suitable for Mary River cod
Comments:	A well shaded, shallow pool (<1 m) through out the majority of the reach. Submerged woody debris was present across the site, providing potential habitat for juvenile Mary River cod. No suitable habitat for the Australian lungfish was present. The presence of flowing water in shallow riffles and a sandy substrate provide habitat that is suitable for white-throated snapping turtles and Mary River turtles, in addition to sandy nesting habitat on the banks. Woody debris provided turtle basking spots.

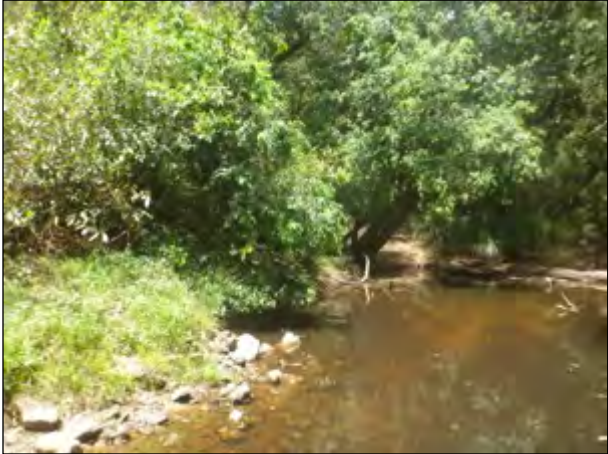
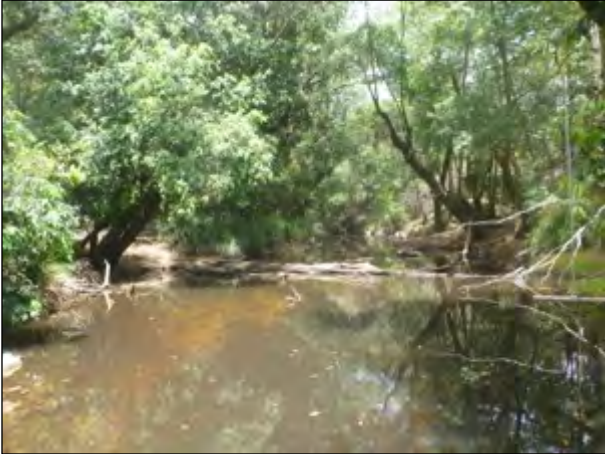
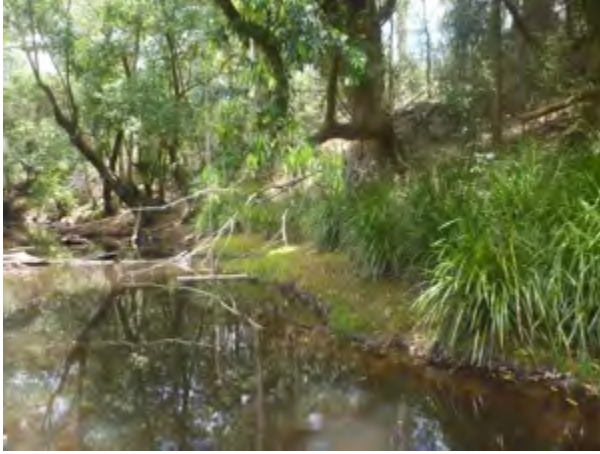
Site SMC5

Right bank at mid-site		Upstream at mid-site		Left bank at mid-site		
Water Quality		Flow Conditions				
Temperature (°C)	20.97	Flow habitats present	Connected in-channel pool, riffle			
Conductivity (µS/cm)	212.7	Water level	Low (below watermark)			
Turbidity (NTU)	4.74	Recent high flow	No			
Dissolved oxygen (mg/L)	3.74	Flow	Upstream	Mid-site	Downstream	
Dissolved oxygen (% sat)	42	Depth (m)	-	0.3	-	
pH	7.45	Width (m)	-	7	-	
		Velocity (m/s)	-	0.062	-

Land Use		Native forest	
Left bank:	Native forest	Right bank:	Native forest
Overall disturbance:	Low		
Bank Assessment			
Left Bank		Right Bank	
Bank material:	Sand	Bank material:	Sand
Bank height:	6 m	Bank height:	6 m
Bank slope:	Steep	Bank slope:	Moderate - steep
Bank shape:	Stepped	Bank shape:	Stepped
Vegetation cover:	Moderate	Vegetation cover:	Moderate
Vegetation type:	Shrubs, trees	Vegetation type:	Grass, shrubs
Shading of river:	15%	Shading of river:	5%
Trailing bank vegetation:	5%	Trailing bank vegetation:	5%
Erosion Assessment			
Left Bank		Right Bank	
Erosion:	Some	Erosion:	None
Stability:	High	Stability:	High
Disturbances:	Erosion, roads	Disturbances:	Weeds, roads, cleared vegetation
Bed Assessment			
Substrate material:	Sand, silt / clay, boulder, cobble, pebble, gravel		
Bed stability rating:	Bed stable	Sediment deposits:	Sand

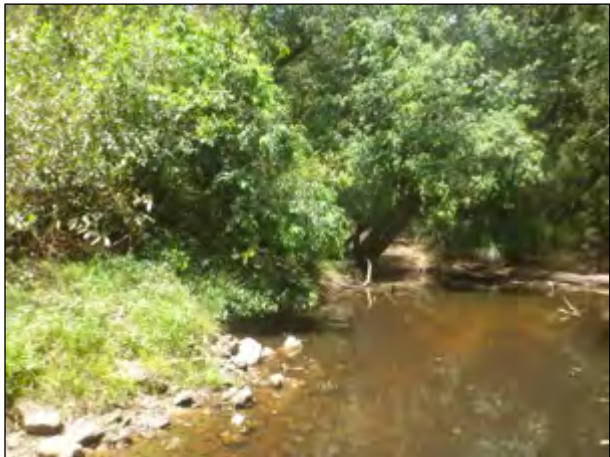
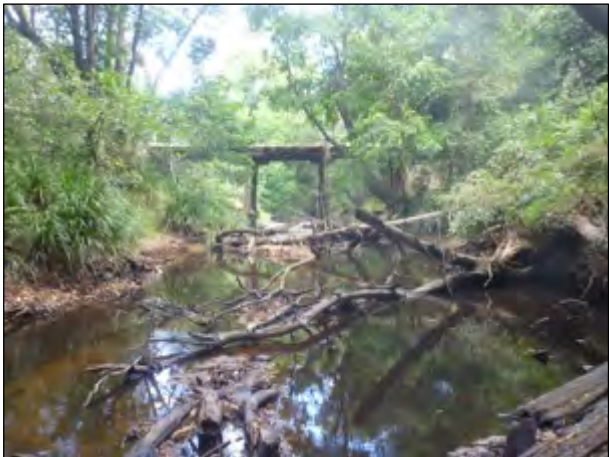
Rocks provide basking habitat		Logs provide basking habitat	
Habitat	Present / Absent	Habitat	Present / Absent
Isolated pools	Absent	Individual log (diameter >250mm)	Present
Connected pools	Present	Individual branch (diameter <300mm)	Present
Riffle	Present	Branch pile <50% dense (diameter <300mm)	Present
Run	Absent	Branch pile >50% dense (diameter <300mm)	Present
Aquatic vegetation	Present	Log jam <50% dense (diameter >300mm)	Present
Turtle basking spots	Present	Log jam >50% dense (diameter >300mm)	Absent
Turtle nesting habitat	Absent	Terrestrial leaves and twigs	Present – Dense
Submerged boulders / rock crevices	Absent		
Overall suitability	Potential for Mary River cod, white-throated snapping turtle and Mary River turtle, unsuitable for Australian lungfish

MNES Species Habitat	
Comments:	Some shaded, shallow (<1 m) pools with submerged woody debris and rock faces and crevices were present that may provide some suitable habitat for juvenile Mary River cod, white-throated snapping turtle and Mary River turtle. Australian lungfish habitat was not present. Some suitable foraging habitat for white-throated snapping turtles or Mary River turtles in fast flowing riffles but no deep foraging pools were present. However, protruding logs and woody debris were present providing suitable basking spots for turtles.
