## Document Information

<b>Citation:</b>	Deere, D. (2020) DNRME DWQMP Audit 2020. Report. Document produced for Seqwater and Water Futures Pty Ltd.
<b>File Name:</b>	Seqwater 2020 DNRME DWQMP Audit Report Final V2.docx
<b>Project Director:</b>	Andrea Clement
<b>Project Owner:</b>	Seqwater
<b>Name of Project:</b>	DNRME DWQMP Audit 2020.
<b>Name of Document:</b>	Report
<b>Cover:</b>	Logos are © Seqwater and Water Futures Pty Ltd. Images are © Water Futures Pty Ltd and Seqwater (photo of Ewen Maddock Dam taken from the WTP during the audit).
<b>Sensitivity:</b>	This document is copyright and confidential. The document, its concepts and contents are not for citation, circulation or duplication without permission.

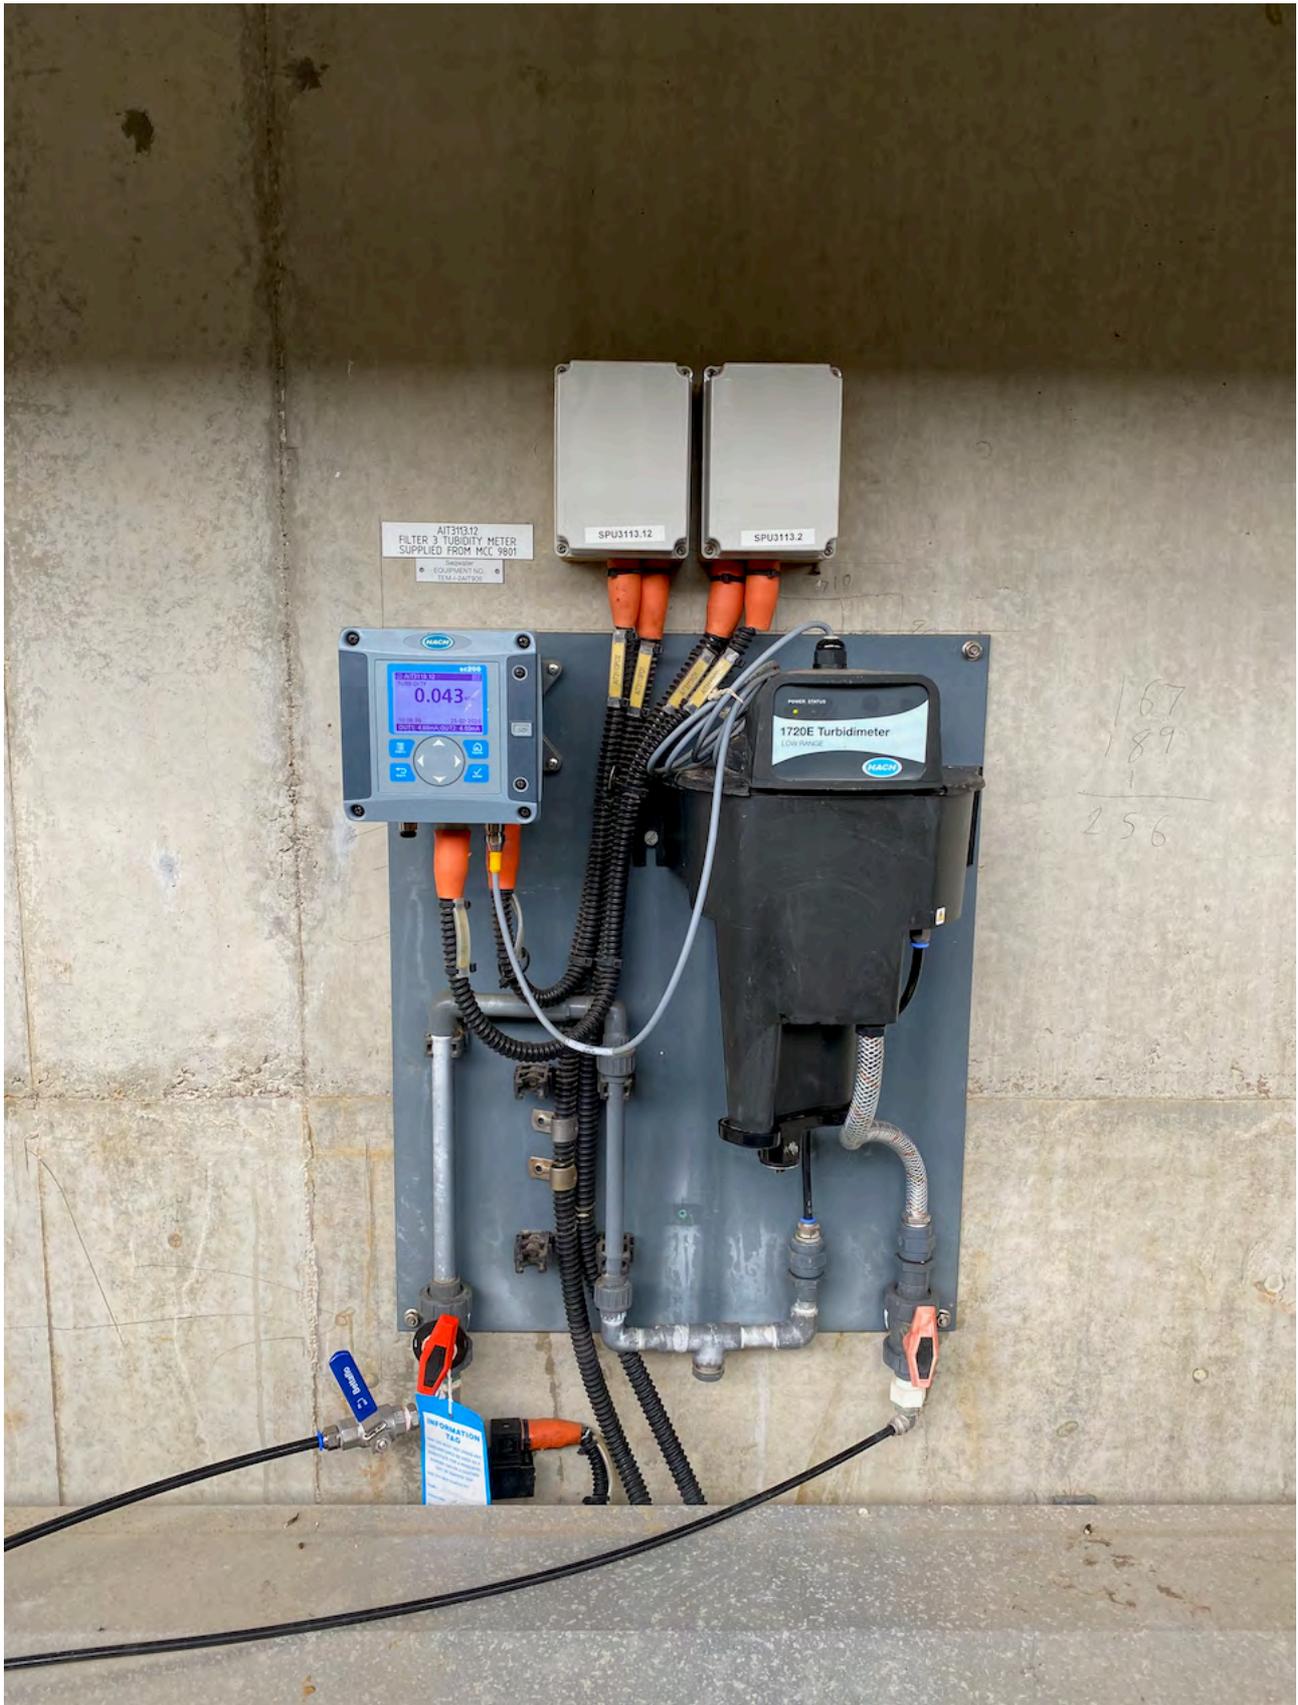
The Hach 1720E IFE turbidity meters were found to be suitably placed close to each filter outlet and clearly labelled (Figure 6-1). SCADA records were viewed for the selected instruments for the month of April 2019 and results were found to be compliant throughout and showing good stability and performance. The WTP Schematic dated to 20 November 2018 was found to be an accurate reflection of the WTP as inspected.

Figure 6-1. Photo of Ewen Maddock WTP turbidity analyser - well labelled and maintained.

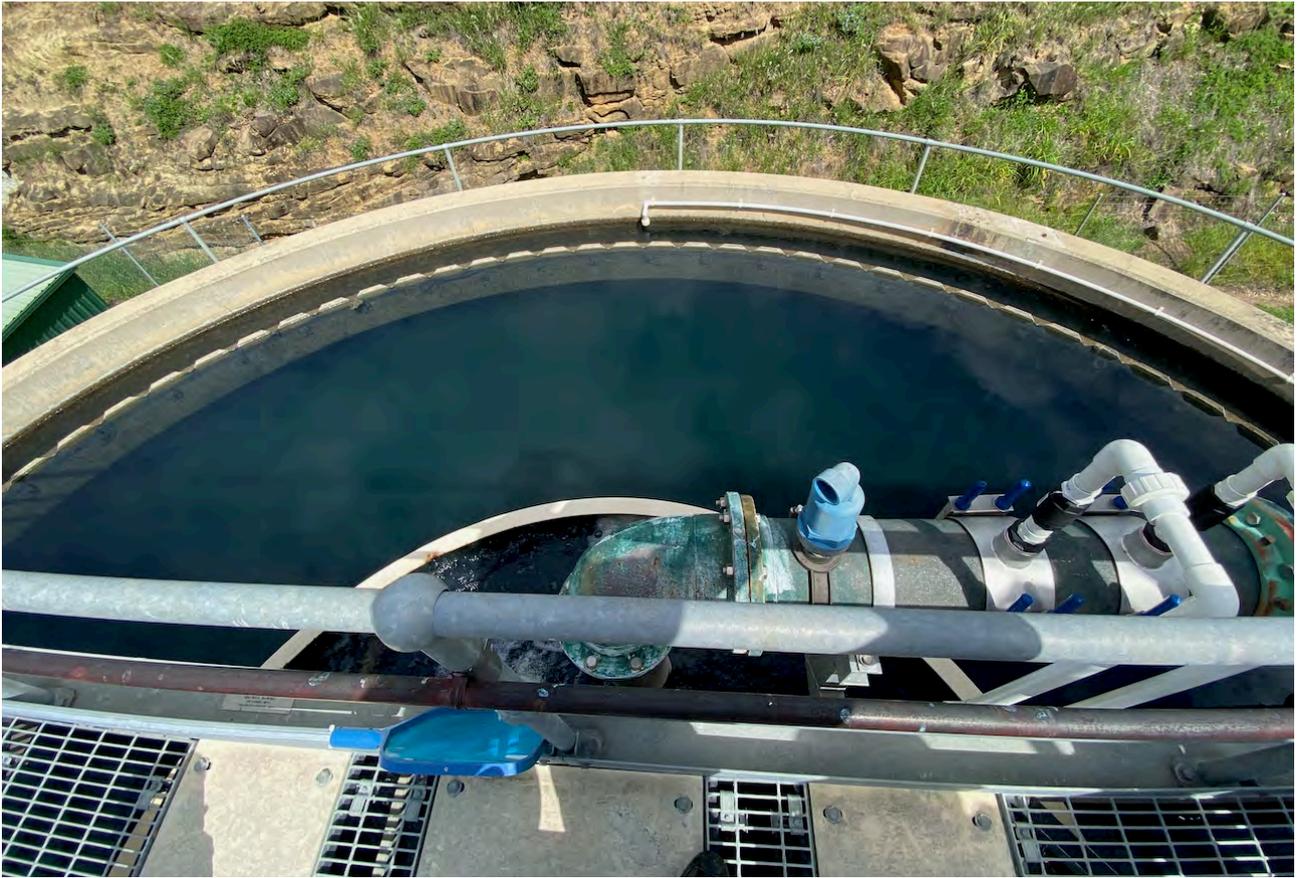
**Figure 6-2. Photo of Kooralbyn WTP clarifier – well maintained and clear.**

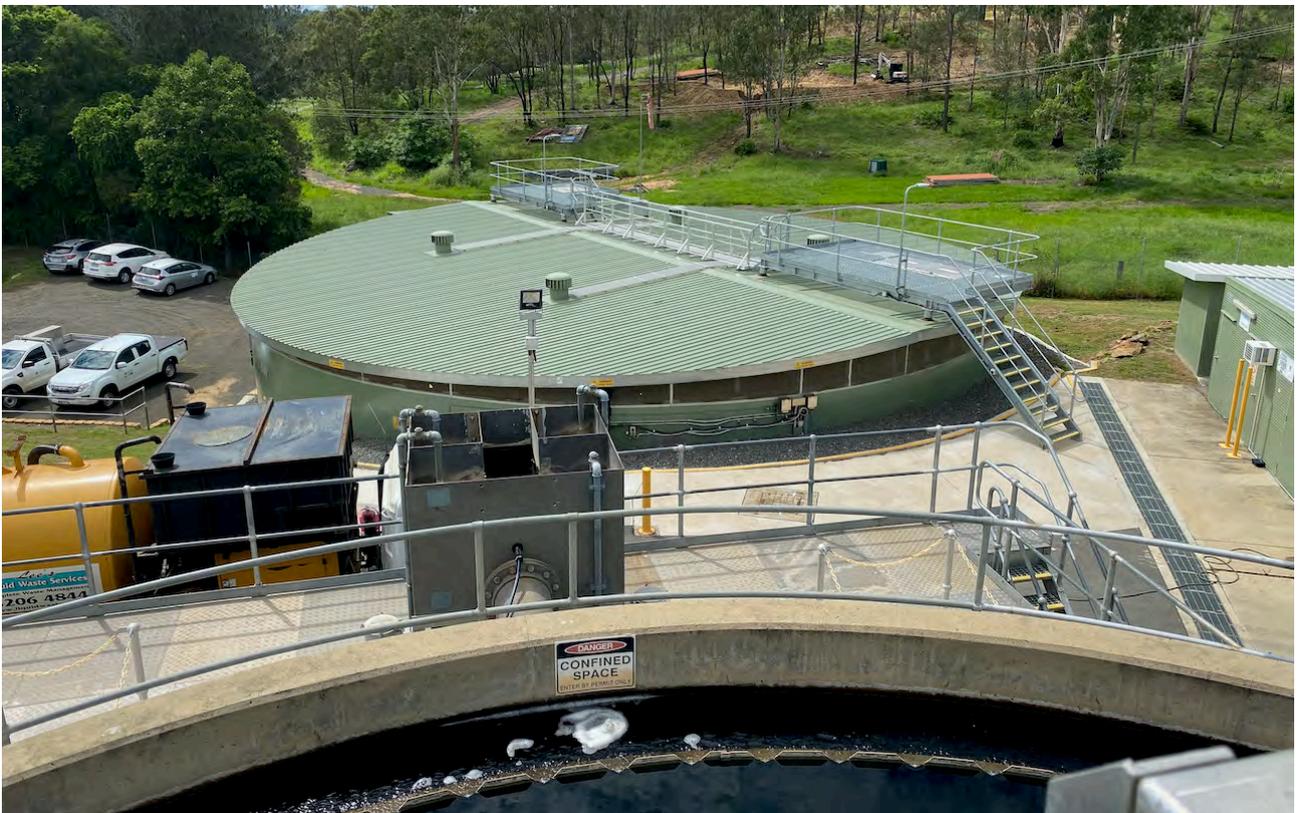
The Kooralbyn WTP and associated infrastructure was audited on site and found to be in good condition and in particular the treated water reservoir was thoroughly protected from vermin and ingress. Online instruments and SCADA systems were functional during the onsite audit. Selected online instruments were compared to SCADA systems, and alarm setpoints were compared to the HACCP Plan Wall Chart from 18 December 2018 (Table 5-7). Examples of good practices observed on site included:

**Figure 6-3. Photo of Kooralbyn CWT – showing excellent condition.**

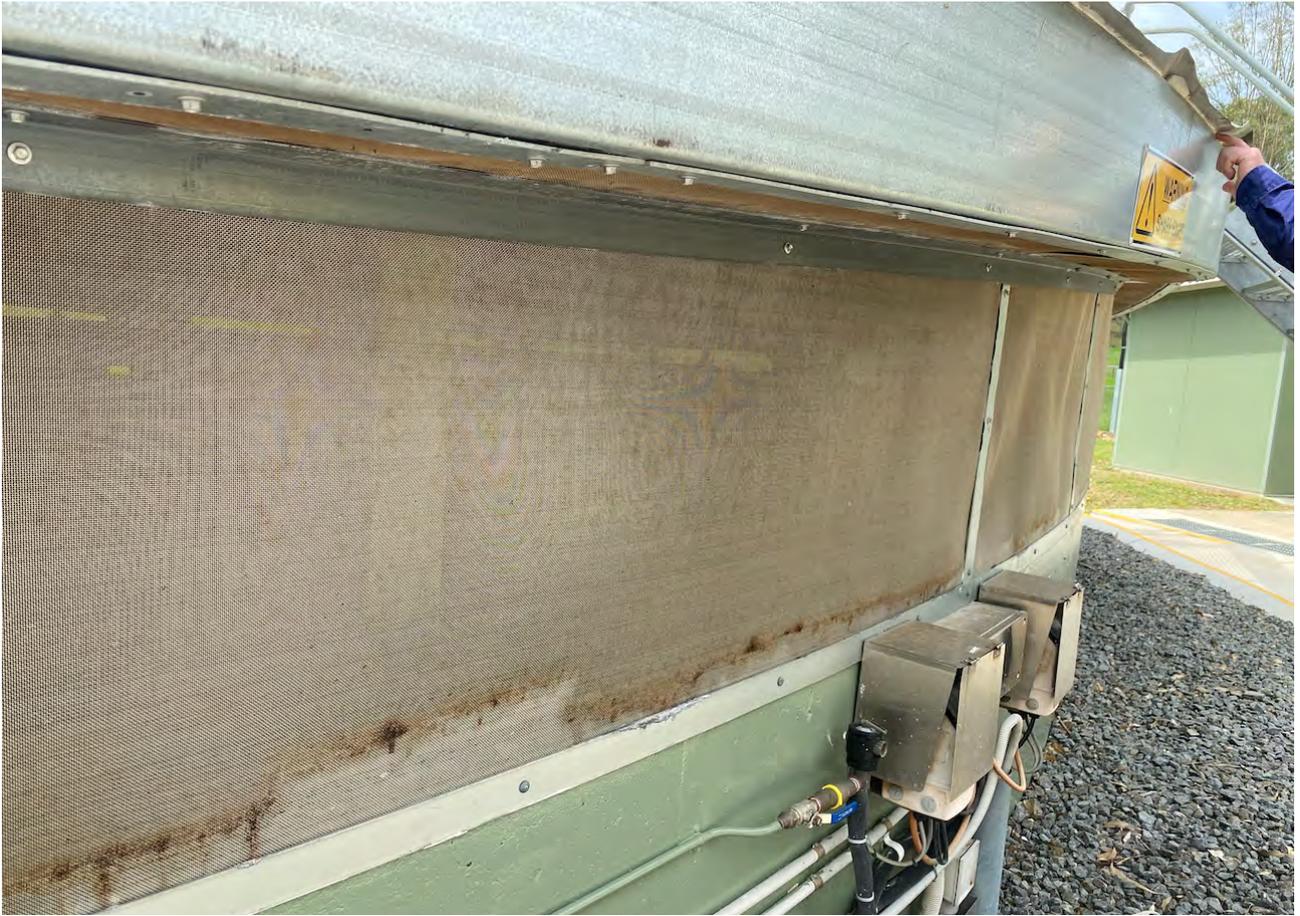
**Figure 6-4. Photo of Kooralbyn CWT – showing excellent screening.**

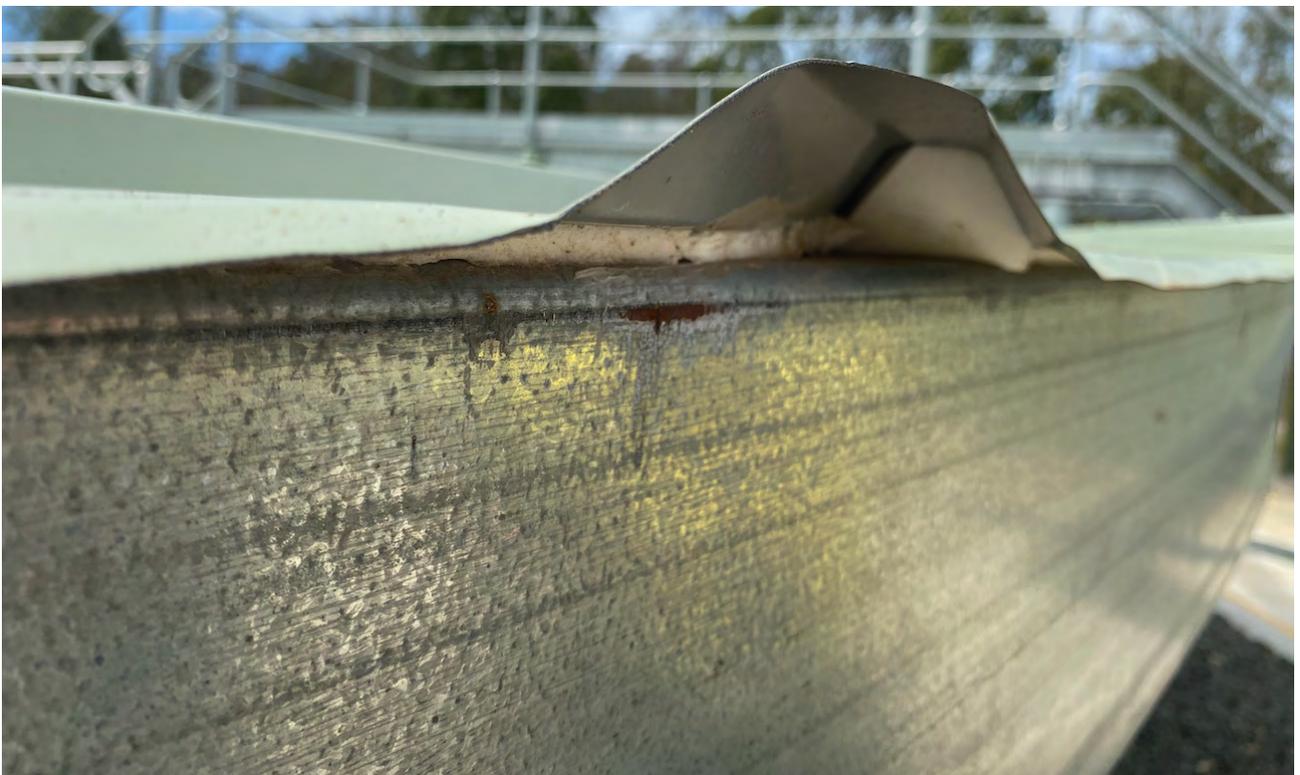
**Figure 6-5. Photo of Kooralbyn CWT – showing excellent vermin-stoppers.**

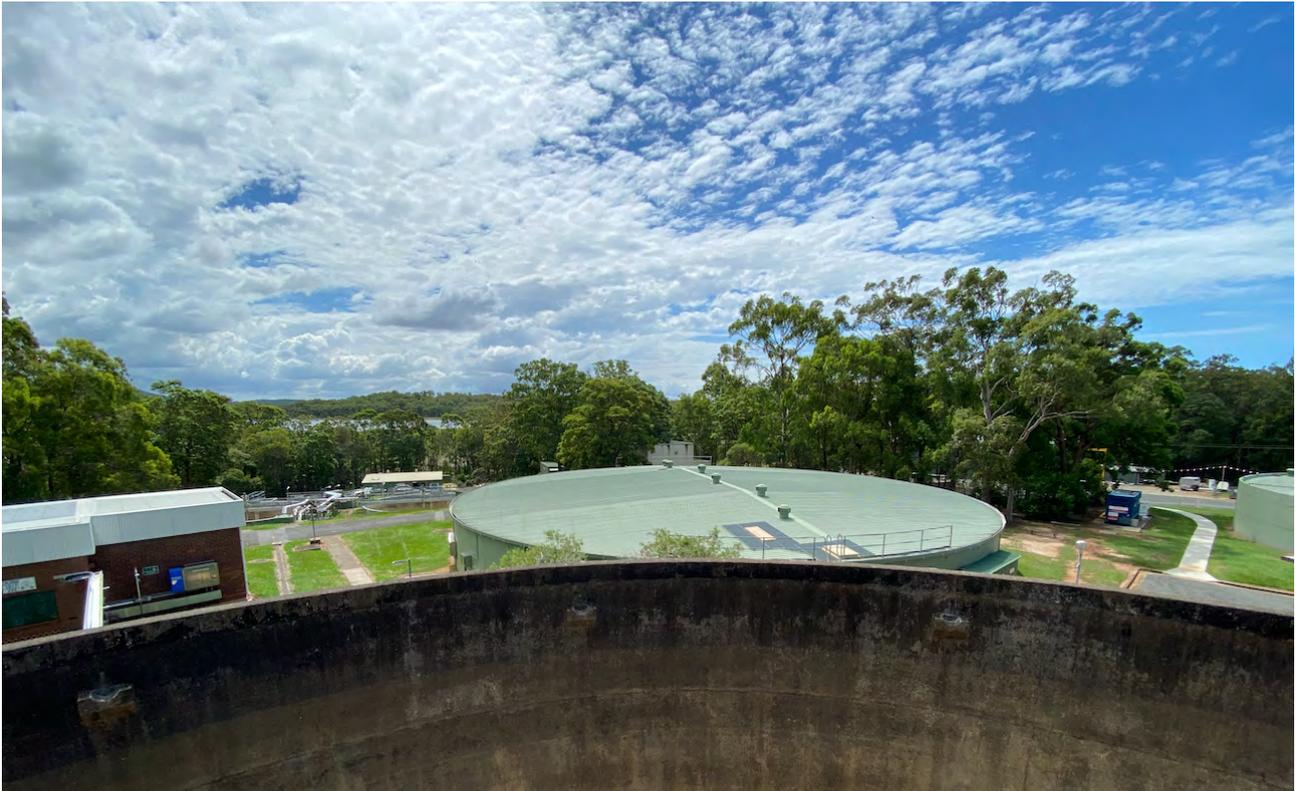
The Capalaba WTP and immediate source water dam were audited and found to be in good condition. Evidence was provided of filter inspections in the form of work orders for process engineering staff to attend and open and inspect filters. The two reservoirs on site were in need of roof upgrades with new roofs to be installed in the coming year and the box gutter removed as part of that upgrade (noting that one roof had blown off the previous year (Figure 6-6). No OFI or other notes were made on the state of the reservoir roof given that these actions are in train, although it is observed as a highlight that it was good to see Seqwater taking these proactive upgrade initiatives – noting reservoirs are a common source of pathogen ingress.

**Figure 6-6. Photo of Capalaba CWT – scheduled for roof replacement.**

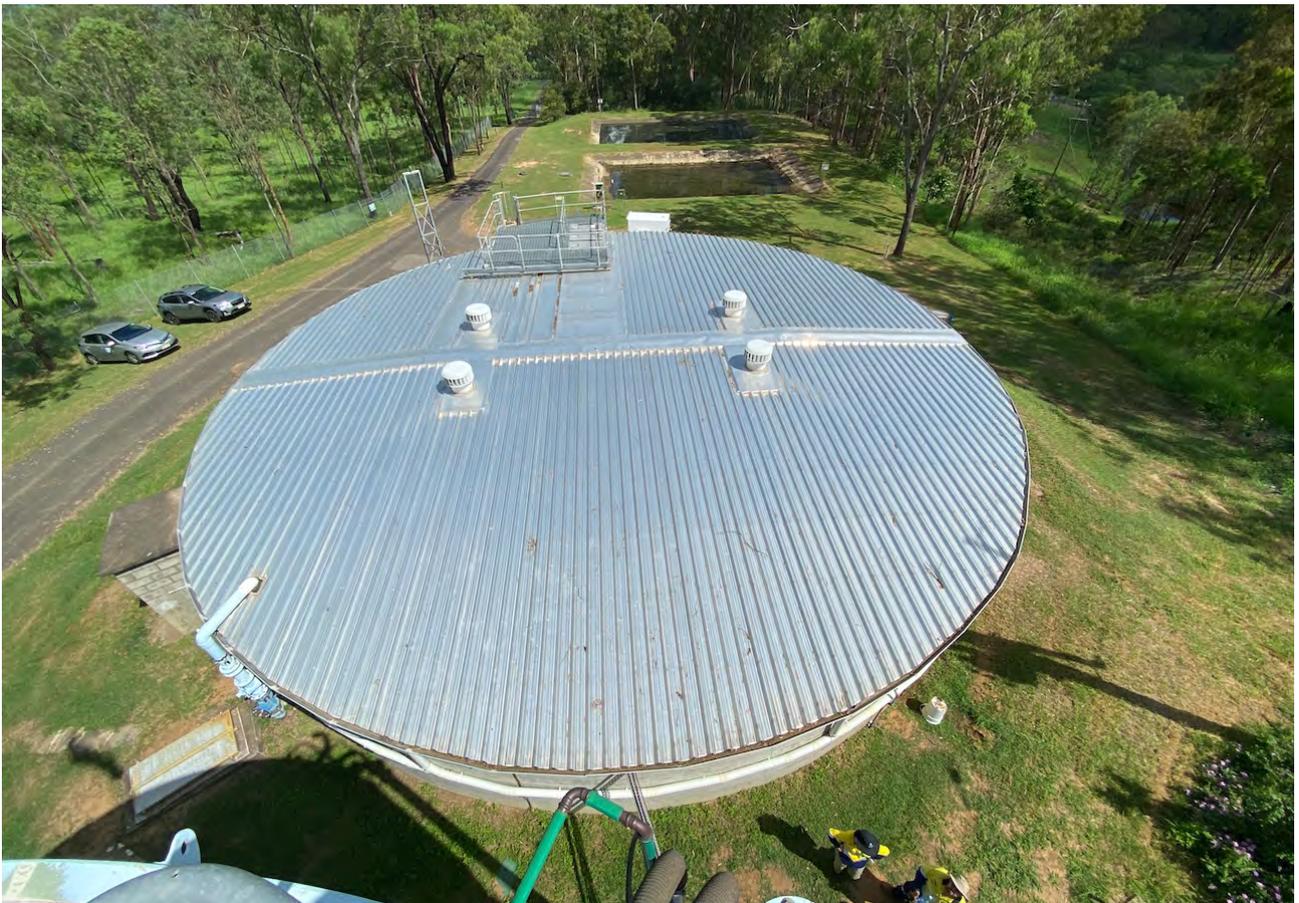
The CWT was in acceptable condition but was a potential source of ingress due to build-up of debris from vegetation and the presence of a gutter (Figure 6-7). As an OFI it might be worth prioritising certain treated water storages with more inherently vulnerable designs, older ages, lower disinfectant residuals, chloramine vs. chlorine, or subject to vegetation build up for more frequent inspection and maintenance by adopting a more risk-based, prioritised program.

**Figure 6-7. Photo of Esk CWT – showing acceptable condition but some inherent challenges.**

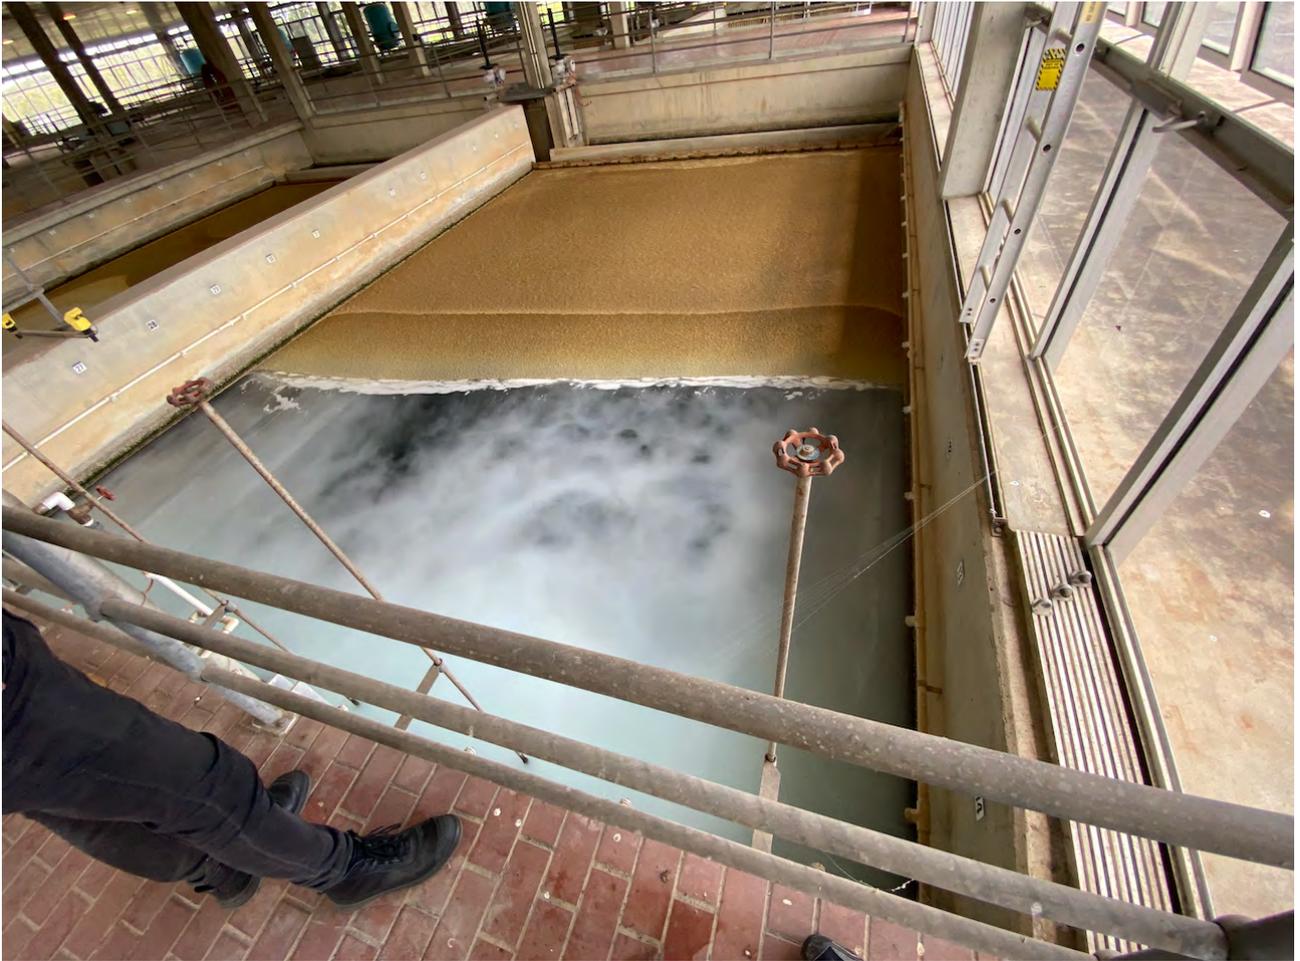
The Mt Crosby WTP overall was found to be in good condition and readily inspectable (Figure 6-8). The raw water (MTC-SP122) sampling point was clearly labelled and of suitable design. An instrument at that point was displaying 3.66 NTU and had a critical limit of 1,500 NTU.

**Figure 6-8. Photo of Mt Crosby Westbank WTP filters – showing excellent inspectability and conditions. The plant was offline during the inspection.**
