# Annual Compliance Report Northern Pipeline Interconnector 2

2021 - 2022

13 May 2022

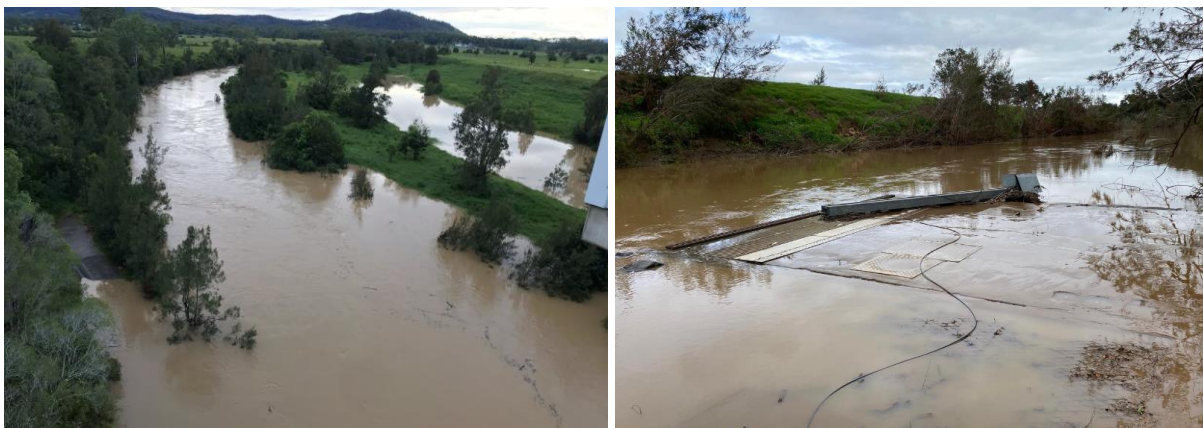
**Figure 1 & 2: Mary River flooding 23 February 2022 (left) and flooding on 8 May 2022 (right)**

In late-February the Gympie region experienced significant rainfall with a total of 827.8mm of rain from 23 February 2022 to 27 February 2022. Floodwaters inundated the project area with a nearby monitoring station indicating the area was approximately ten metres underwater during this event. This flooding event and subsequent high flows in the catchment caused significant erosion and damage from debris and fallen vegetation which prevented safe access to site. The site remained submerged / partially submerged until late-March 2022. The majority of equipment from the initial phase of the project remained onsite and undamaged with the exception of the specialised data cables. Seqwater engaged a contractor to conduct a geotechnical assessment on 28 April 2022 due to local landslips and site safety concerns. Flooding occurred again on 7 May 2022 and the site was partially inundated again. Site cleanup was completed and the access track was restored on 8 May 2022. The Doppler has been installed on site (in non-working condition) and will be commissioned as soon as practical following project completion.

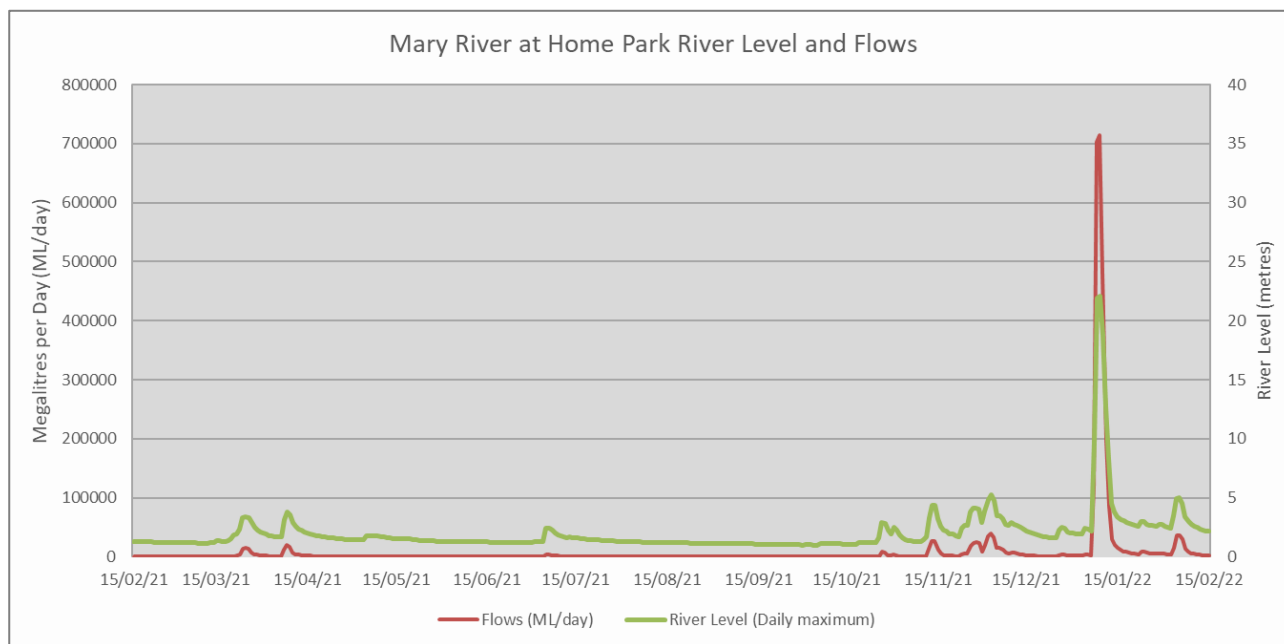
Figure 5: Flow volumes and levels at Home Park gauging station

Flow volumes and levels at the Home Park gauging station (station number 138014A) are recorded on a daily basis by the Department of Regional Development, Manufacturing and Water (DRDMW) and summarised for the current reporting period in **Error! Reference source not found.** and Figure 5 below. Home Park gauging station data is publicly available on the DRDMW Water Monitoring Website.

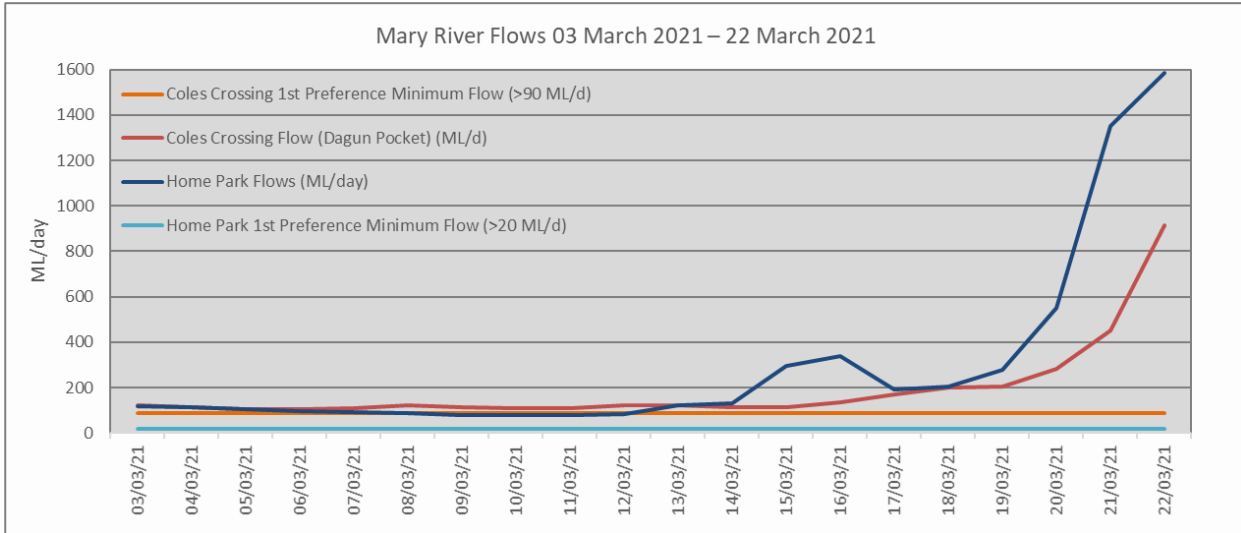
Figure 10 – Mary River Flows during 03 March 2021 – 22 March 2021

Controlled releases during these periods were primarily undertaken for the purposes of supplying water to high priority users downstream including irrigation customers and Gympie Regional Council. Between the 25/09/2021 – 6/10/2021 Home Park gauging station recorded flows below 20 ML/d and between the 24/08/2021 – 7/11/2021 Coles Crossing periodically received flows below 90 ML/d. During these times releases from Borumba Dam were occurring in accordance with EPBC Condition 9. Mary River flows during these periods have been illustrated in Figure 10 - 12 below.

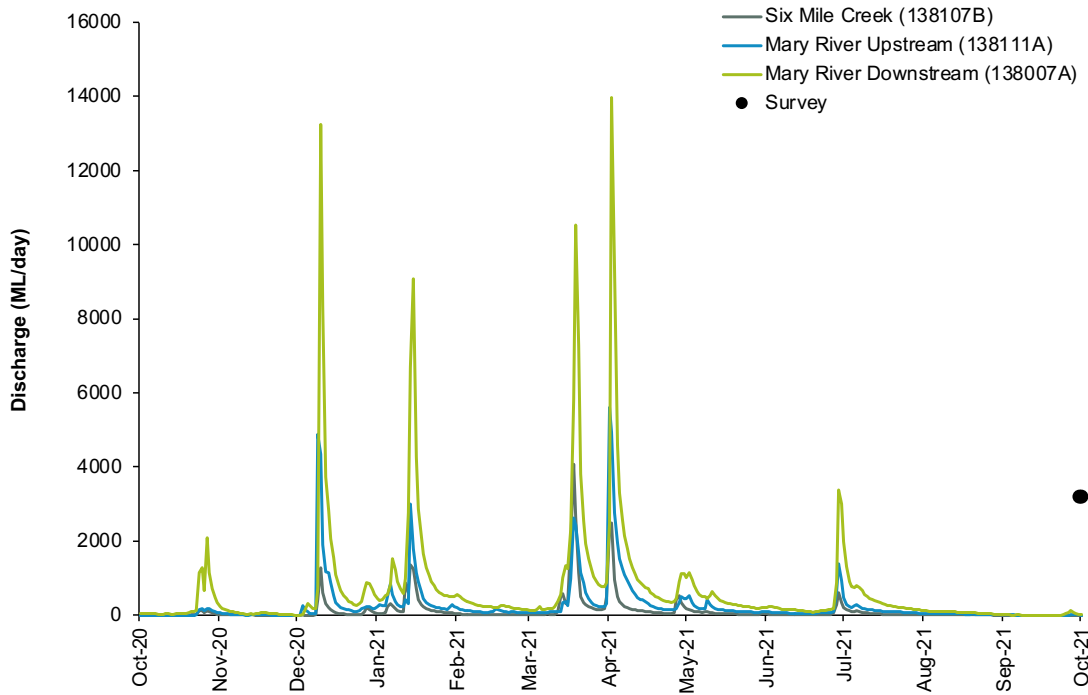
Figure 3.3 Mean daily discharge recorded at stream flow monitoring stations on Six Mile Creek and Mary River.

Flow and water levels in the Mary River and Six Mile Creek were generally low, except in December 2020, January, March, April and July 2021 where there were brief high flow events (Figure 3.3 and Figure 3.4). In the Mary River in 2021, the maximum recorded high flow event (i.e. 13,967 ML/day in April 2021) was of lower magnitude than recorded in the previous year (i.e. 2020) and was similar to the maximum flow events in 2016 (i.e. ~ 14,000 ML/day). Mary River maximum flows of a much higher magnitude were recorded in 2014, 2017 and 2018 (i.e. 50 000 to 60 000 ML/day), with maximum flows recorded in 2013 and 2015 being significantly larger again (i.e. ~380 000 ML/day in 2013; and ~200 000 ML/day in 2015 in the Mary River) to flows recorded in 2021.

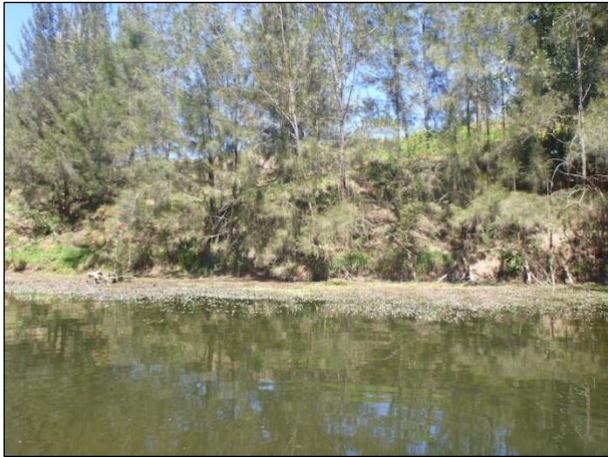
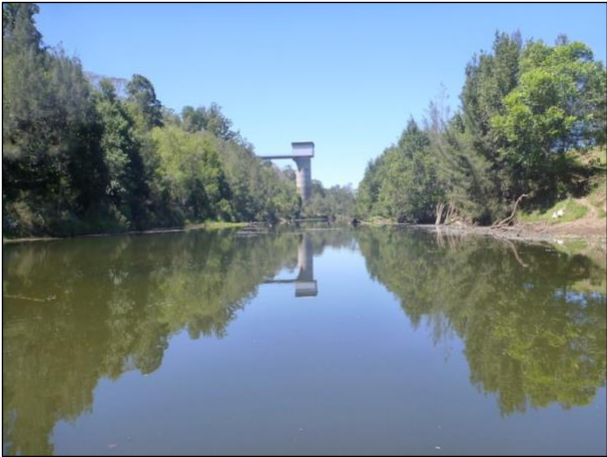
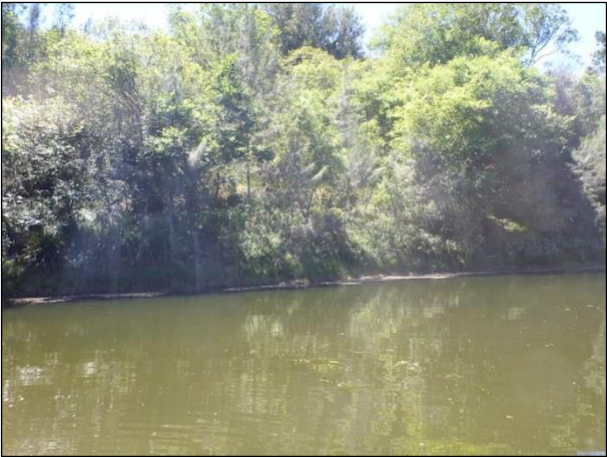
Site MR1

Right bank at mid-site		Upstream at mid-site		Left bank at mid-site	
Water Quality		Flow Conditions			
Temperature (°C)	24.8	Flow habitats present	Connected in-channel pool		
Conductivity (µS/cm)	335	Water level	Moderate (at watermark)		
Turbidity (NTU)	2.23	Recent high flow	No		
Dissolved oxygen (mg/L)	10.08	Flow	Upstream	Mid-site	Downstream
Dissolved oxygen (% sat)	121.2	Depth (m)	1.2	1.7	2
pH	8.37	Width (m)	38	38	39
		Velocity (m/s)	0	0	0

<b>Land Use</b>	Grazing land		
Left bank:	Grazing	Right bank:	pump station
Overall disturbance:	Moderate		
<b>Bank Assessment</b>			
<b>Left Bank</b>		<b>Right Bank</b>	
Bank material:	sand, silt/clay	Bank material:	sand, clay
Bank height:	5 m	Bank height:	5 m
Bank slope:	steep	Bank slope:	steep
Bank shape:	Convex	Bank shape:	Convex
Vegetation cover:	Moderate	Vegetation cover:	Moderate
Vegetation type:	grass and trees	Vegetation type:	Shrubs and trees
Shading of river:	5%	Shading of river:	5%
Trailing bank vegetation:	10%	Trailing bank vegetation:	5%
<b>Erosion Assessment</b>			
<b>Left Bank</b>		<b>Right Bank</b>	
Erosion:	Some	Erosion:	Some
Stability:	Moderate	Stability:	Moderate
Disturbances:	Weeds, cleared vegetation	Disturbances:	Weeds, cleared vegetation
<b>Bed Assessment</b>			
Substrate material:	Cobble, pebble, gravel, sand and silt/clay		
Bed stability rating:	Bed stable	Sediment deposits:	Sand and silt

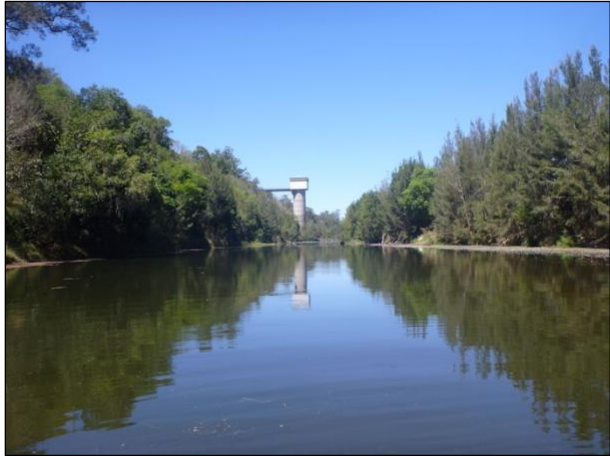
Connected pool with no flow		Logs suitable for basking	
<b>Habitat</b>	<b>Present / Absent</b>	<b>Habitat</b>	<b>Present / Absent</b>
Isolated pools	Absent	Individual log (diameter >250mm)	Present
Connected pools	Present	Individual branch (diameter <300mm)	Present
Riffle	Absent	Branch pile <50% dense (diameter <300mm)	Present
Run	Absent	Branch pile >50% dense (diameter <300mm)	Absent
Aquatic vegetation	Present–dense	Log jam <50% dense (diameter >300mm)	Present
Turtle basking spots	Present	Log jam >50% dense (diameter >300mm)	Absent
Turtle nesting habitat	Absent	Terrestrial leaves and twigs	Present – sparse
Submerged boulders / rock crevices	Present

<b>MNES Species Habitat</b>	
<b>Overall suitability</b>	Suitable
<b>Comments:</b>	Patches of suitable habitat for Mary River cod, white-throated snapping turtles, Mary River turtles and lungfish were scattered throughout the site. Pools were deep to 2 m. Most banks were shaded and contained large woody debris. Turtle basking spots, nesting habitat and submerged habitat features were present at MR1. Aquatic vegetation comprised <i>Elodea</i> sp. (submerged), <i>Azolla</i> sp. (floating), <i>Pistia</i> sp. (floating), <i>Juncus</i> sp. (emergent).

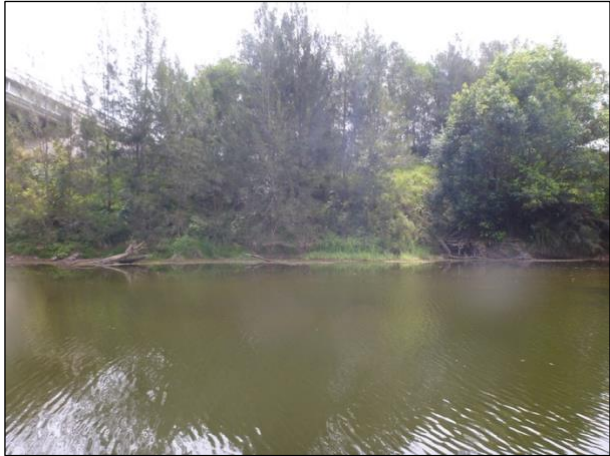
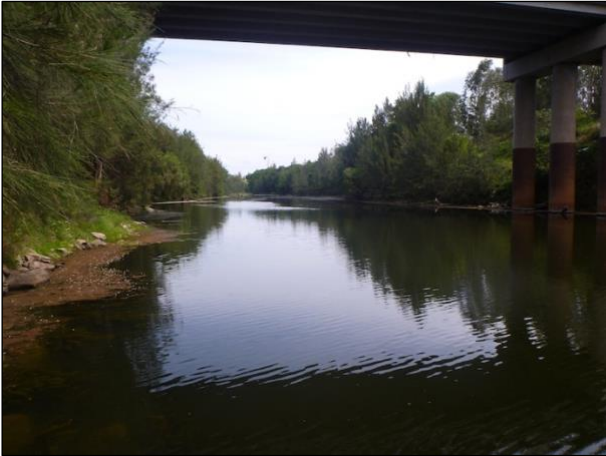
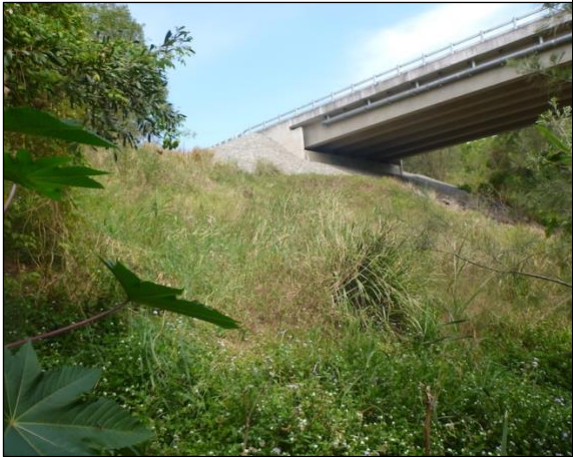
Site MR2

Right bank at upstream site		Upstream at upstream site		Left bank at upstream site	
Water Quality		Flow Conditions			
Temperature (°C)	25.40	Flow habitats present	Connected in-channel pool		
Conductivity (µS/cm)	376.8	Water level	Moderate (at watermark)		
Turbidity (NTU)	3.11	Recent high flow	Yes		
Dissolved oxygen (mg/L)	9.56	Flow	Upstream	Mid-site	Downstream
Dissolved oxygen (% sat)	117.3	Depth (m)	max = 2 <sup>a</sup> , mean = 1.5 <sup>a</sup>	-	-
pH	7.93	Width (m)	32	-	-
		Velocity (m/s)	<0.01	<0.01	<0.01

<b>Land Use</b>	Grazing land		
Left bank:	Grazing	Right bank:	Grazing
Overall disturbance:	High		
<b>Bank Assessment</b>			
<b>Left Bank</b>		<b>Right Bank</b>	
Bank material:	Boulder, cobble, sand, clay	Bank material:	cobble, sand, silt/clay
Bank height:	8 m	Bank height:	10 m
Bank slope:	Steep	Bank slope:	Steep
Bank shape:	Convex	Bank shape:	Convex
Vegetation cover:	Moderate	Vegetation cover:	Moderate
Vegetation type:	Grass, trees	Vegetation type:	Grass, trees
Shading of river:	10%	Shading of river:	10%
Trailing bank vegetation:	15%	Trailing bank vegetation:	25%
<b>Erosion Assessment</b>			
<b>Left Bank</b>		<b>Right Bank</b>	
Erosion:	Some	Erosion:	Some
Stability:	Moderate	Stability:	Moderate
Disturbances:	Erosion, weeds, cleared vegetation, access tracks, road	Disturbances:	Erosion, weeds, cleared vegetation, access tracks, road
<b>Bed Assessment</b>			
Substrate material:	Cobble, pebble, gravel, sand and silt/clay

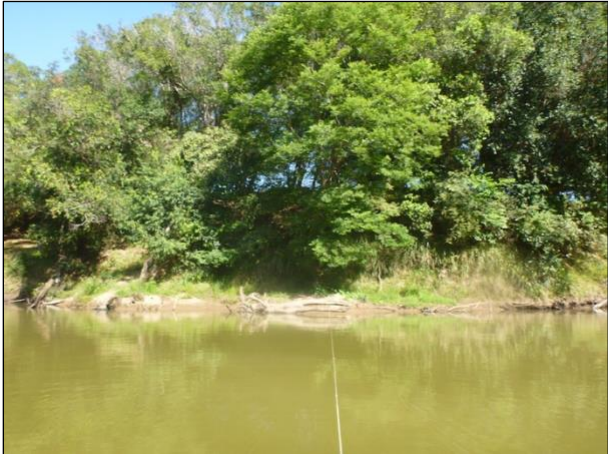
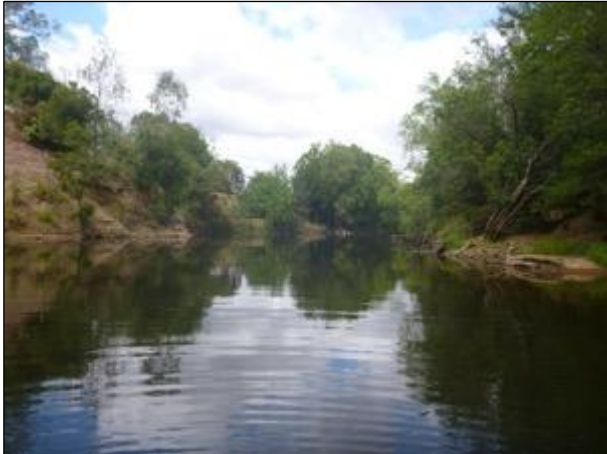
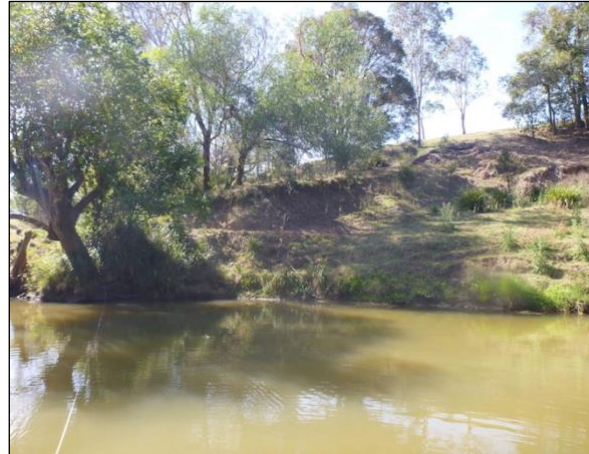
Site MR4

Right bank at mid-site		Upstream at mid-site		Left bank at mid-site	
Water Quality		Flow Conditions			
Temperature (°C)	22.39	Flow habitats present	Connected in-channel pool		
Conductivity (µS/cm)	472	Water level	Low (below watermark)		
Turbidity (NTU)	4.98	Recent high flow	No		
Dissolved oxygen (mg/L)	6.86	Flow	Upstream	Mid-site	Downstream
Dissolved oxygen (% sat)	79.2	Depth (m)	2.4	4	1.2
pH	7.39	Width (m)	32	42	42
		Velocity (m/s)	0.001	0	0.019

<b>Land Use</b>	Grazing		
Left bank:	Grazing	Right bank:	Grazing
Overall disturbance:	Very high		
<b>Bank Assessment</b>			
<b>Left Bank</b>		<b>Right Bank</b>	
Bank material:	silt/clay	Bank material:	silt/clay
Bank height:	5 m	Bank height:	7 m
Bank slope:	Steep	Bank slope:	Steep
Bank shape:	Convex	Bank shape:	Convex
Vegetation cover:	Some	Vegetation cover:	Moderate
Vegetation type:	Grass, shrubs and trees	Vegetation type:	Grass, shrubs and trees
Shading of river:	5%	Shading of river:	10%
Trailing bank vegetation:	10%	Trailing bank vegetation:	15%
<b>Erosion Assessment</b>			
<b>Left Bank</b>		<b>Right Bank</b>	
Erosion:	Some	Erosion:	Moderate
Stability:	Moderate	Stability:	Moderate
Disturbances:	weeds, and cleared vegetation	Disturbances:	Weeds, erosion and cleared vegetation
<b>Bed Assessment</b>			
Substrate material:	Pebble, gravel, sand and silt / clay		
Bed stability rating:	Moderate aggradation	Sediment deposits:	Sand and silt

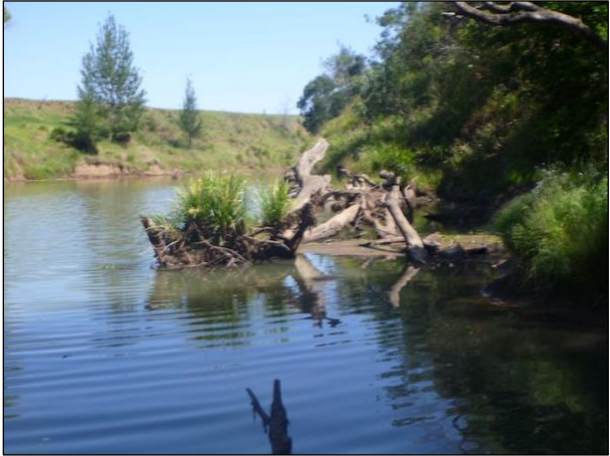
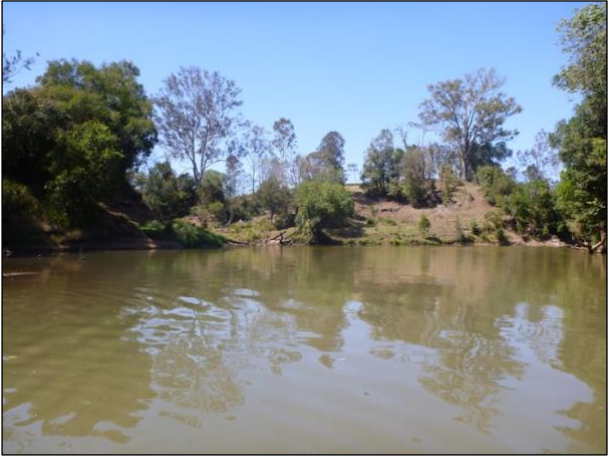
Logs and woody debris suitable for basking		Connected pool with slow flow	
<b>Habitat</b>	<b>Present / Absent</b>	<b>Habitat</b>	<b>Present / Absent</b>
Isolated pools	Absent	Individual log (diameter >250mm)	Present
Connected pools	Present	Individual branch (diameter <300mm)	Present
Riffle	Absent	Branch pile <50% dense (diameter <300mm)	Present
Run	Absent	Branch pile >50% dense (diameter <300mm)	Absent
Aquatic vegetation	Present/sparse	Log jam <50% dense (diameter >300mm)	Present
Turtle basking spots	Present	Log jam >50% dense (diameter >300mm)	Absent
Turtle nesting habitat	Present	Terrestrial leaves and twigs	Present – scattered
Submerged boulders / rock crevices	Present

<b>MNES Species Habitat</b>	
<b>Overall suitability</b>	Suitable
	Suitable habitat for Mary River cod, lungfish, white-throated snapping turtles and Mary River turtles was scattered through the site. Deep pools (4 m) were present throughout the site during the 2021 survey. Most deep pools contained large woody debris, with some shading from overhanging vegetation. Turtle basking spots were present in the form of exposed logs that were scattered throughout the site. Aquatic vegetation in emergent form ( <i>Juncus</i> sp.) and floating form ( <i>Azolla</i> sp. and <i>Salvinia</i> sp.) was observed at site.

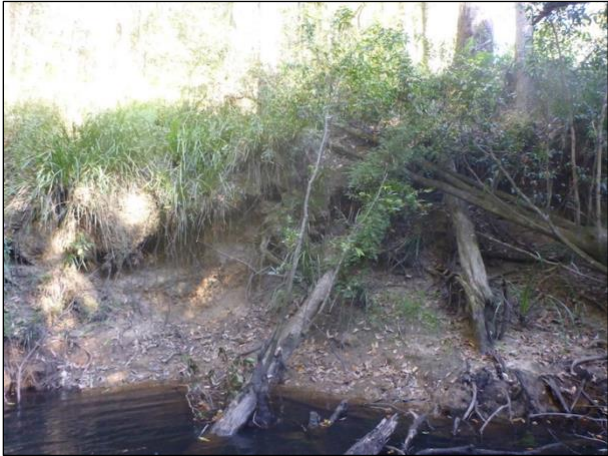
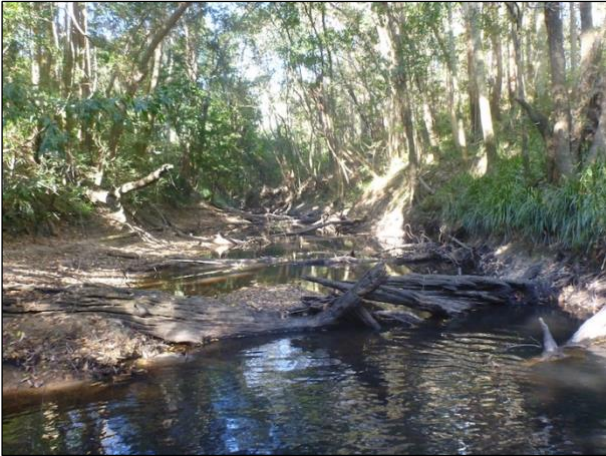
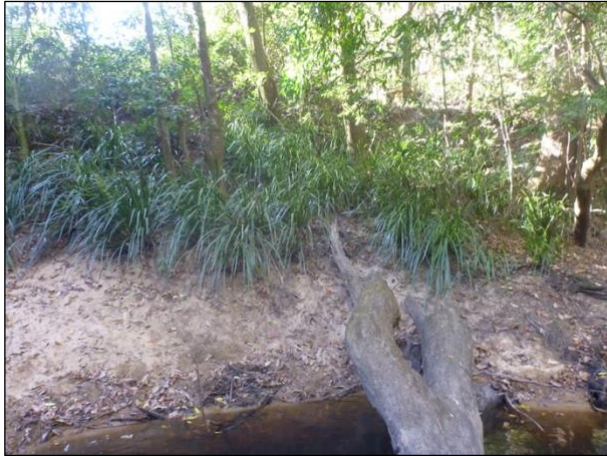
Site SMC5

Right bank at mid-site		Upstream at mid-site		Left bank at mid-site	
Water Quality		Flow Conditions			
Temperature (°C)	19.26	Flow habitats present	Connected in-channel pool, riffle, run		
Conductivity (µS/cm)	182.4	Water level	Low (below watermark)		
Turbidity (NTU)	7.96	Recent high flow	No		
Dissolved oxygen (mg/L)	3.92	Flow	Upstream	Mid-site	Downstream
Dissolved oxygen (% sat)	42.8	Depth (m)	0.5	1	0.3
pH	6.79	Width (m)	6.5	9	8.5
		Velocity (m/s)	0.018	0.005	0.11

<b>Land Use</b>	grazing		
Left bank:	grazing	Right bank:	grazing
Overall disturbance:	High		
<b>Bank Assessment</b>			
<b>Left Bank</b>		<b>Right Bank</b>	
Bank material:	Sand and silt/clay	Bank material:	Sand and silt/clay
Bank height:	3 m	Bank height:	3 m
Bank slope:	Steep	Bank slope:	Moderate - steep
Bank shape:	Convex	Bank shape:	Convex
Vegetation cover:	Extensive	Vegetation cover:	Moderate
Vegetation type:	Shrubs ( <i>Lomandra sp.</i> ) and trees	Vegetation type:	Shrubs ( <i>Lomandra sp.</i> ) and trees
Shading of river:	90%	Shading of river:	90%
Trailing bank vegetation:	15%	Trailing bank vegetation:	5%
<b>Erosion Assessment</b>			
<b>Left Bank</b>		<b>Right Bank</b>	
Erosion:	Moderate to heavy	Erosion:	Moderate
Stability:	Low to moderate	Stability:	Moderate
Disturbances:	Erosion, cleared vegetation, roads (bridge)	Disturbances:	Erosion, cleared vegetation, tracks and roads
<b>Bed Assessment</b>			
Substrate material:	Cobble, pebble, gravel, sand, silt / clay

Bed stability rating:	Bed stable	Sediment deposits:	Sand and silt

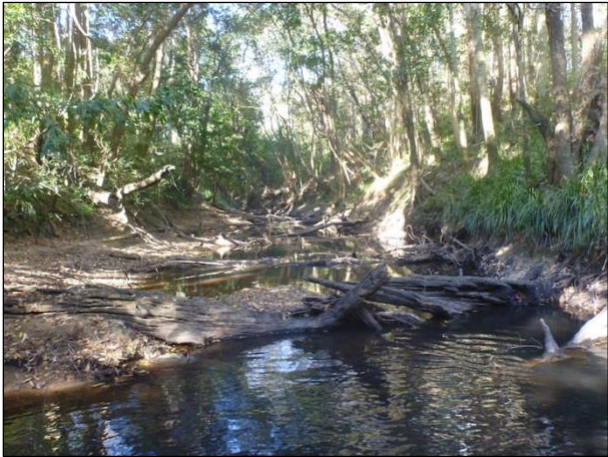
Woody debris provides basking spot		Riffle provides foraging habitat

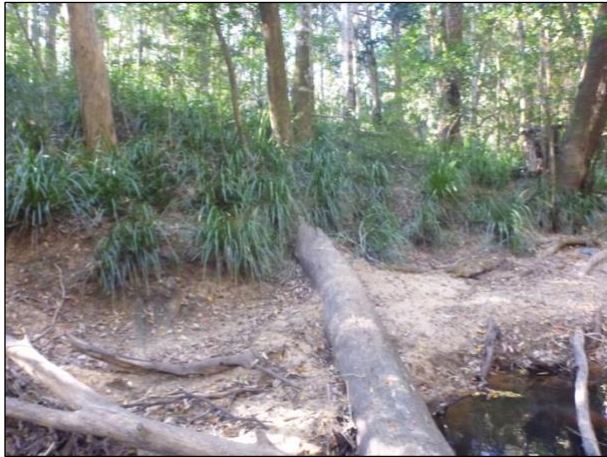
Sandy bank provides nesting habitat			
<b>Habitat</b>	<b>Present / Absent</b>	<b>Habitat</b>	<b>Present / Absent</b>
Isolated pools	Absent	Individual log (diameter >250mm)	Present
Connected pools	Present	Individual branch (diameter <300mm)	Present
Riffle	Present	Branch pile <50% dense (diameter <300mm)	Present
Run	Present	Branch pile >50% dense (diameter <300mm)	Present
Aquatic vegetation	Absent (none in-stream)	Log jam <50% dense (diameter >300mm)	Present
Turtle basking spots	Present	Log jam >50% dense (diameter >300mm)	Absent
Turtle nesting habitat	Present	Terrestrial leaves and twigs	Present – dense
Submerged boulders / rock crevices	Absent		
<b>Overall suitability</b>	Suitable for white-throated snapping turtles and Mary River turtles, potentially suitable for juvenile Mary River cod

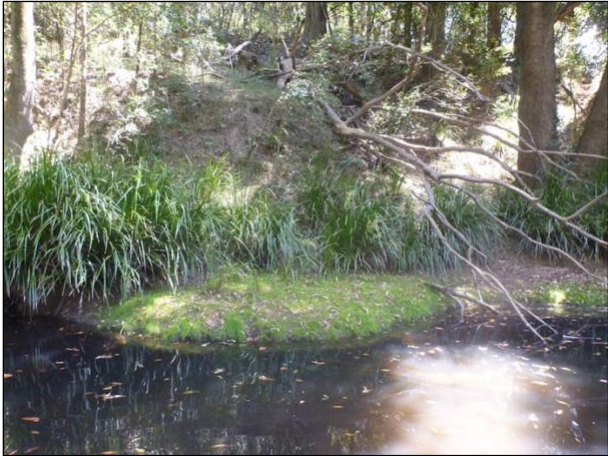
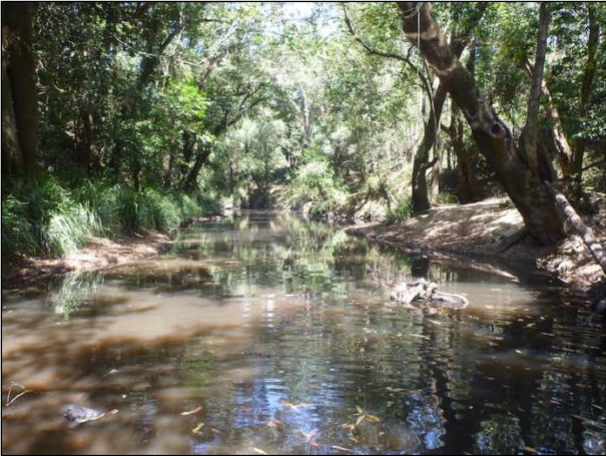
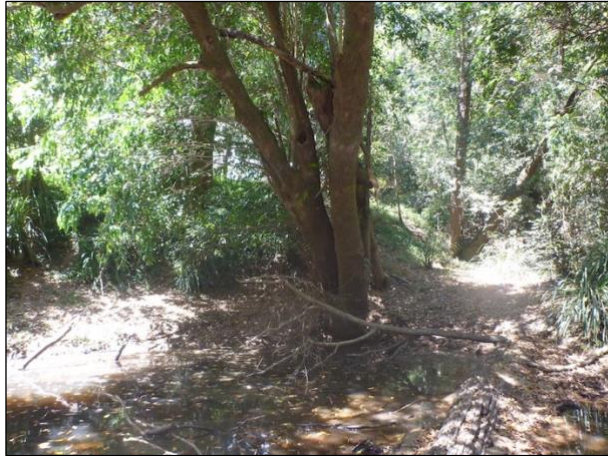
Site SMC5

Right bank at mid-site		Upstream at mid-site		Left bank at mid-site	
Water Quality		Flow Conditions			
Temperature (°C)	19.03	Flow habitats present	Connected and isolated in-channel pool, riffle, run		
Conductivity (µS/cm)	221.7	Water level	Moderate (at watermark)		
Turbidity (NTU)	4.62	Recent high flow	No		
Dissolved oxygen (mg/L)	3.42	Flow	Upstream	Mid-site	Downstream
Dissolved oxygen (% sat)	37.1	Depth (m)	0.2	0.5	0.4
pH	6.89	Width (m)	8	14	12
		Velocity (m/s)	0.018	0.025	0.08

<b>Land Use</b>	Grazing		
Left bank:	Grazing	Right bank:	Grazing
Overall disturbance:	Moderate		
<b>Bank Assessment</b>			
<b>Left Bank</b>		<b>Right Bank</b>	
Bank material:	Sand and clay	Bank material:	Cobble, gravel, sand, silt/clay
Bank height:	6 m	Bank height:	6 m
Bank slope:	Steep	Bank slope:	Steep
Bank shape:	Stepped	Bank shape:	Stepped
Vegetation cover:	Extensive	Vegetation cover:	Extensive
Vegetation type:	Shrubs ( <i>Lomandra</i> sp.), trees	Vegetation type:	Trees, shrubs ( <i>Lomandra</i> )
Shading of river:	75%	Shading of river:	50%
Trailing bank vegetation:	10%	Trailing bank vegetation:	5%
<b>Erosion Assessment</b>			
<b>Left Bank</b>		<b>Right Bank</b>	
Erosion:	Moderate	Erosion:	Moderate
Stability:	Moderate	Stability:	Moderate
Disturbances:	Weeds, erosion, cleared vegetation, road	Disturbances:	Erosion, cleared vegetation, access tracks, road
<b>Bed Assessment</b>			
Substrate material:	Sand, silt / clay, gravel, pebble

Bed stability rating:	Bed stable	Sediment deposits:	Sand

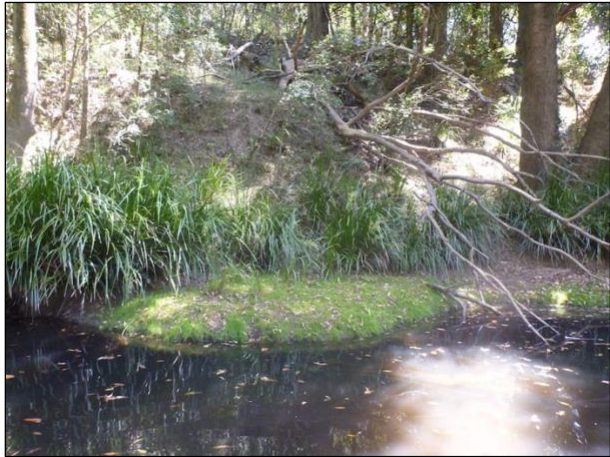
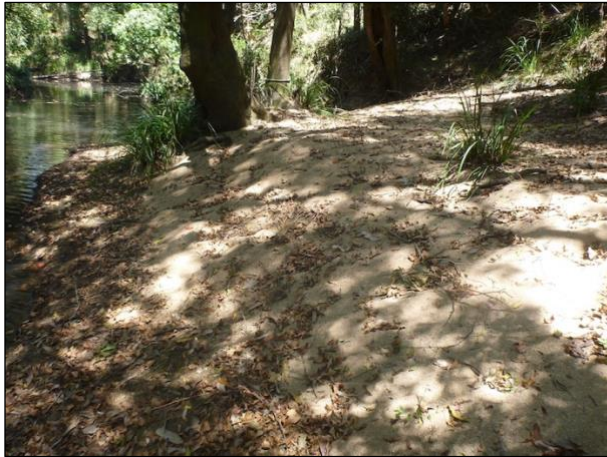
Bank provide basking habitat		Logs provide basking habitat	
Habitat	Present / Absent	Habitat	Present / Absent
Isolated pools	Present	Individual log (diameter >250mm)	Present
Connected pools	Present	Individual branch (diameter <300mm)	Present
Riffle	Present	Branch pile <50% dense (diameter <300mm)	Present
Run	Present	Branch pile >50% dense (diameter <300mm)	Present
Aquatic vegetation	Present	Log jam <50% dense (diameter >300mm)	Present
Turtle basking spots	Present	Log jam >50% dense (diameter >300mm)	Present
Turtle nesting habitat	Present	Terrestrial leaves and twigs	Present – Dense
Submerged boulders / rock crevices	Present		
<b>Overall suitability</b>	Potential for Mary River cod, white-throated snapping turtle and Mary River turtle, unsuitable for Australian lungfish
