Adaptive Management Plan

# Lake Macdonald (Six Mile Creek) Dam Improvement Project

<b>Document Type</b>	Adaptive Management Plan
<b>Project Title</b>	Lake Macdonald (Six Mile Creek) Dam Improvement Project
<b>Project Number</b>	30035740
<b>Doc Number</b>	LMDIP-05327-GNL-ENV-MPL-00002
<b>Revision Number</b>	Rev 16
<b>Project Use</b>	Issued for Use (IFU)

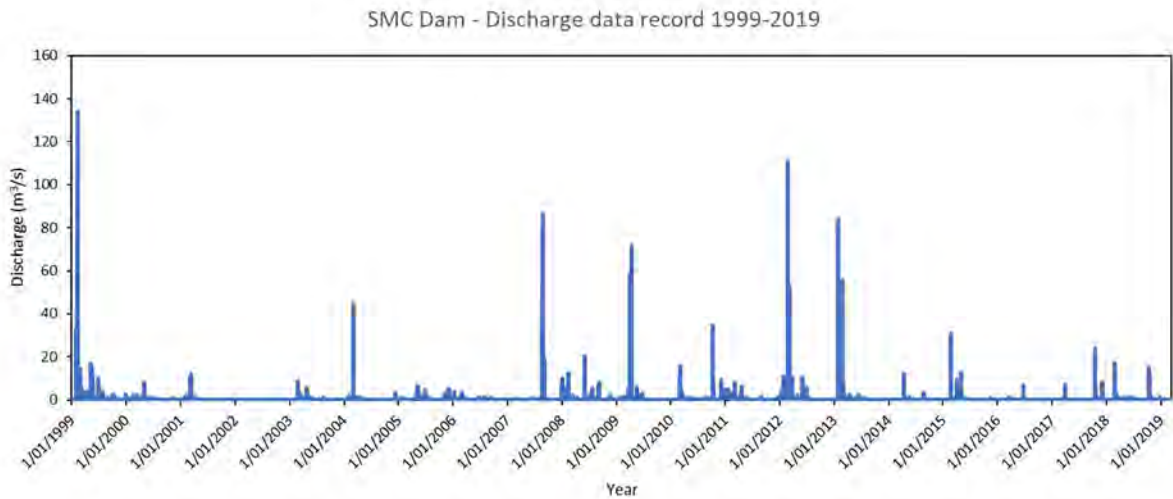
Figure 16-1: Discharge record for Six Mile Creek (SMC) Dam for the period 1999-2019

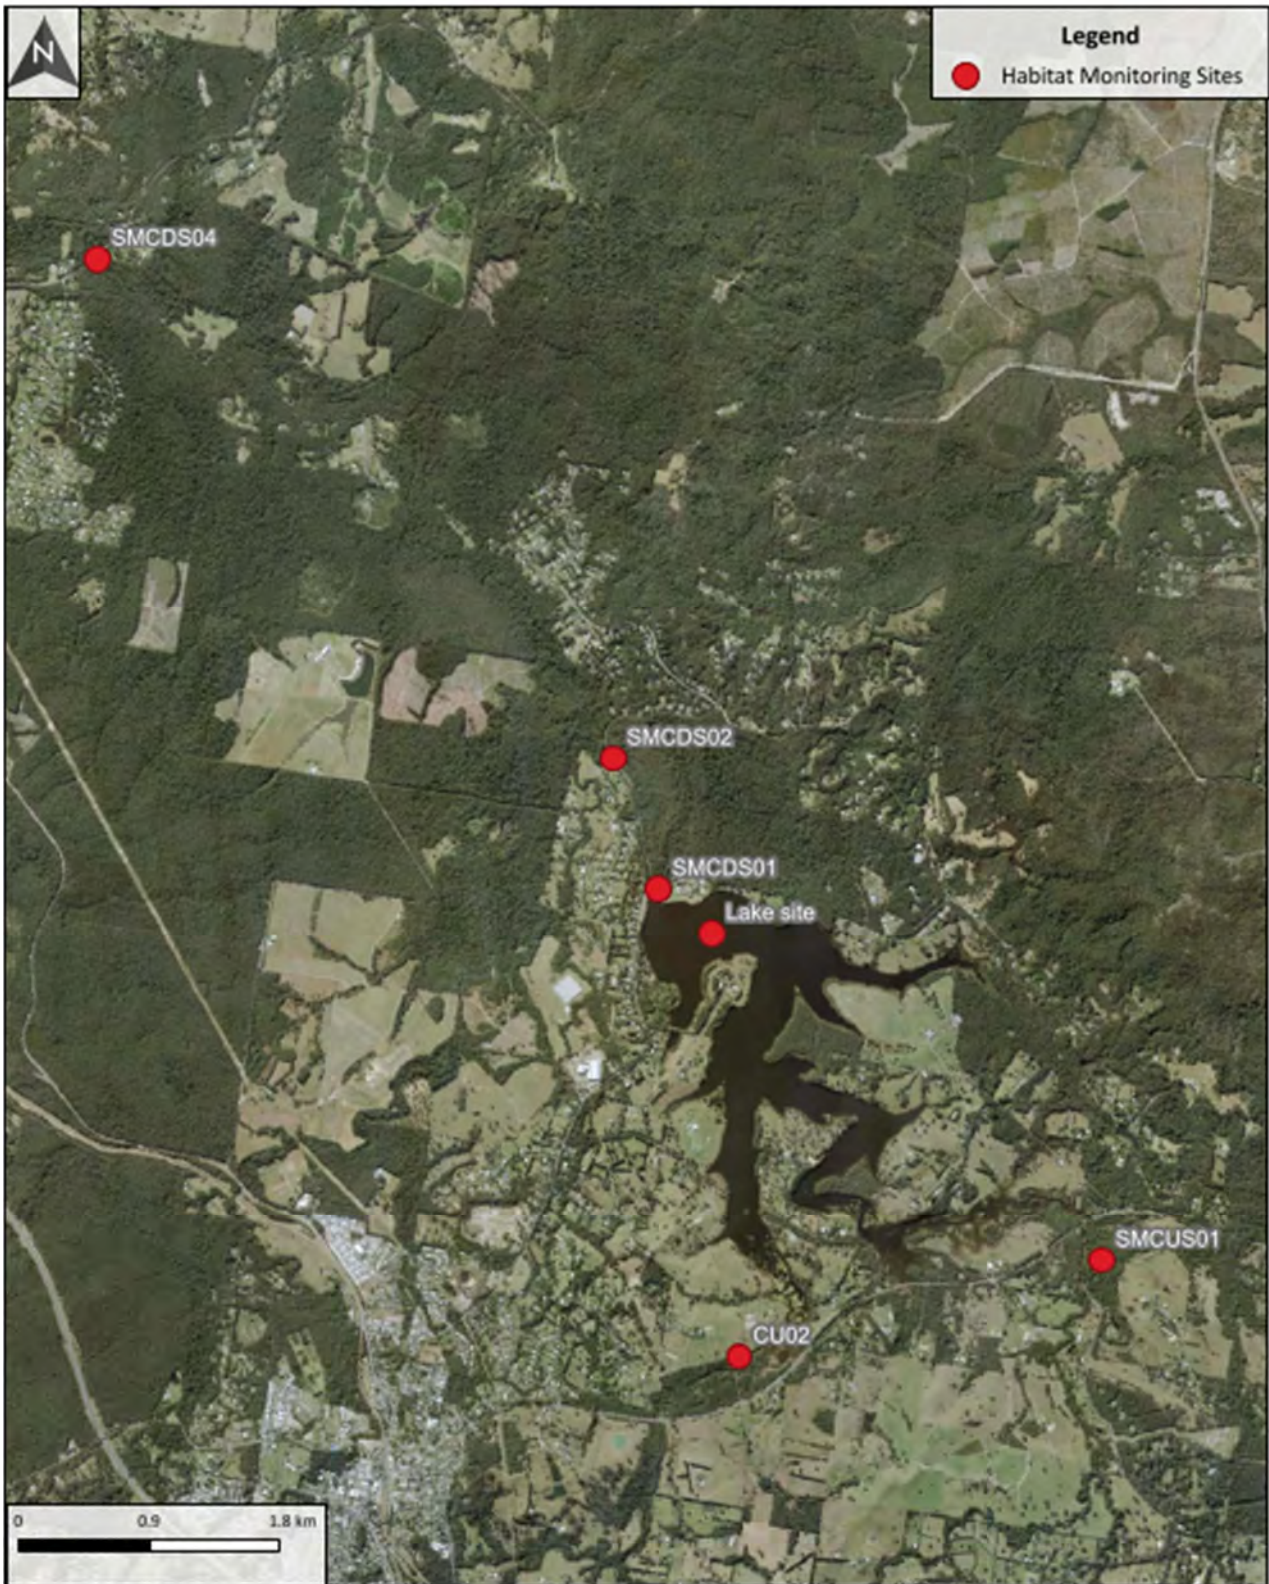
**PROJECT** Lake Macdonald Adaptive Management Plan  
**PROJECT NO** 30035740  
**FIGURE NO** Figure 16-4: Habitat Monitoring Sites  
**DATE** 23-07-2025  
**CREATED BY** TJ14235  
**SOURCES** Roadnet, Queensland Spatial

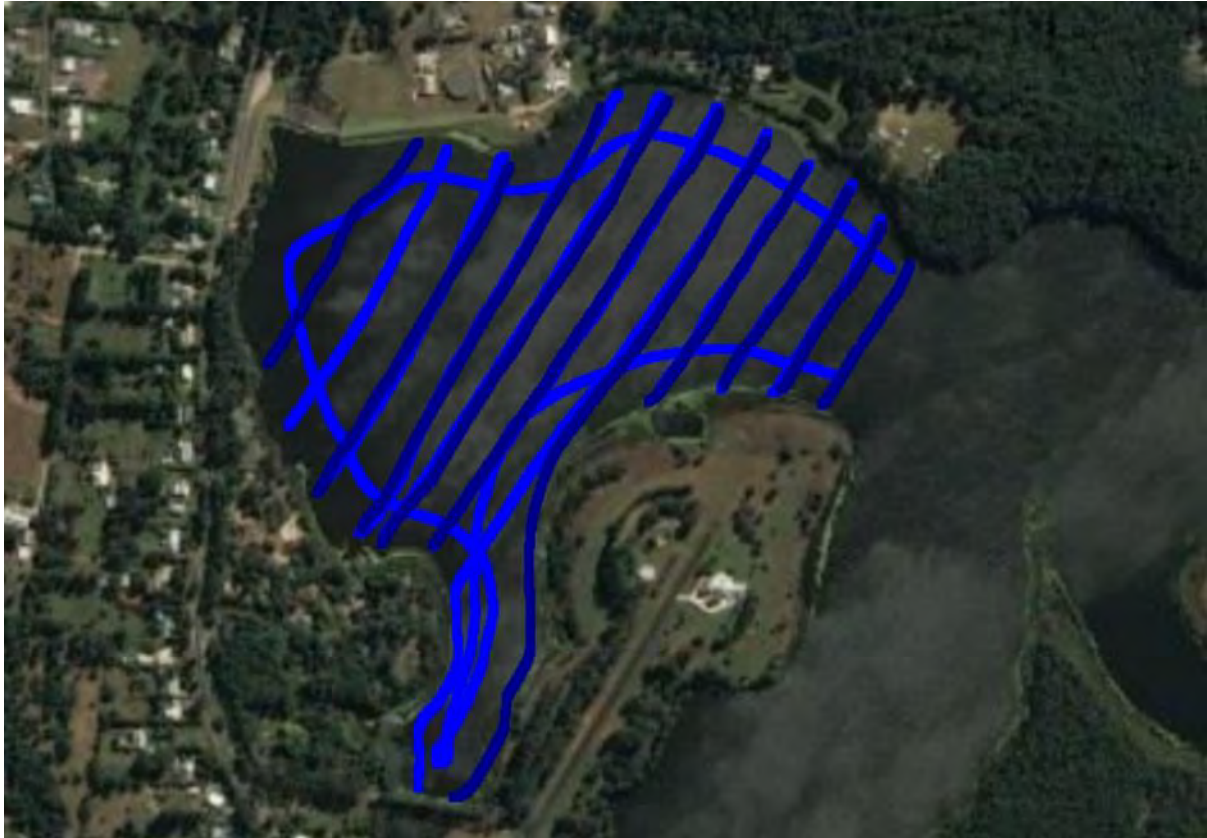
Figure 4. Typical survey transect pattern used in each zone recorded in the internal gps unit in the head unit of the DT-X.
