Lake Macdonald Dam Improvement Project

Quarterly Compliance
and Monitoring
Summary Report for
the Coordinator-
General

Document Number: LMDIP-10000-GNL-ENV-REP-00004 LMDIP Quarterly Compliance Monitoring Report for the Coordinator General

Reporting period: 1 March 2026 – 31 May 2026

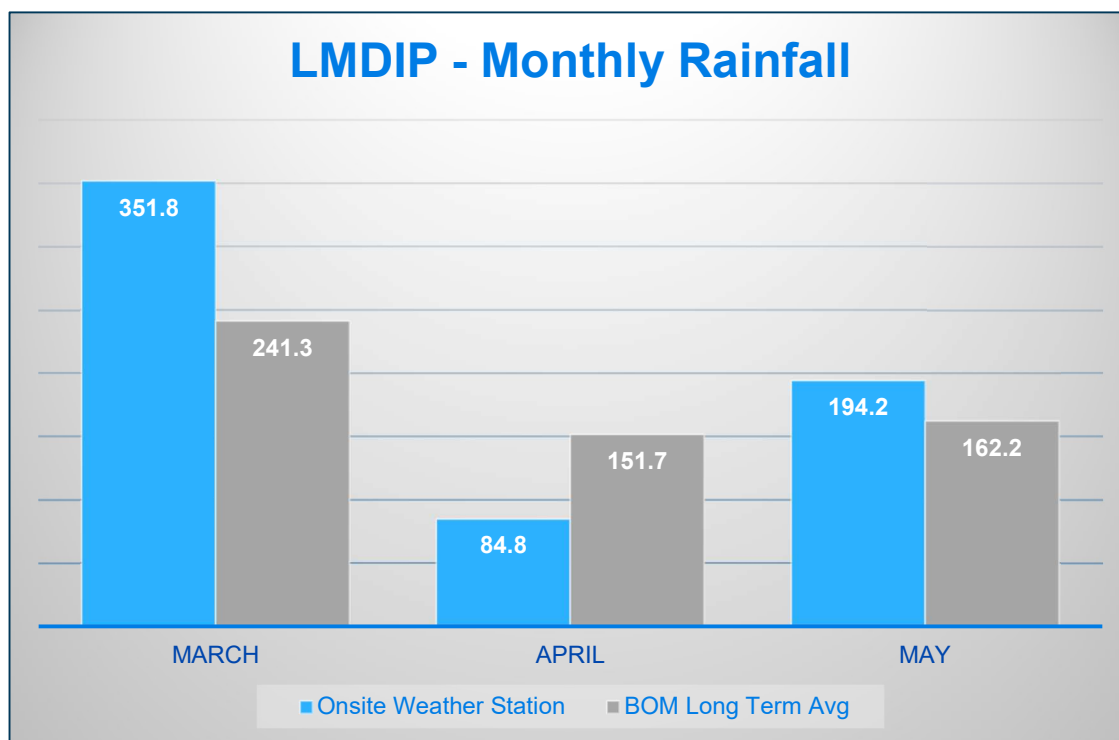
Rainfall observed on site was above the BOM long term average during monitoring period. There was frequent short intense rain events during this time which saw heavy falls and storm events. Two significant rainfall events occurred in this monitoring period which caused the site controls to overtop their designed capacity and was recorded as an environmental incident, (Refer to section 8).

Figure 1: LMDIP Monthly Rainfall compared to the Tewantin long term average.

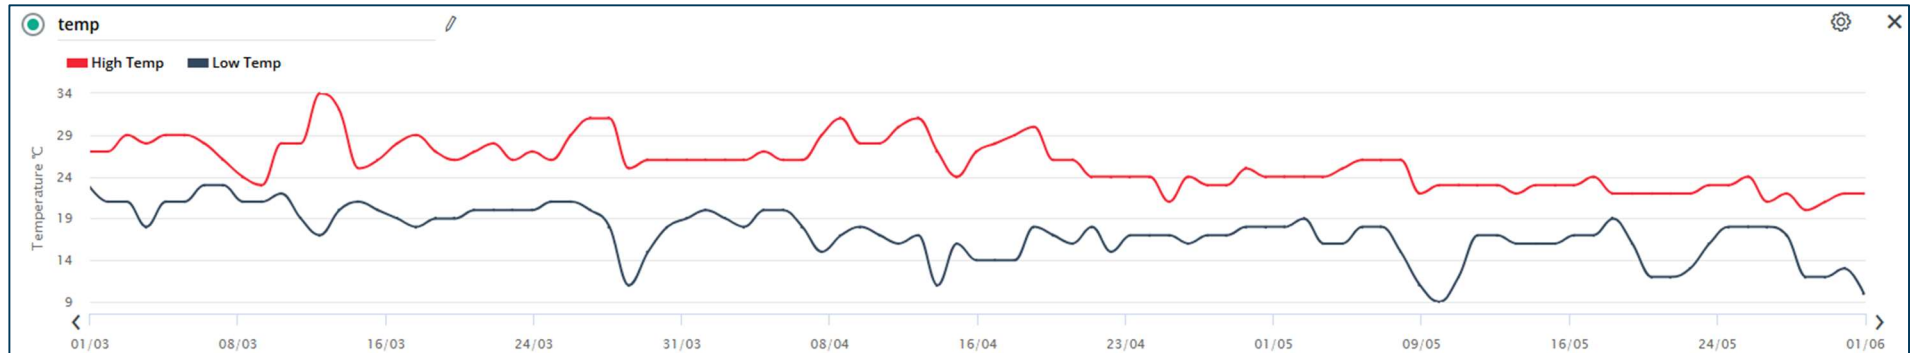
A weekly temperature trace is provided in Figure 2.

Figure 2: LMDIP Weekly Temperature Trace results

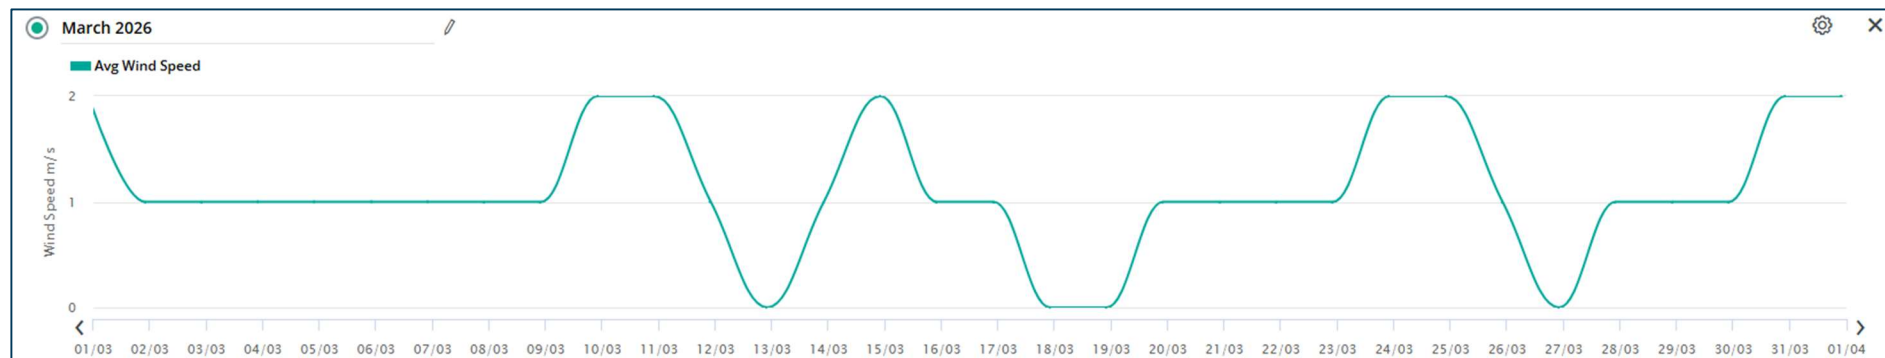
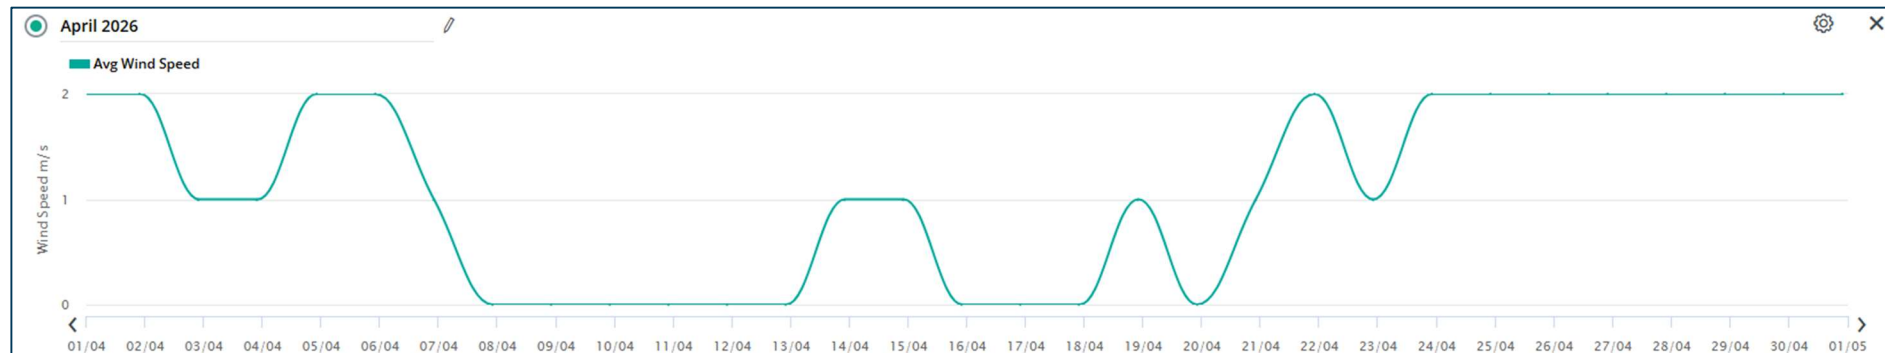
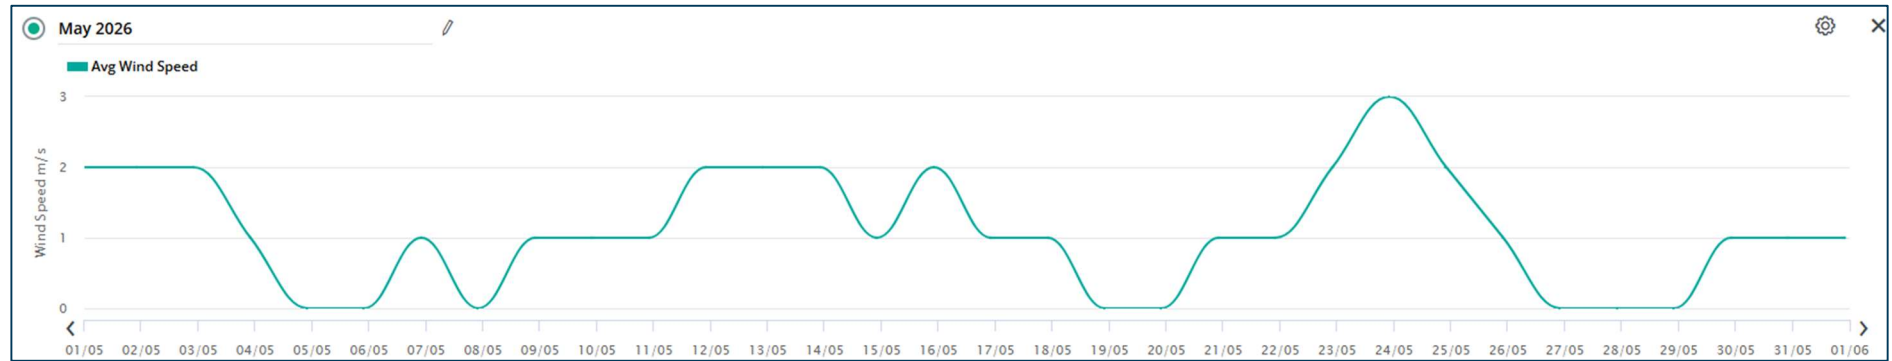
Windspeed and direction recorded during the period continued to be unremarkable with average daily windspeeds ranging between 1-5m/s with a predominant North Westerly direction. Refer to Figure 3 for average wind speed and Figure 4 for direction.

Figure 3: LMDIP Average Wind Speed

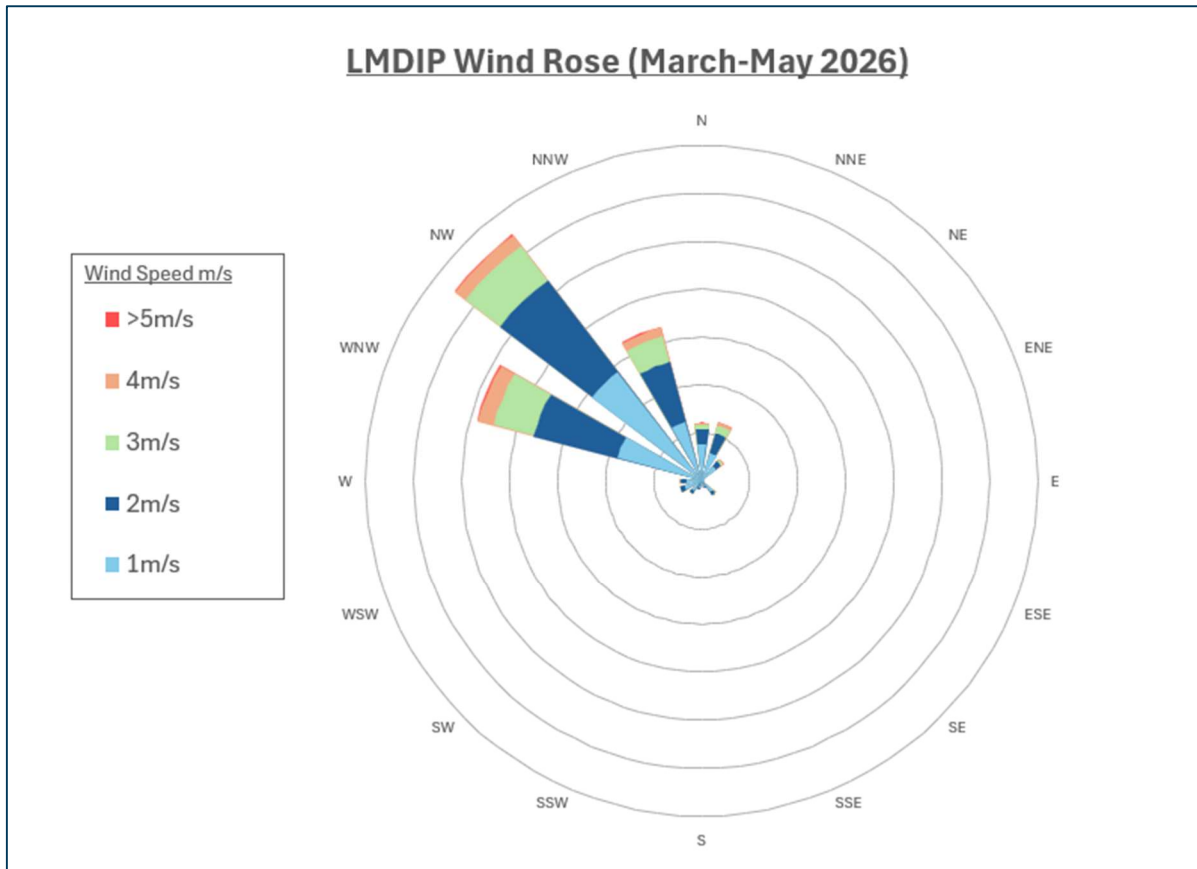
Figure 4: Wind Rose – 01/03/2026 to 31/06/2026

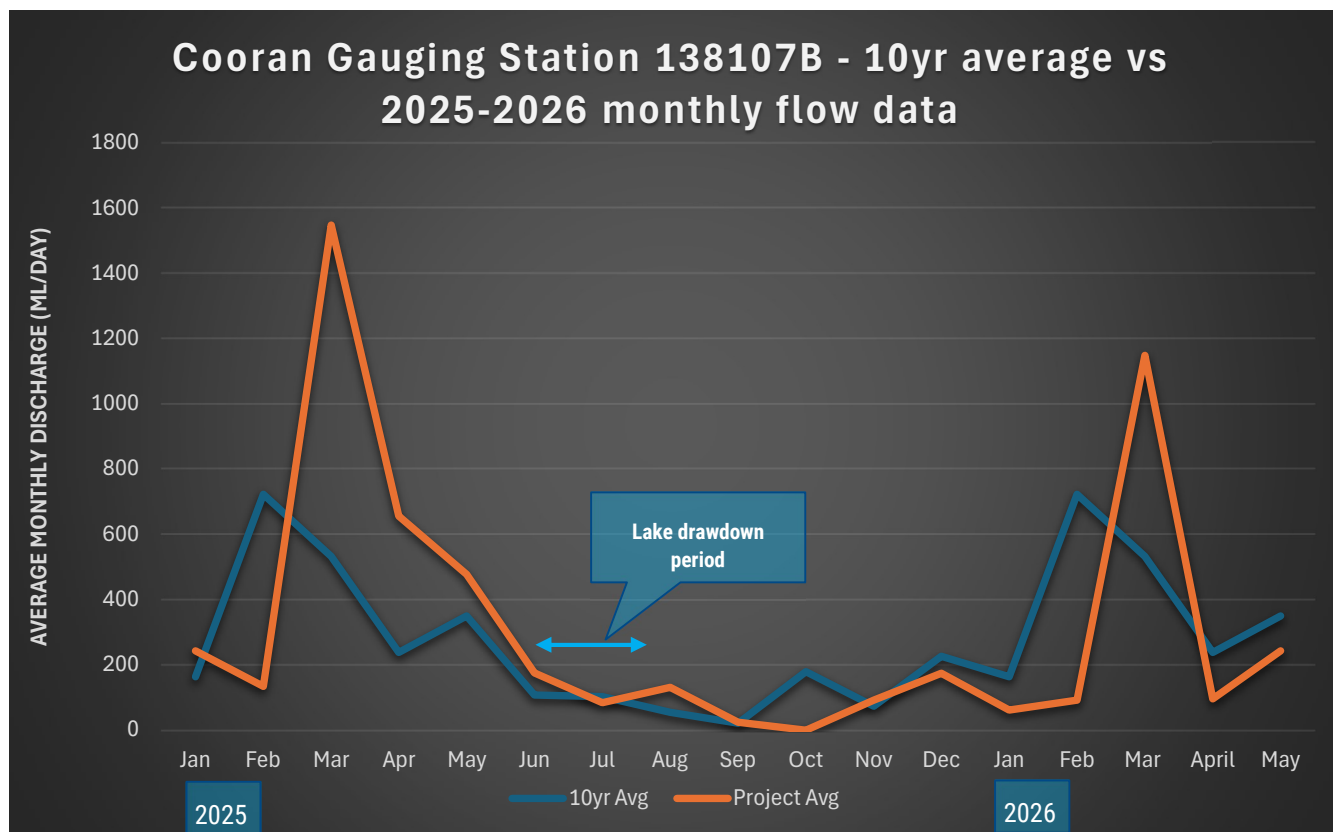
LMDIP regularly monitor the gauging station along Six Mile Creek at Cooran (138107B) to ensure flow regimes remain comparable to what’s considered normal. This gauging station is located approximately 20km downstream from Lake Macdonald. Figure 5 shows the average monthly flows throughout the project timeline compared to the 10yr average. Environmental flows are always maintained as per the Lake Macdonald Water License.

Figure 5: Comparing monthly average flows against the 10yr average – Cooran Gauging Station 138107B

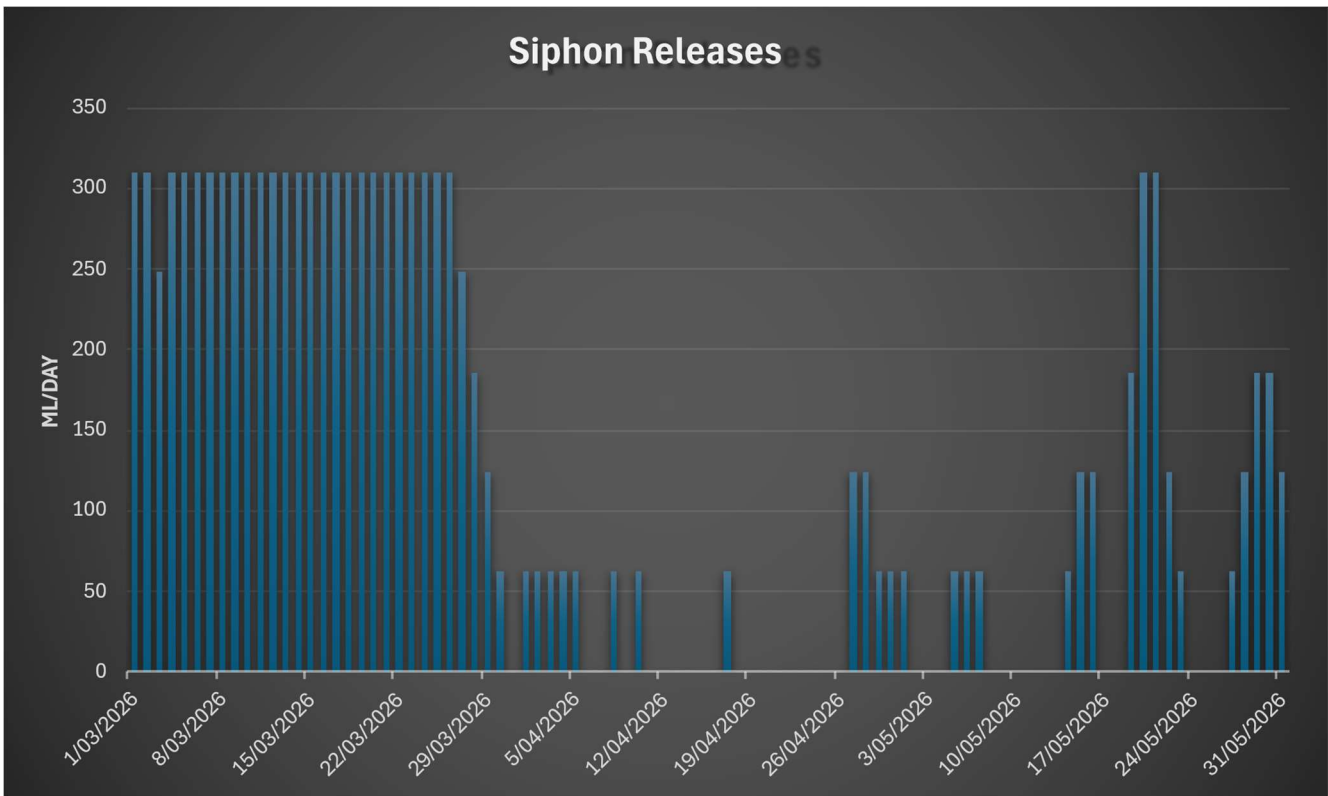
The following graph gives an estimation of ML/day discharged downstream through the siphon system throughout the reporting period. This is based on an average of 62ML/day passing through each siphon pipe (Figure 6).

Figure 6: Discharge to Six Mile Creek (Siphons and Environmental Flows).

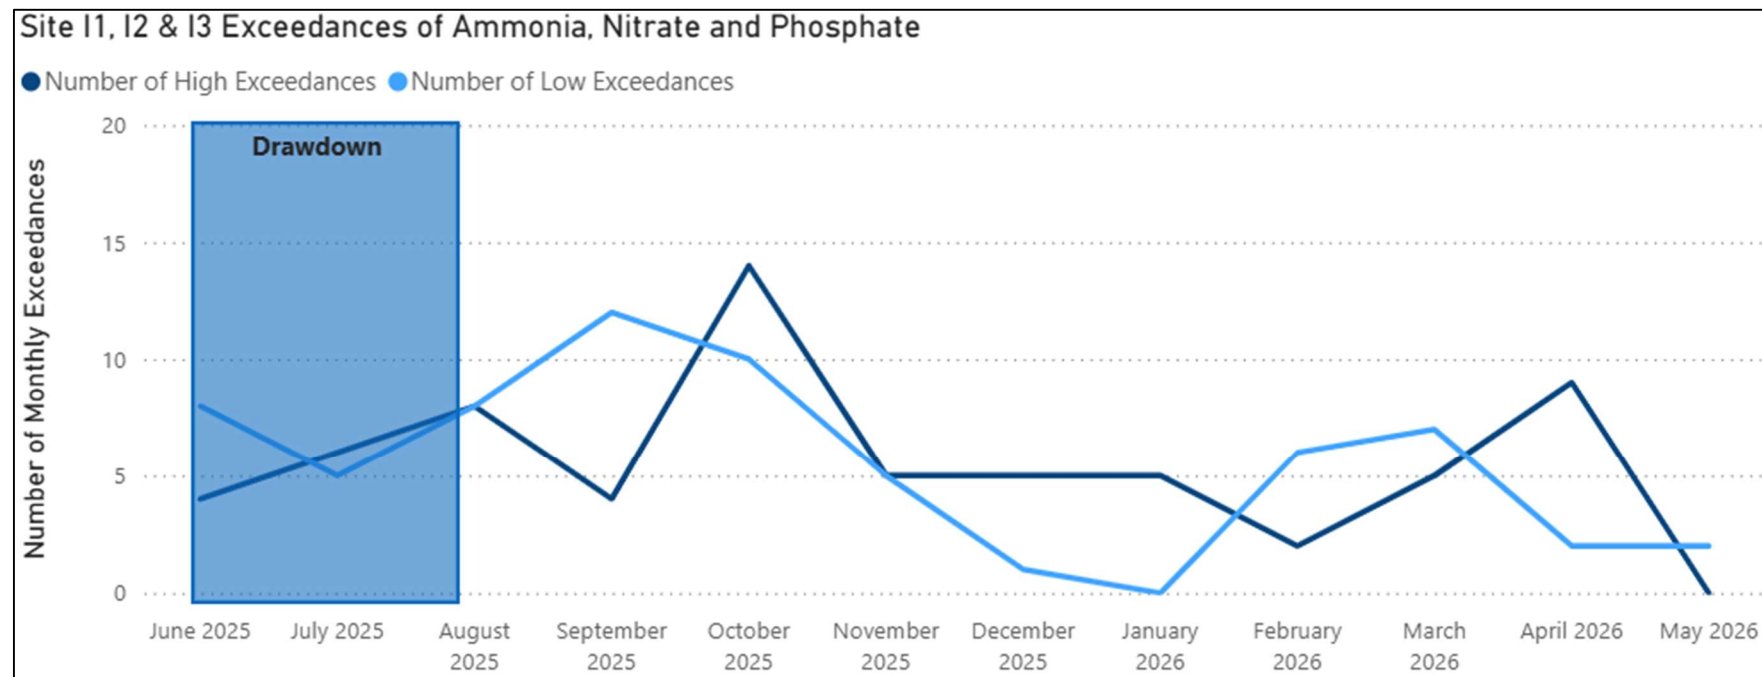
Figures 8, 9 and 10 display the historical inclusive water quality trends at all monitoring locations.

Figure 8: Number of exceedances of ammonia, nitrate and phosphate at the main body of the impoundment of Lake Macdonald (I1, I2 and I3)

The data graphed above in Figures 8, 9 and 10 indicate the trends of nutrients from the start of project activities until the end of this reporting period. Figure 9 highlights a continued stabilisation of exceedances in the upper reaches. Figure 8 also shows a similar trend in the main impoundment (I1, I2 and I3) of Lake MacDonald. The increase in nutrient exceedances observed in March and April is attributed to the large rainfall event on the 9-10th of March, which resulted in overtopping of the Dam Spillway and increased nutrient runoff input from the local catchment area. A similar increase in high exceedances was observed downstream over March and April coinciding with the overtopping of the spillway. Downstream sites show a subsequent decrease in low and high exceedance numbers in the month of May, as seen in Figure 10.

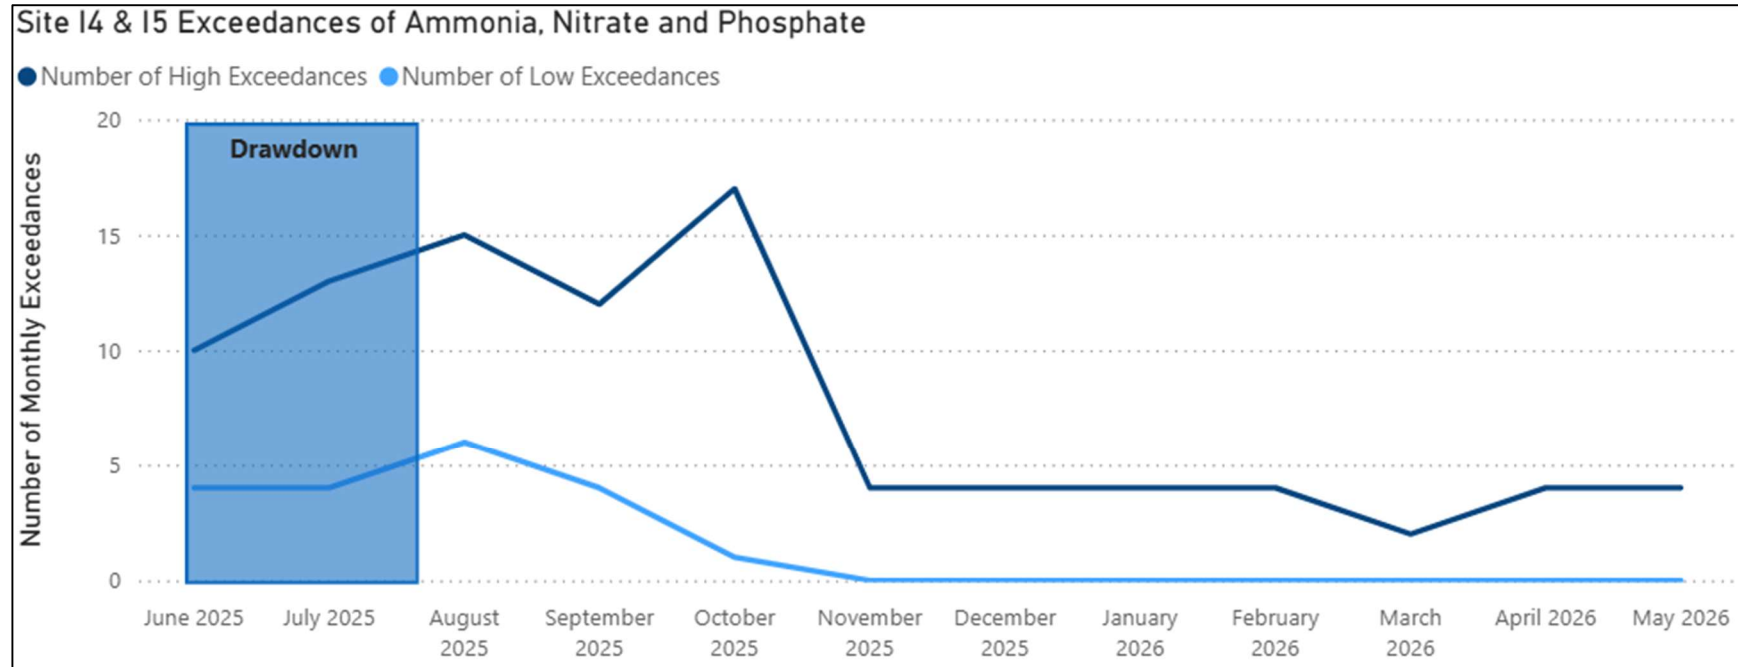
Figure 9: Number of exceedances of ammonia, nitrate and phosphate at the upper reaches of Lake Macdonald at sites I4 and I5

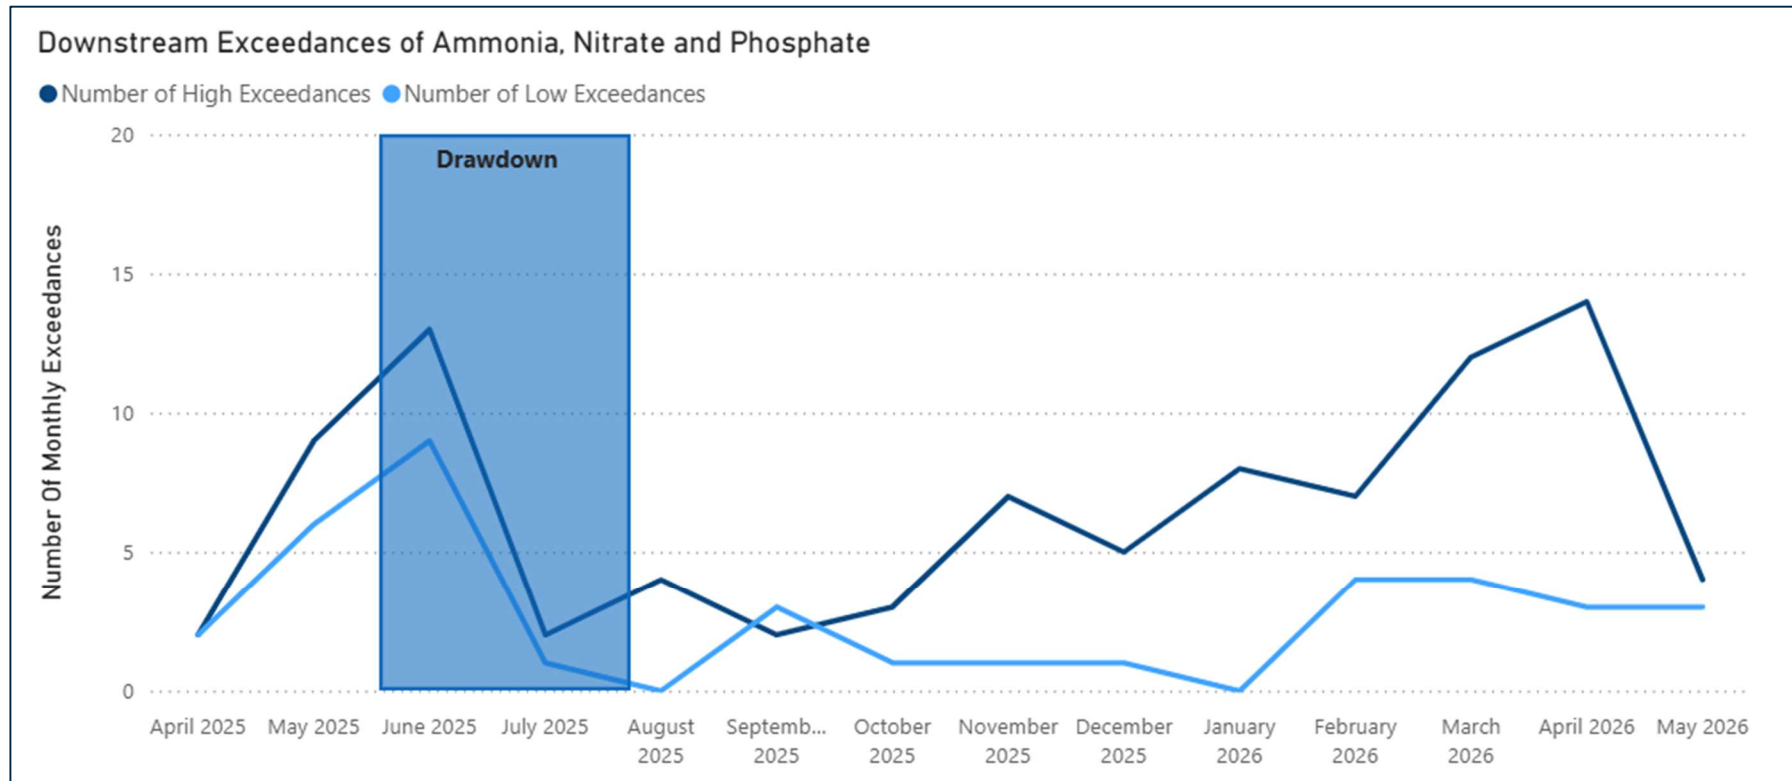
Figure 10: Number of exceedances of ammonia, nitrate and phosphate downstream at sites DS01, DS02, DS03 and DS04.

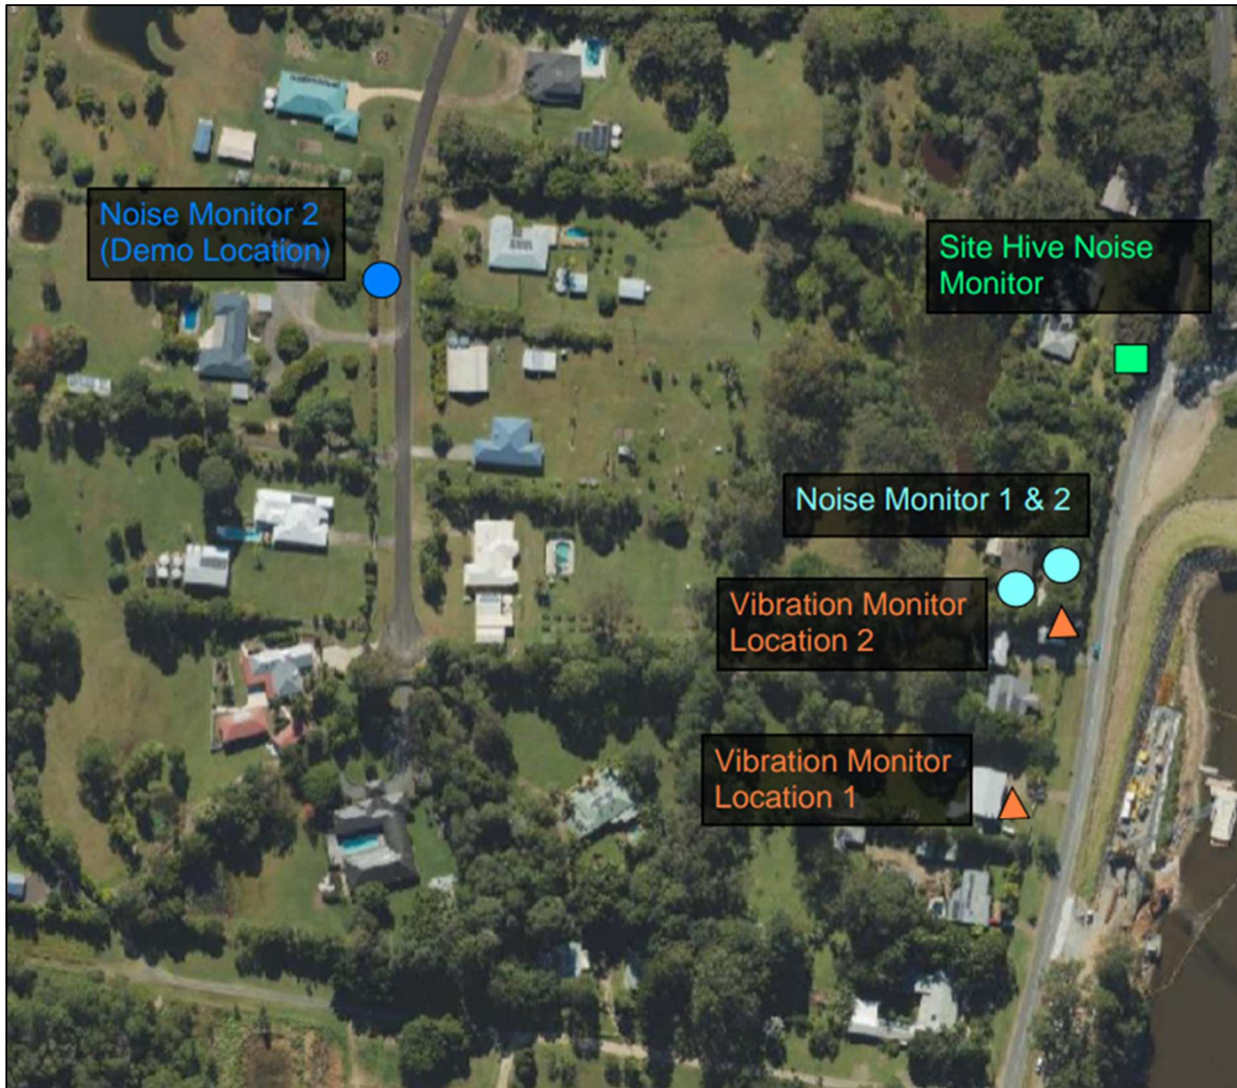
The noise and vibration monitoring locations are shown in Figure 13 below.

Figure 13: Noise and Vibration Monitoring Locations

Vibration monitoring occurred at two locations during this reporting period (Refer to Figure 13).

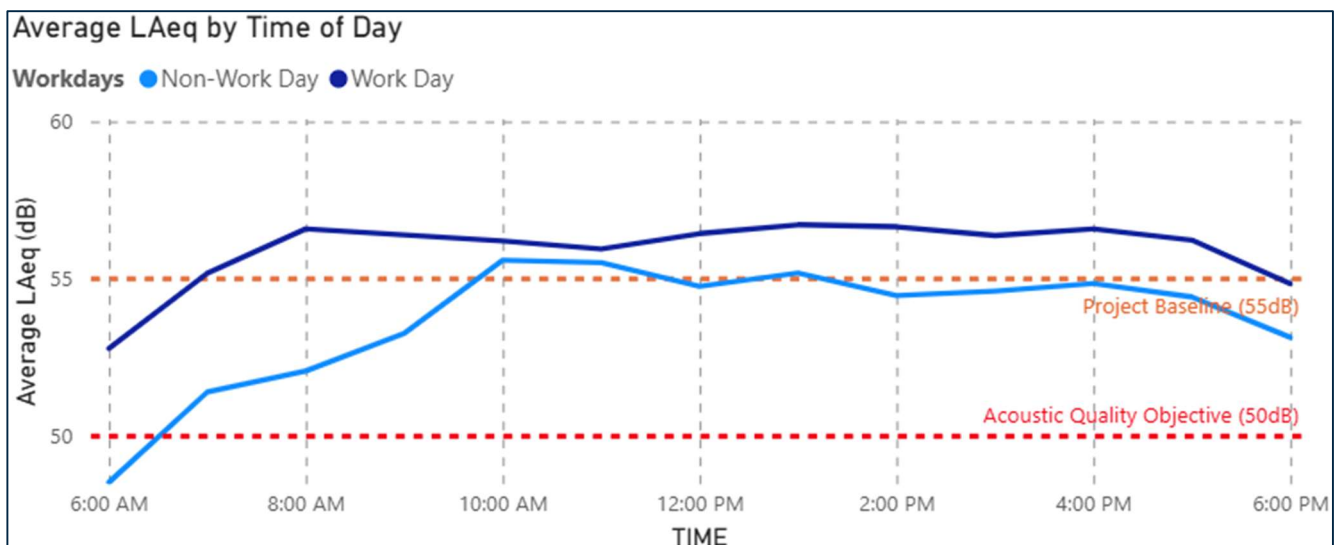
Figure 14: Average hourly LAeq by time of day during work hours (6:30am-6:30pm), during standard work-days (Monday to Saturday) and non-work days (Sunday).

Data collected from the project noise loggers during the standard construction works continues to show slight exceedance of the acoustic quality objectives throughout the construction workdays (Mon-Sat 6:30am-6:30pm) as well as Sundays when no construction activities were occurring (Refer to Figure 13). In addition, the recorded noise levels were similar between workdays (average LA_{eq} 55.92) and non-workdays (average LA_{eq} 53.68) demonstrating minimal construction impact (Refer to Figures 14 and 15).

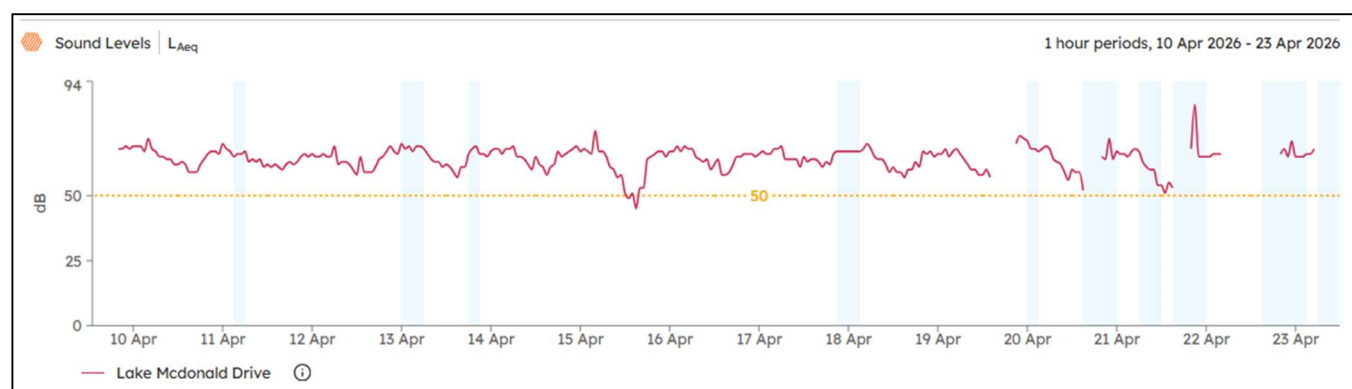
Figure 16 further displays the hourly LA_{eq} readings from the site hive over the demolition period. As can be seen, the noise levels stayed fairly consistent throughout the demolition period. No night works occurred on the 15-16th of April, hence the decrease in the night dB(A) to just below the target at 45dB(A). Periods of adverse weather are being shaded in blue on the telemetry graphs. Adverse weather is defined by defaults as 1mm or more of rain and/or 5 or more m/s wind speed. Noise monitoring is avoided during rain or strong winds as it generates false background noise – hence why there appears to be some gaps in the data presented.

Figure 16: Site Hive LAeq Over the Demolition Period (1-Hour Intervals, daily averages)

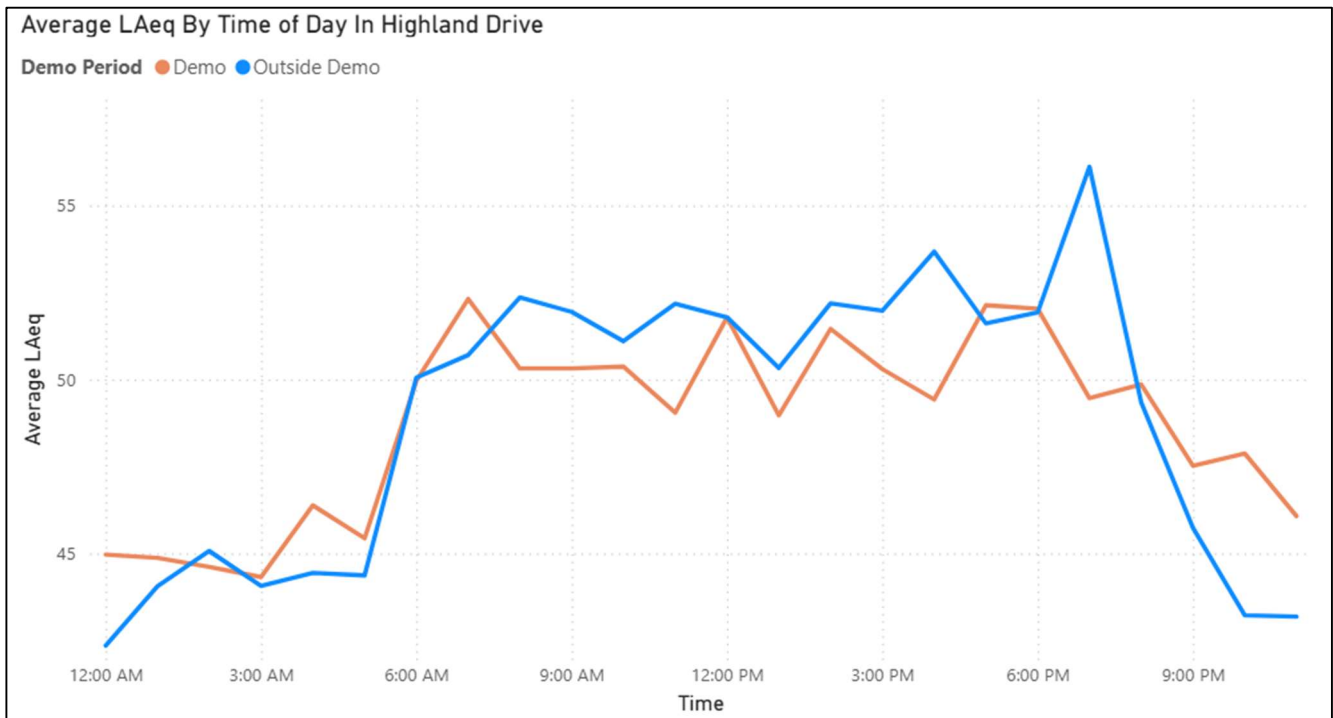
On Highland Drive, noise levels recorded during the demolition period were generally similar to, or slightly lower than, those measured prior to the demolition period, with differences of 1-3dBA (Refer Figure 17). This indicates that the primary noise impacts were confined to Lake MacDonal Drive. Figure 17 also clearly shows the effectiveness of scheduling high-impact demolition works during the day and lower-impact activities at night.

Figure 17: Comparison of the LA_{eq} average (1-Hour intervals) during the demolition period and outside the demolition period

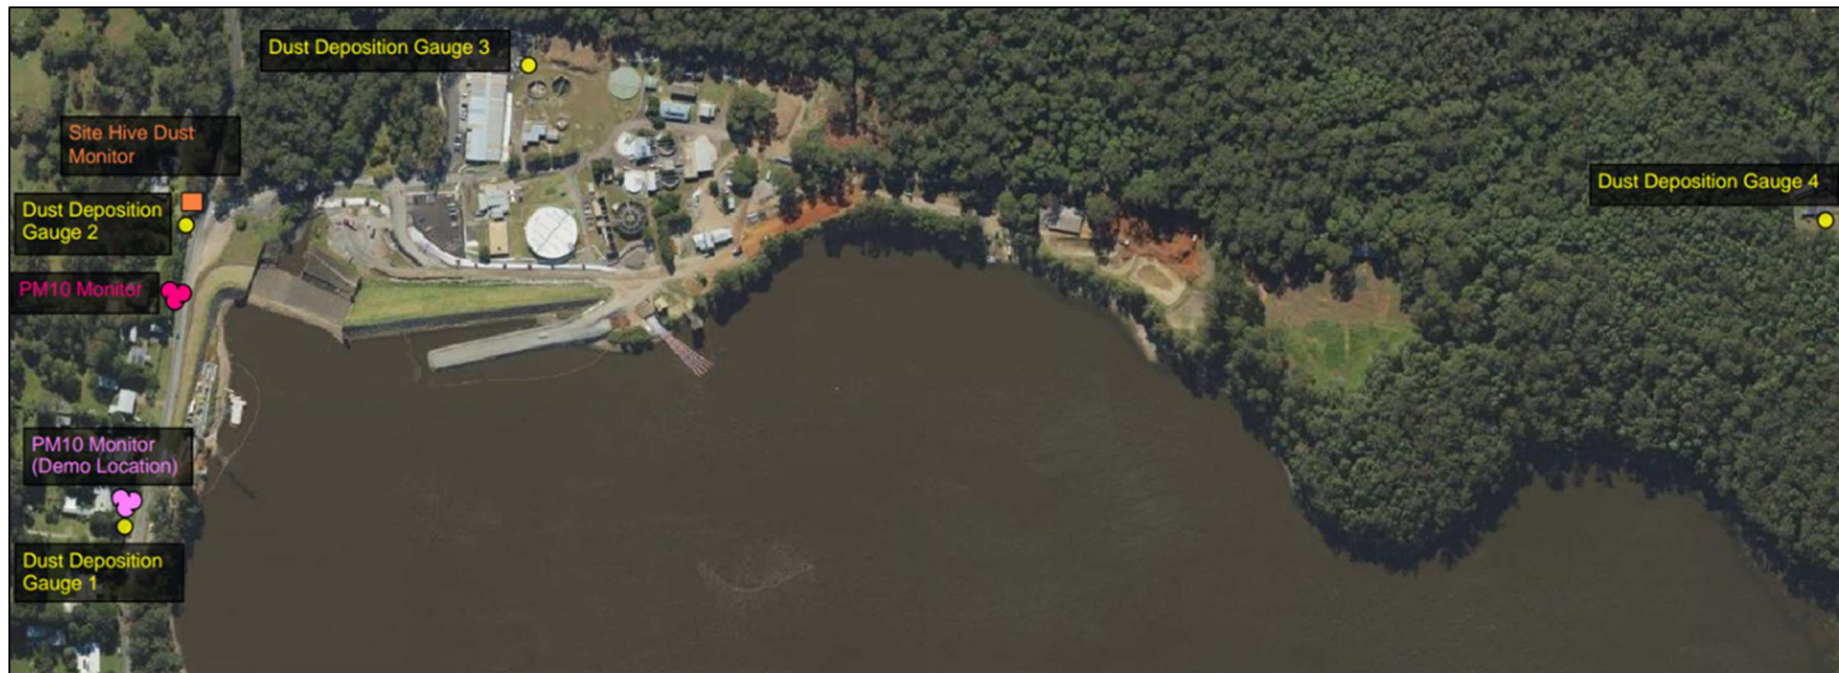
Air quality has been monitored throughout the period via dust deposition gauges and a real-time PM₁₀ monitor at the locations shown in Figure 17.

During the spillway demolition period (10 April - 24 April 2026), an additional Site Hive dust monitor was installed on Lake MacDonal Drive opposite the Project site's entrance and the other PM₁₀ monitor was temporarily relocated to the corner of Lake MacDonal Drive and Liane Drive to ensure broader monitoring of the potential dust impacts from the demolition.

Figure 18: Air Quality Monitoring Locations (including PM₁₀ Monitor)

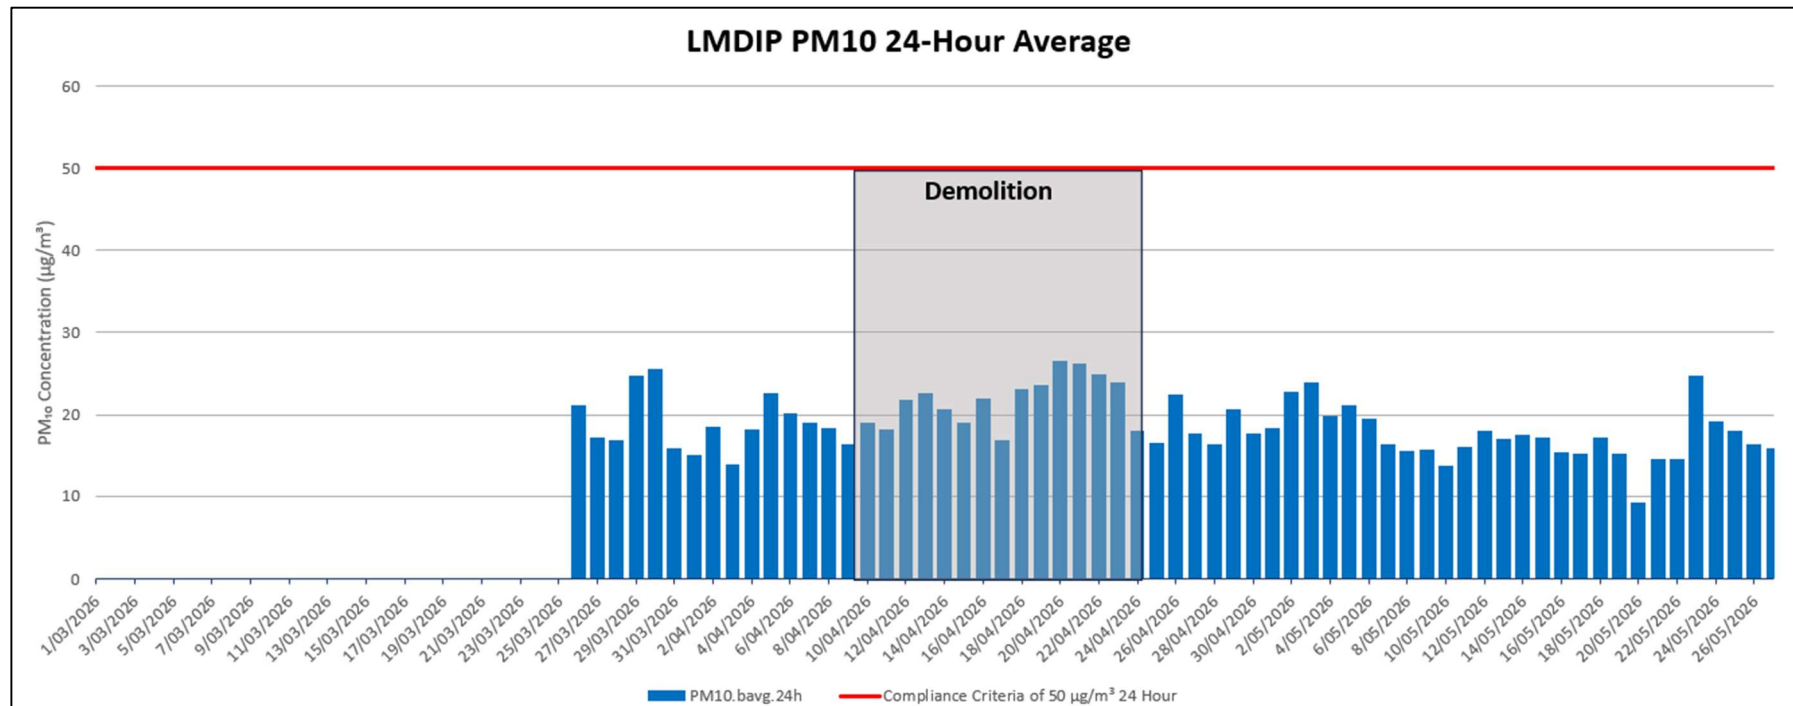
The data collected as seen in Figure 18, demonstrates no exceedances in this reporting period with all data captured well below the 50µg/m³ 24-hour criteria.

Figure 19: LMDIP PM10 24-Hour Average

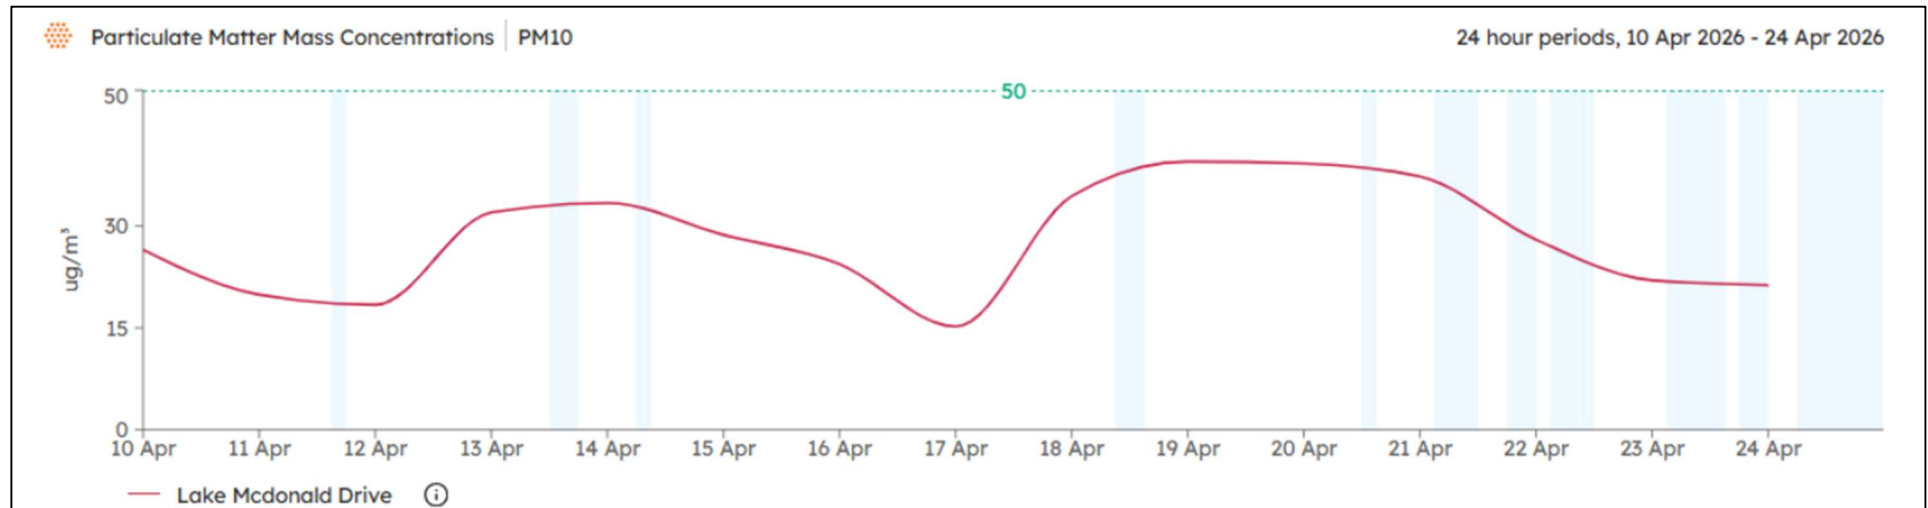
The Site Hive included a dust monitoring unit measuring PM₁₀, located at the site entrance. Figure 19 shows that there was no exceedance of the PM₁₀ 50µg/m³ 24-hour criteria during the demolition period indicating that the dust mitigation measures in place were effective.

Figure 20: LMDIP Site Hive PM₁₀ Levels (24-Hour Average)
