# **Lake Macdonald Dam Improvement Project**

Quarterly Compliance  
and Monitoring  
Summary Report for  
the Coordinator-  
General

Document Number: LMDIP-10000-GNL-ENV-REP-00004 LMDIP Quarterly Compliance Monitoring Report for the Coordinator General

Reporting period: 1 March 2026 – 31 May 2026

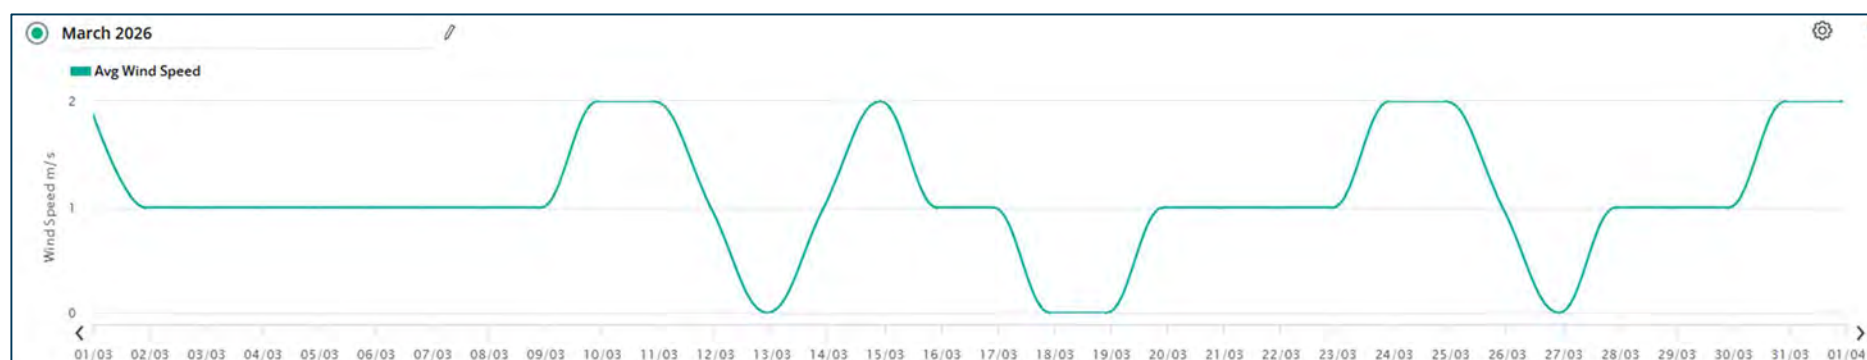
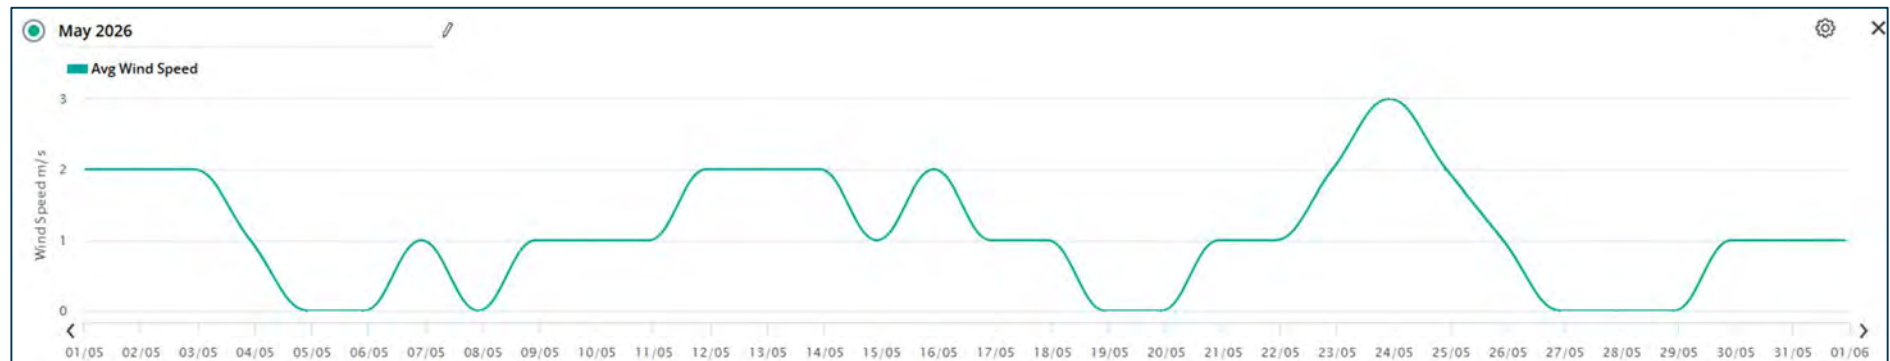
Windspeed and direction recorded during the period continued to be unremarkable with average daily windspeeds ranging between 1-5m/s with a predominant North Westerly direction. Refer to Figure 3 for average wind speed and Figure 4 for direction.

**Figure 3: LMDIP Average Wind Speed**

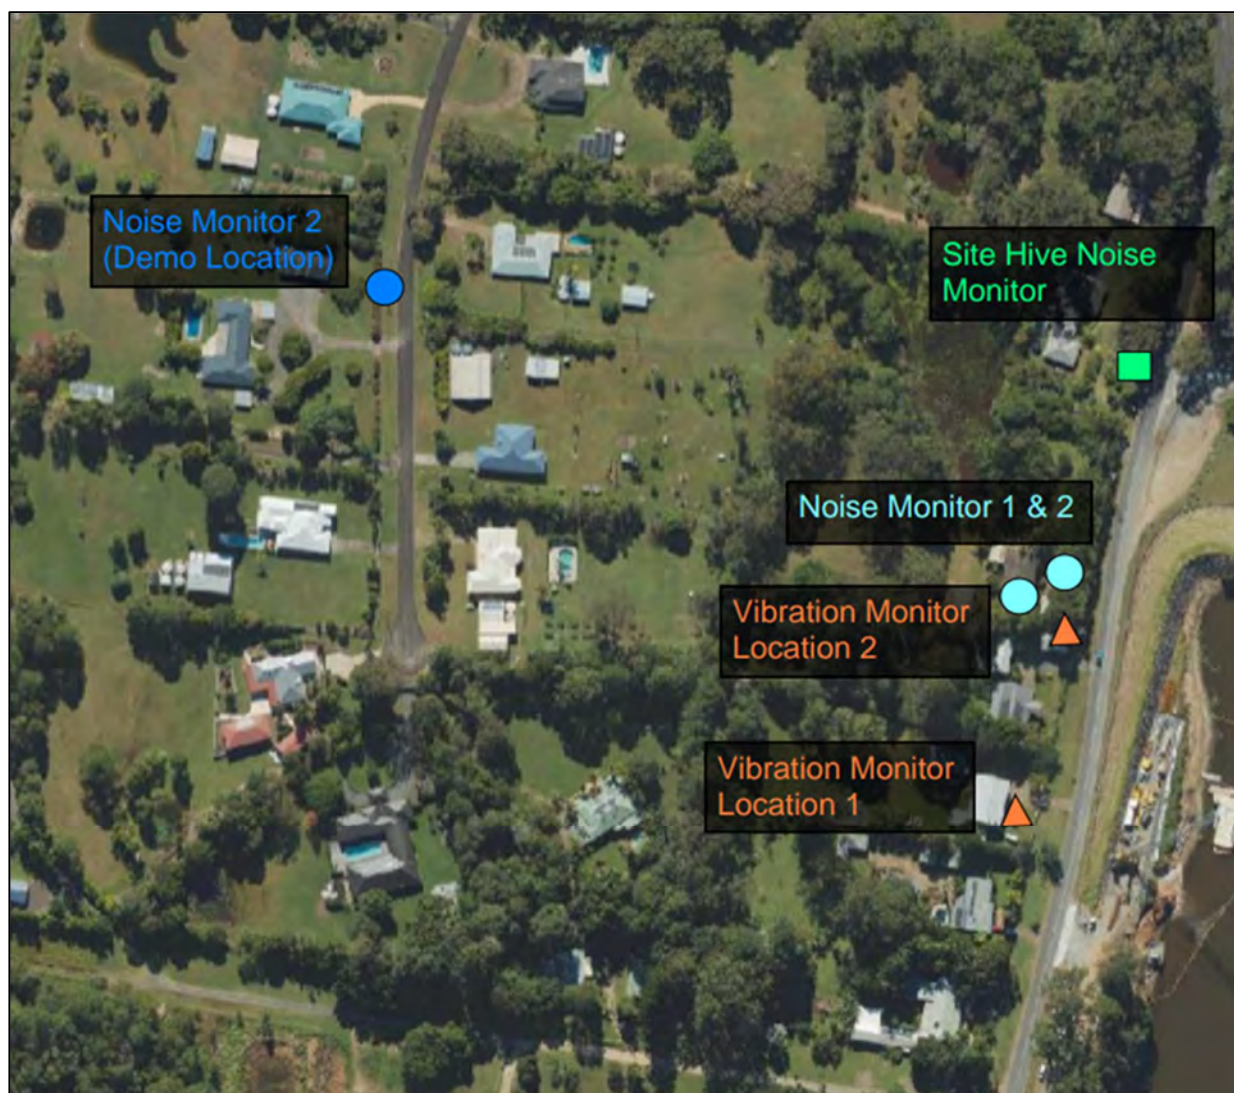
The noise and vibration monitoring locations are shown in Figure 13 below.

**Figure 13: Noise and Vibration Monitoring Locations**
