# Lake Macdonald Dam Improvement Project

Quarterly Compliance  
and Monitoring  
Summary Report for  
the Coordinator-  
General

Document Number: LMDIP-10000-GNL-ENV-REP-00003 LMDIP Quarterly Compliance Monitoring Report for the Coordinator General

Reporting period: 1 December 2025 – 28 February 2026

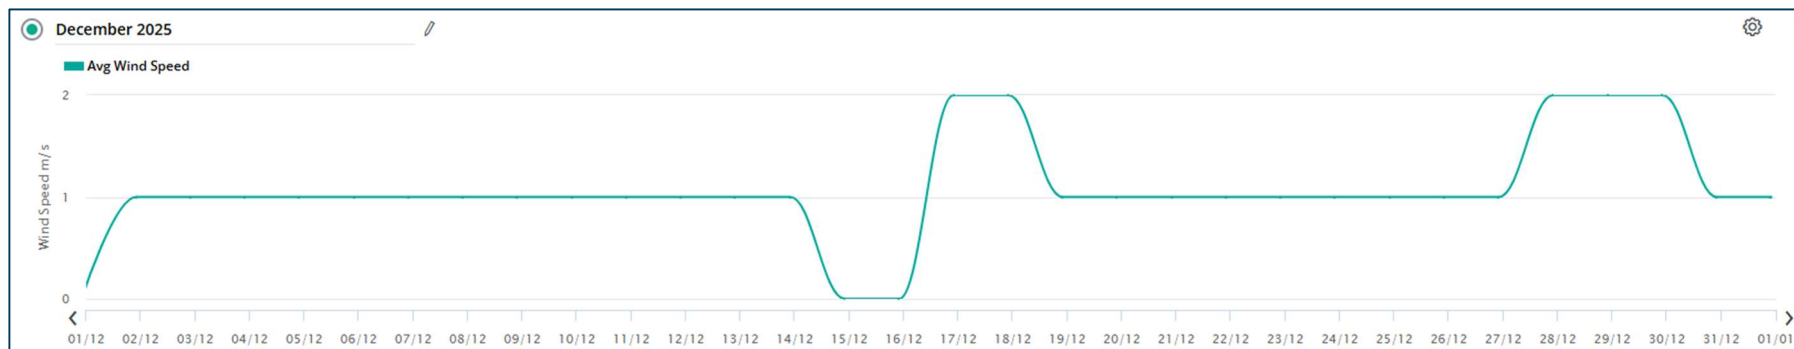
**Figure 3: LMDIP Average Wind Speed**

Windspeed and direction recorded during the period continued to be unremarkable with average daily windspeeds ranging between 1-5m/s with a predominant West North Westerly direction. Refer to Figure 3 for average wind speed and Figure 4 for direction.

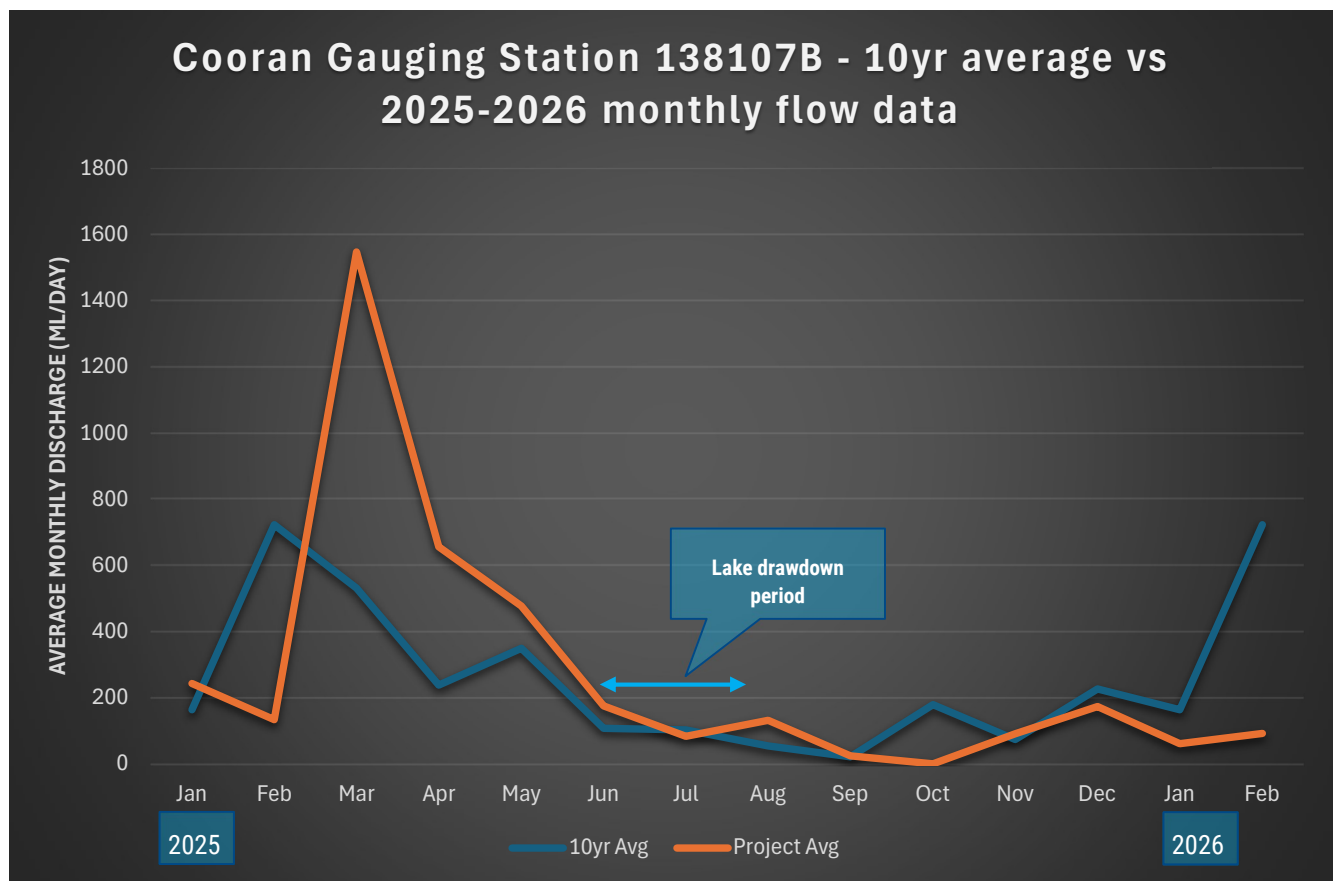
Figure 5: Comparing monthly average flows against the 10yr average – Cooran Gauging Station 138107B

LMDIP regularly monitor the gauging station along Six Mile Creek at Cooran (138107B) to ensure flow regimes remain comparable to what’s considered normal. Figure 5 shows the average monthly flows throughout the project timeline compared to the 10yr average. Environmental flows are always maintained as per the Lake Macdonald Water License.

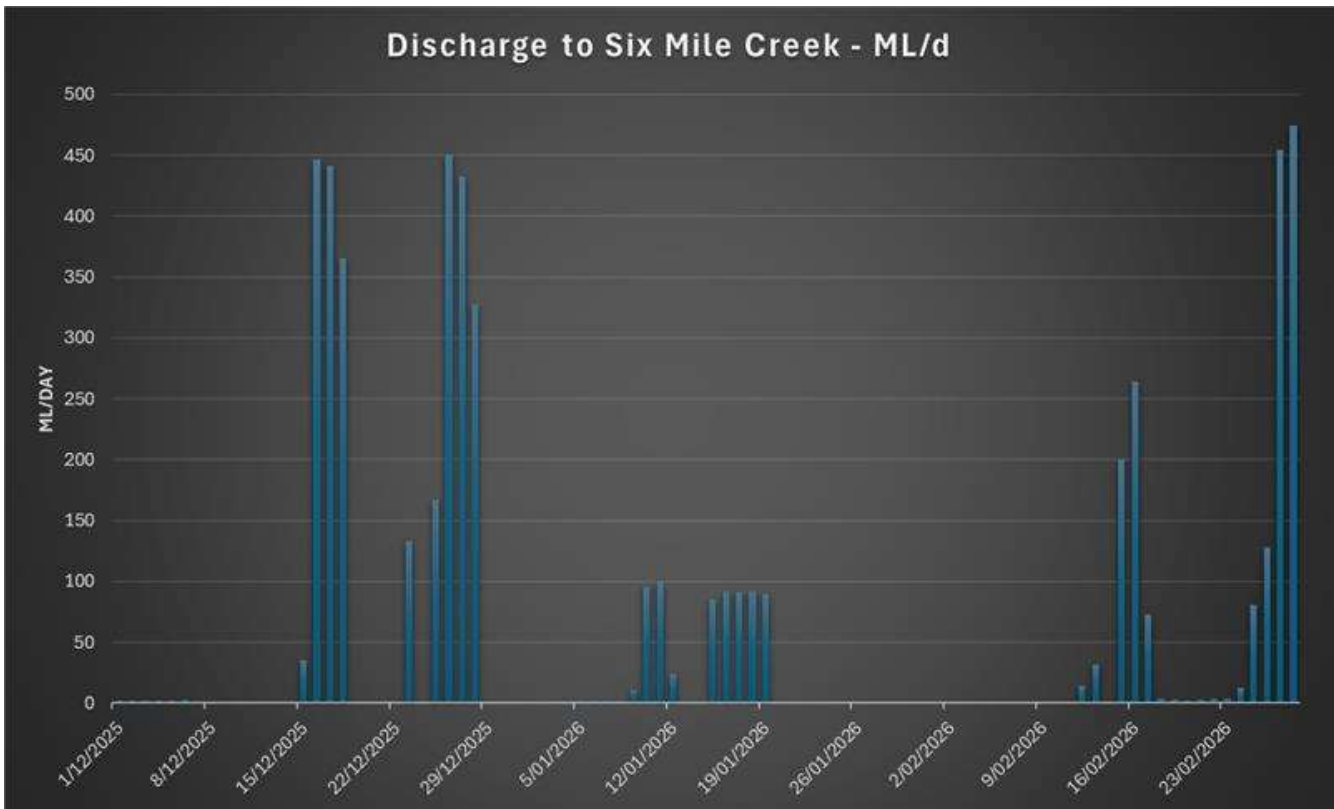
Figure 6: Discharge to Six Mile Creek (Siphons and Environmental Flows).

The following graph gives an estimation of ML/day discharged downstream through the siphon system throughout the reporting period. This is based on an average of 62ML/day passing through each siphon pipe.

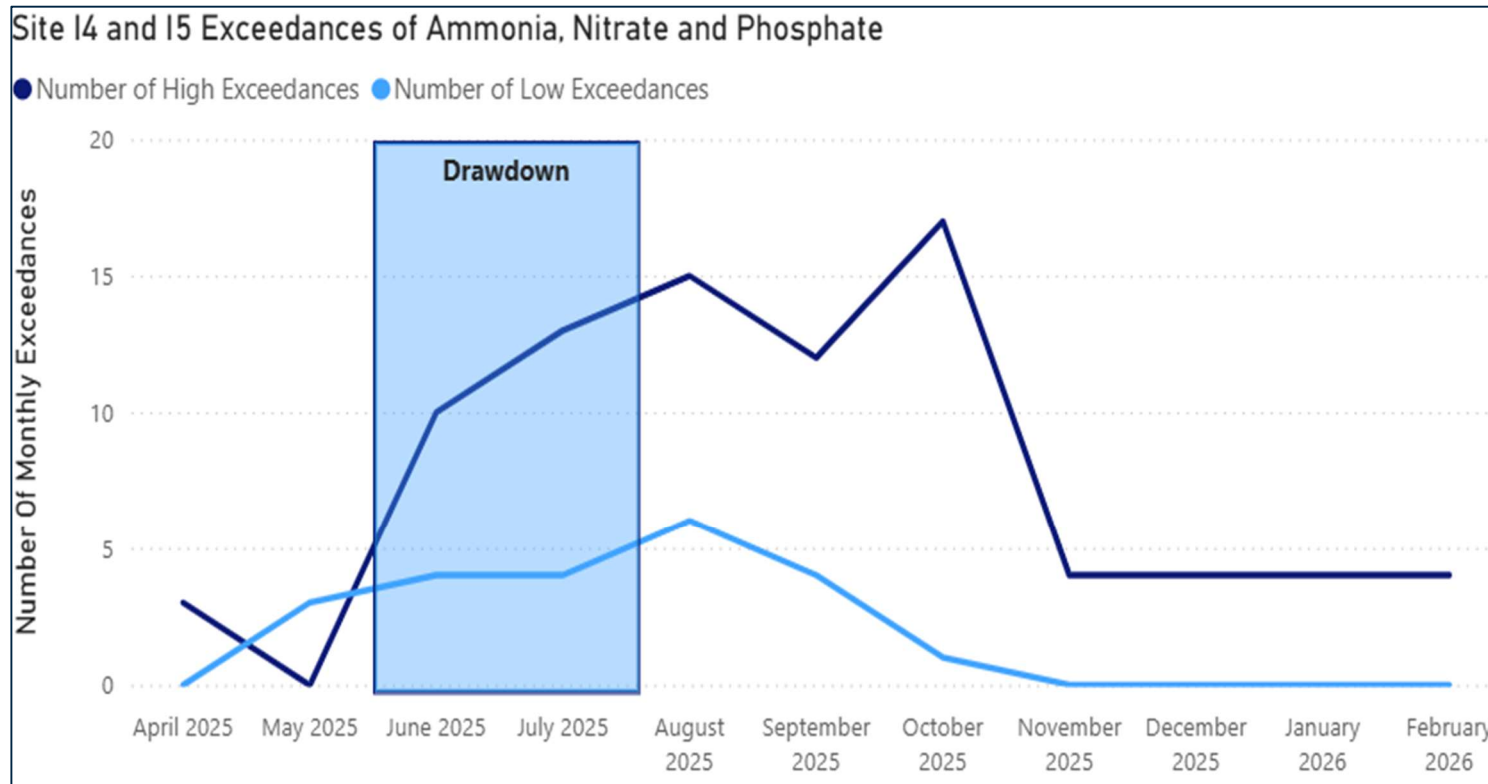
**Figure 9: Number of exceedances of ammonia, nitrate and phosphate at the upper reaches of Lake Macdonald at the sites I4 and I5**

Figures 8, 9 and 10 display the historical inclusive water quality trends at all monitoring locations. These graphs show the number of times the high and low trigger values were exceeded each month since the project began.

The data graphed above in Figures 8, 9 and 10 indicate the trends of nutrients from baseline through drawdown until the end of this reporting period. They show not only a downward trend in the upper reaches but also a stabilisation. Impoundment numbers at I1, I2 and I3 are also showing signs of stabilisation. It is also important to note that these exceedances, are not reflected in the downstream numbers, which were clearly spiking before drawdown but are now reaching a more stabilising trend, shown in Figure 10.

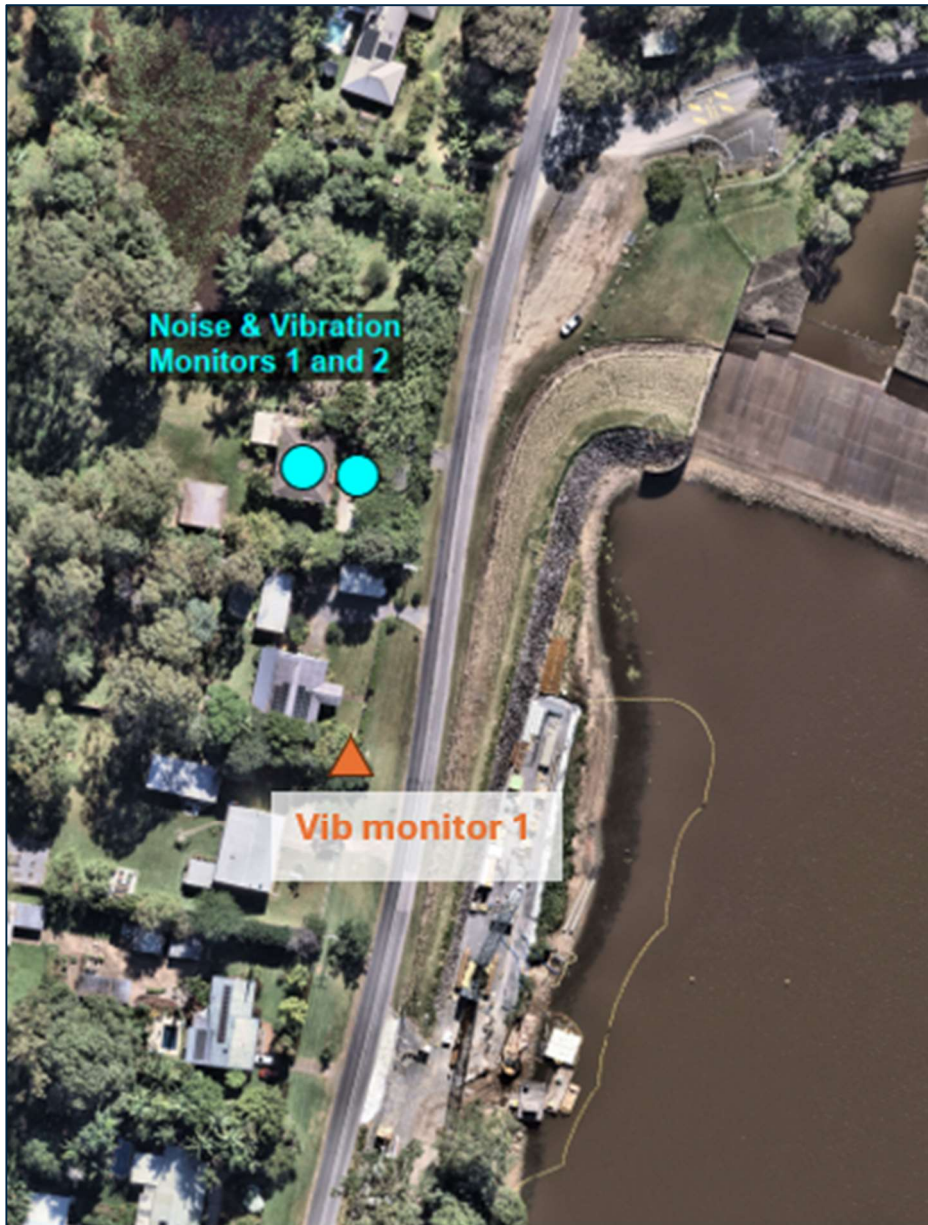
Figure 14: Noise and Vibration Monitoring Locations

Noise and Vibration is monitored at the locations shown in Figure 9.

The vibration monitor and noise loggers were placed at a residential property on Lake Macdonald Drive, the vibration monitor was placed at a property boundary adjacent to Lake Macdonald Drive. The two noise loggers were placed on another residential property with one placed inside the property and another on the property façade (Refer to Figure 14).

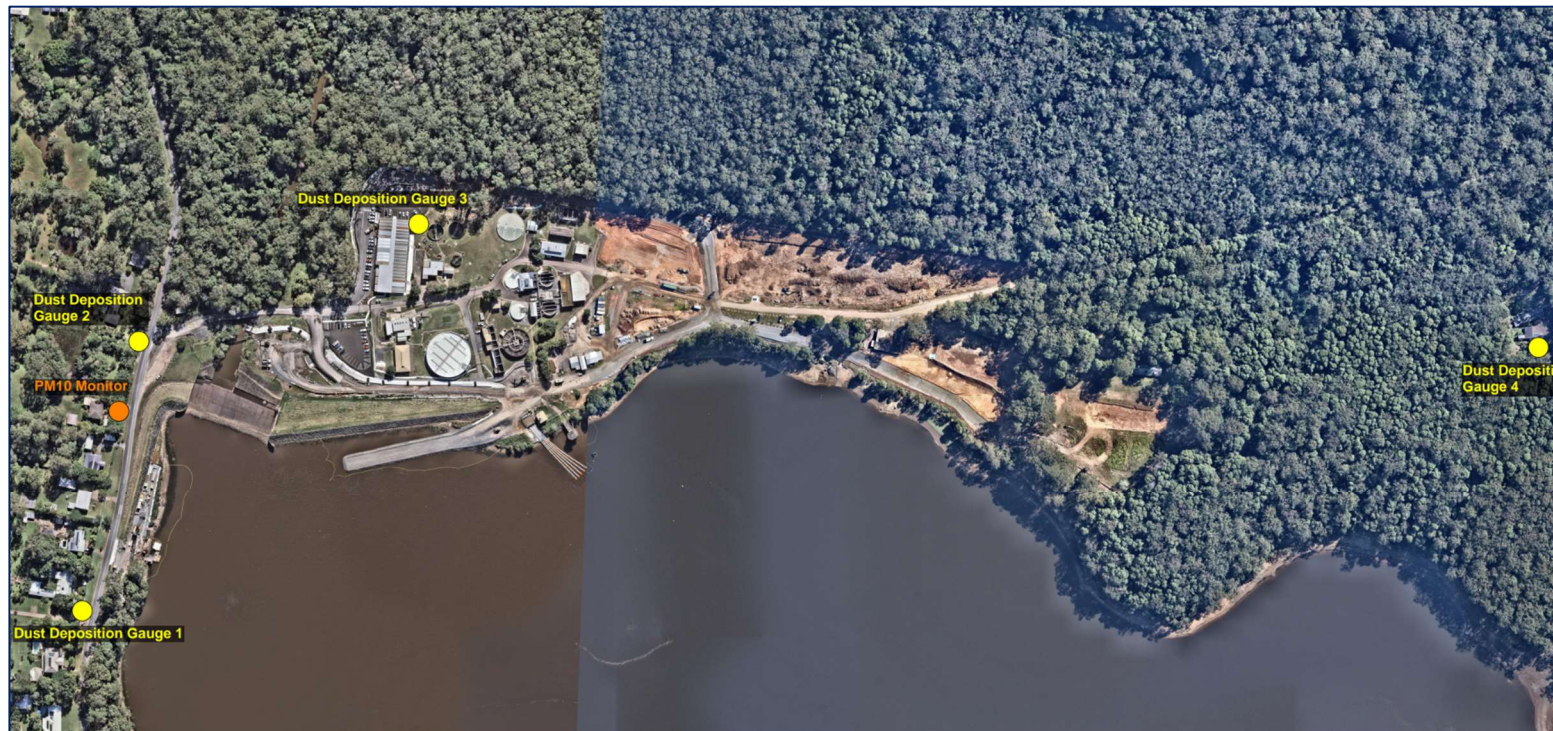
**Figure 19: Air Quality Monitoring Locations, (including PM10 Monitor)**

Air quality has been monitored throughout the period via dust deposition gauges and 1 real-time PM10 monitor at the locations as shown in Figure 19. During the monitoring reporting period the PM10 monitor was moved from its previous location onsite to a more representative location at a residential property adjacent to the project site. Table 21 shows the dust deposition gauge results. No exceedances were observed for this quarterly report period.
