Annual Compliance Report Northern Pipeline Interconnector 2

2018 - 2019

14 May 2019

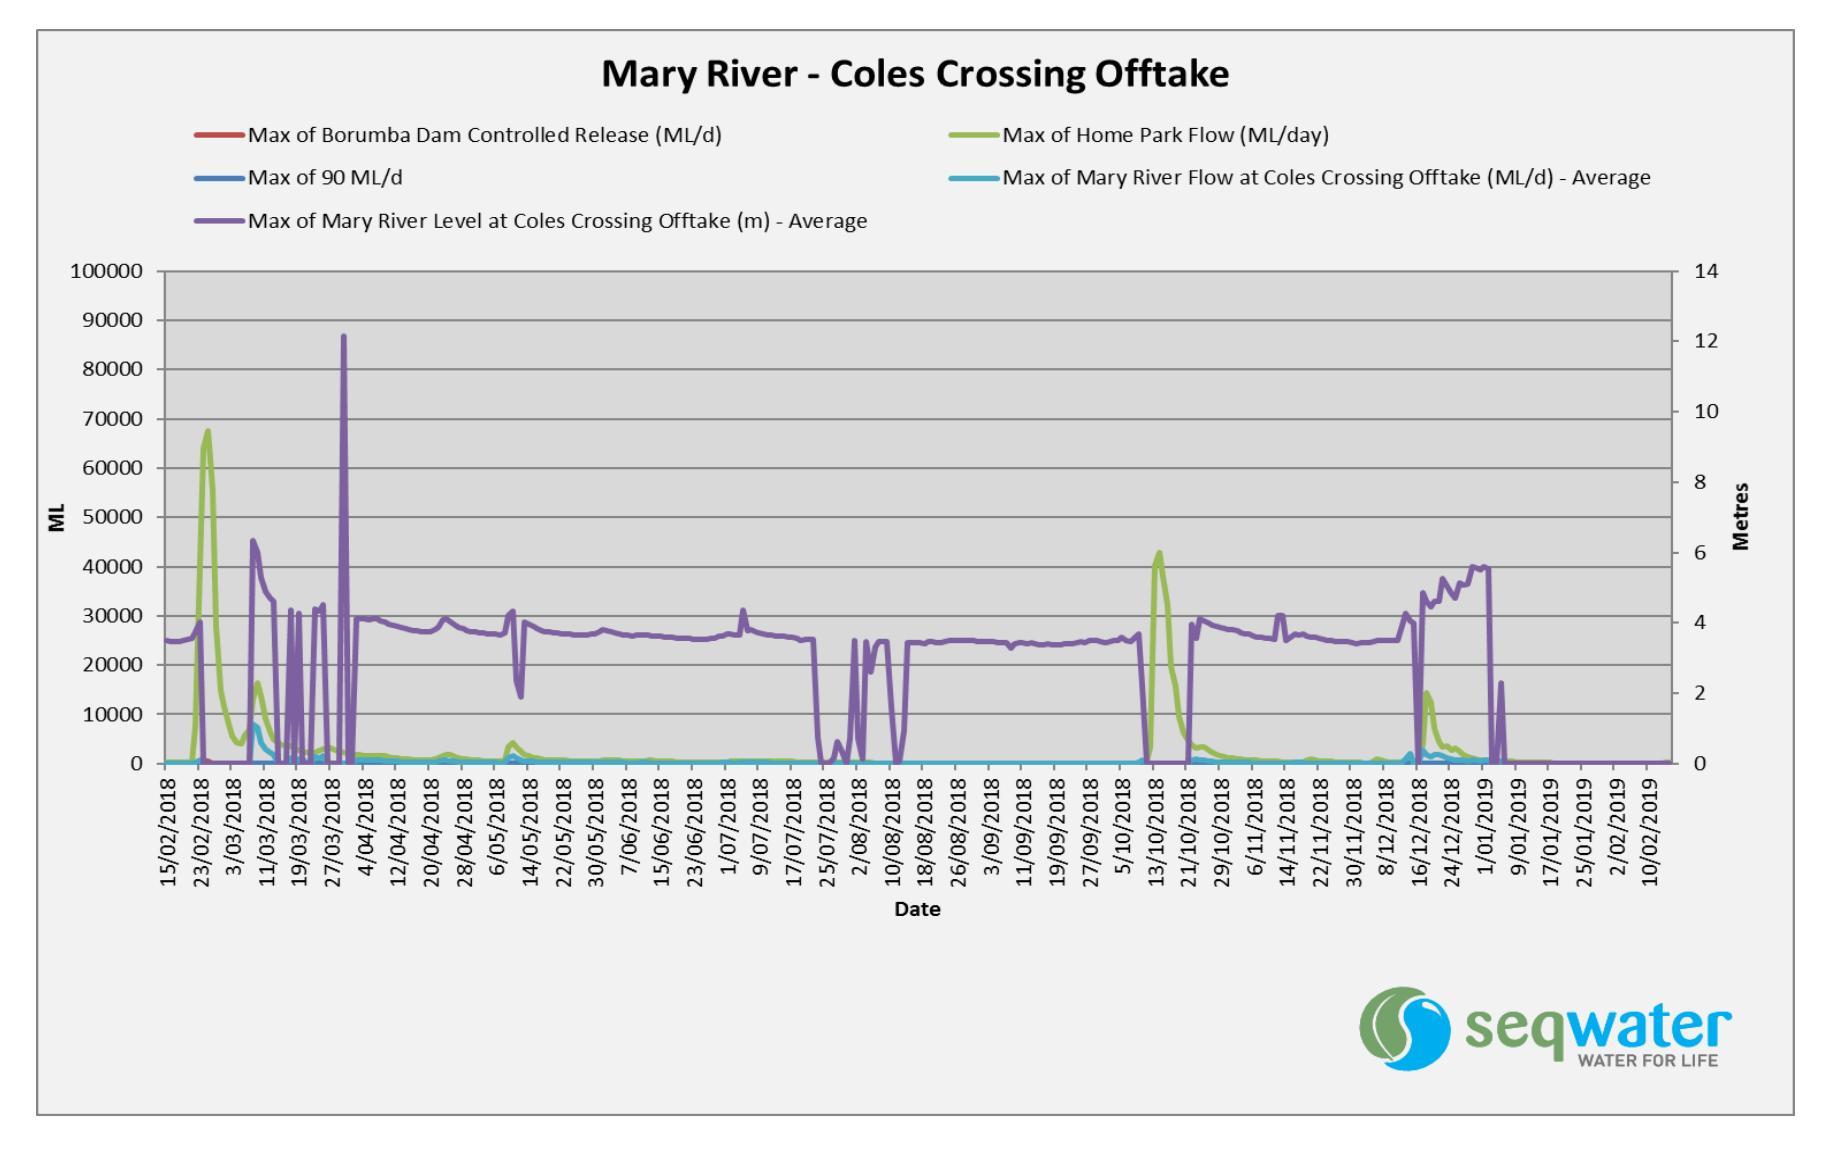
Figure 1: Mary River – Coles Crossing Offtake

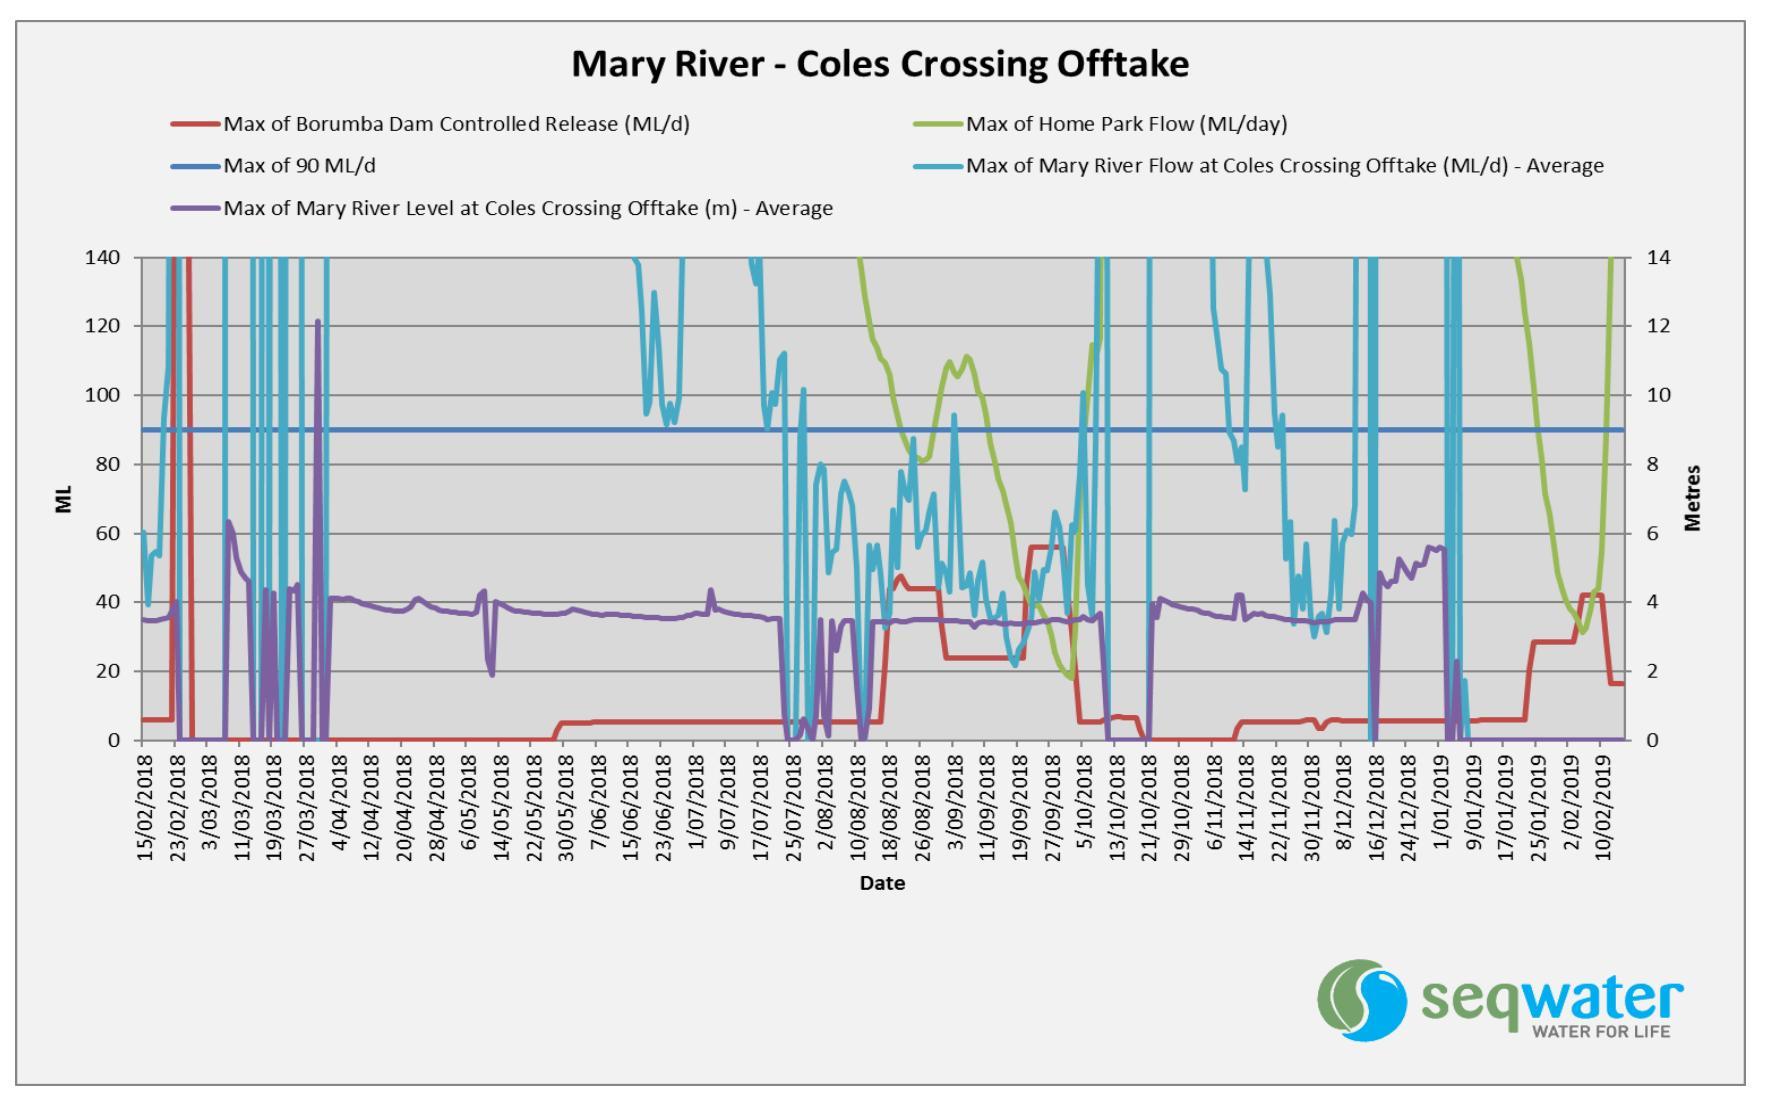
Figure 2: Mary River – Borumba Dam Controlled release

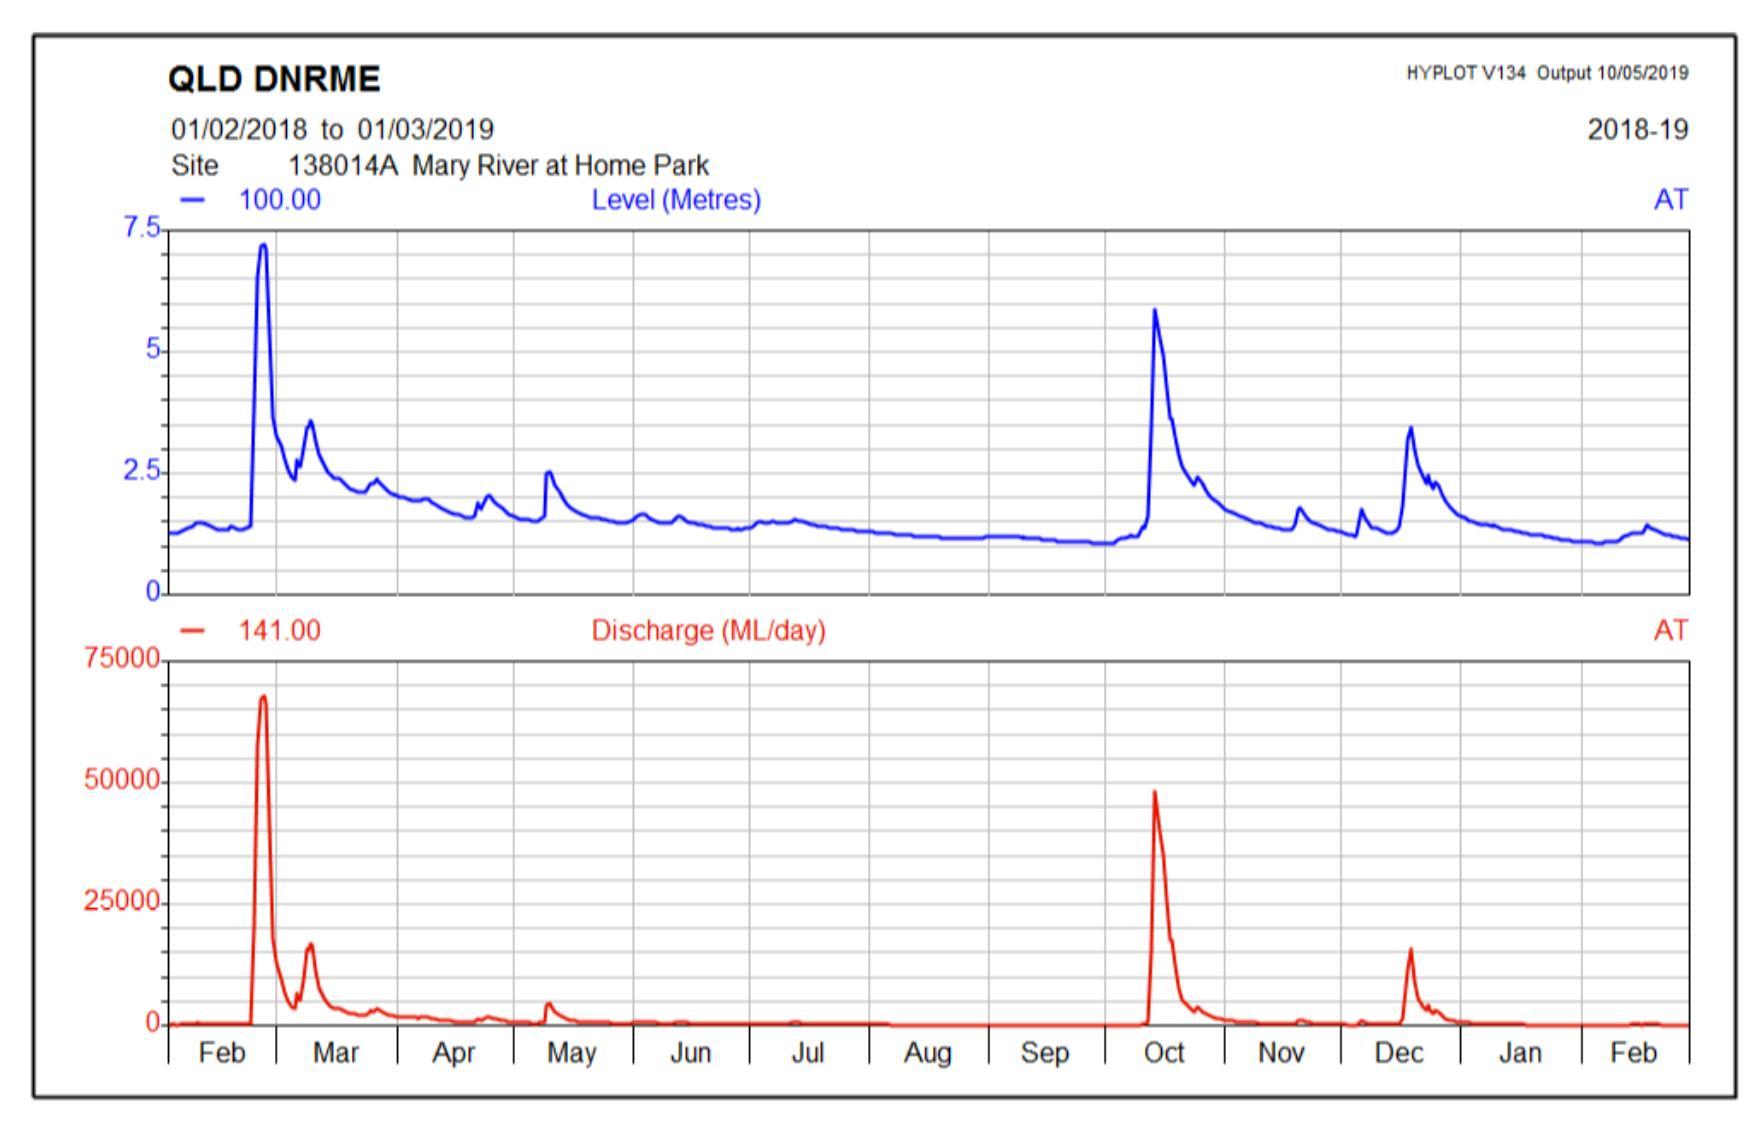
Figure 3: Flow volumes and levels at the Home Park gauging station

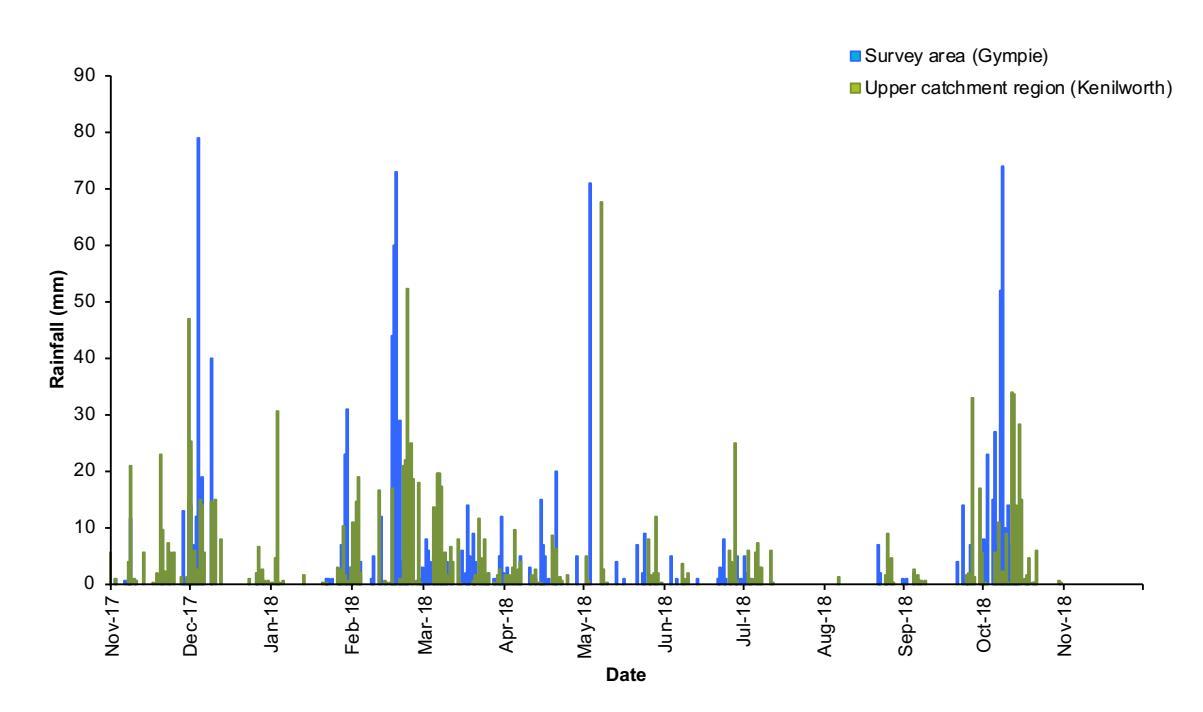
There was notable rainfall in early to mid- October 2018, prior to the survey, but no rainfall immediately before or during the survey (Figure 3.1). There were four relatively large rainfall events in the 12 months leading up to the survey: December 2017, February 2018, May 2018 and October 2018.

Figure 3.1 Total daily rainfall twelve months prior to the November 2018 survey in the survey area (Gympie) and upper catchment (Kenilworth).

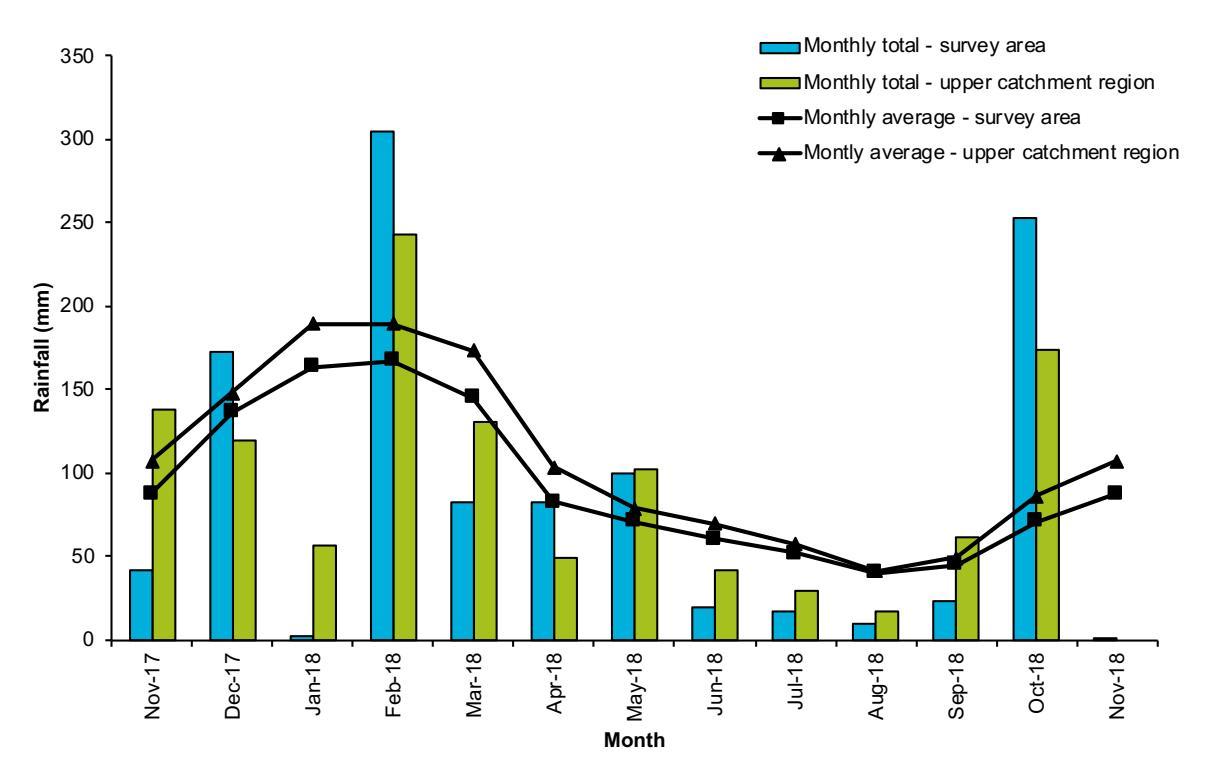
- higher than the long-term monthly averages in:
 - February, May and October 2018 for both the survey area and upper catchment area
 - December 2017 in the survey area
 - November 2017 and September 2018 in the upper catchment, and
- below the long-term averages in all other months.

Figure 3.2 Total monthly rainfall for twelve months prior to the 2018 survey and long term mean rainfall for each month in the survey area (Gympie) and the upper catchment region (Kenilworth).

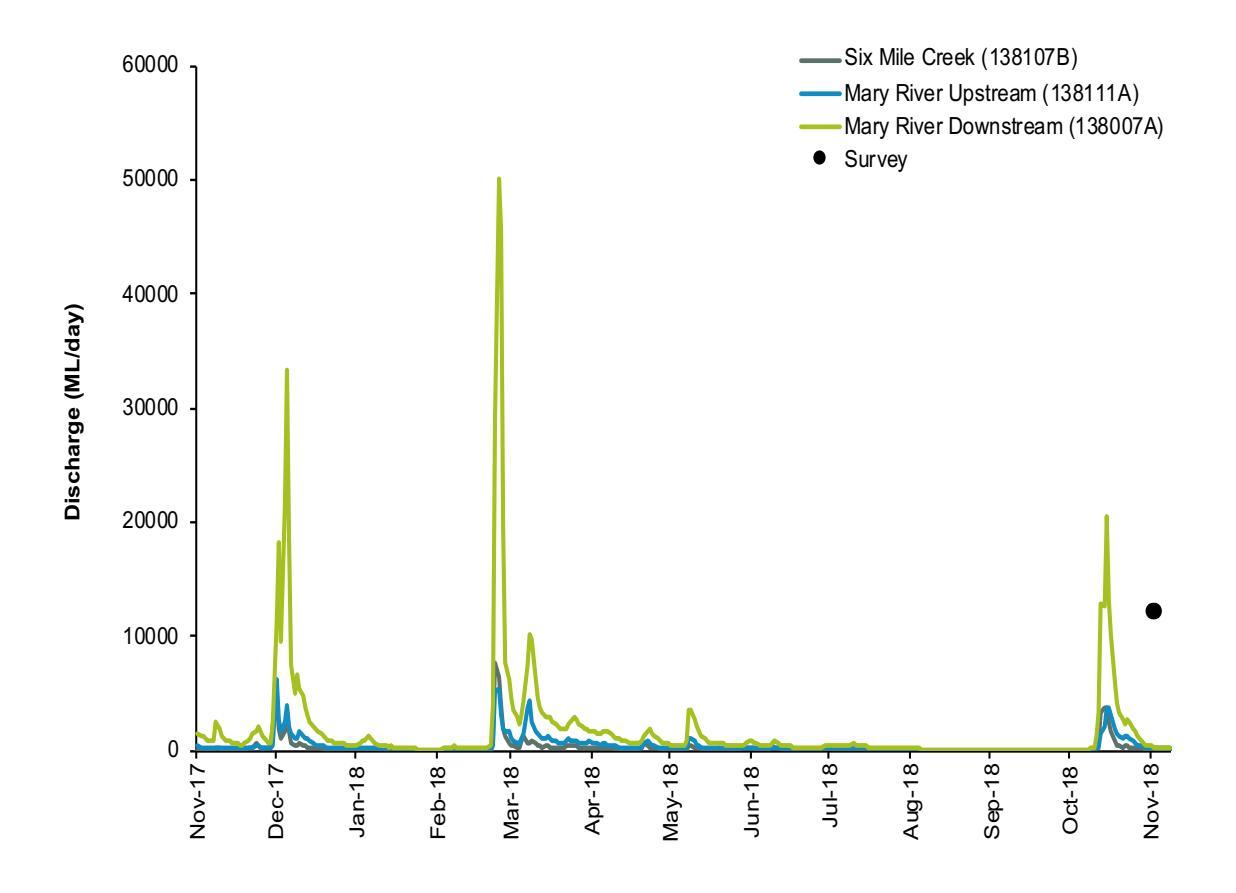
Flow and water levels in the Mary River and Six Mile Creek were generally low, except in December 2017, March through to mid-May 2018, and October 2018 where there were brief high flow events (Figure 3.3 and Figure 3.4). In the Mary River, the maximum recorded high flow event was of similar magnitude as maximum flows recorded in 2014 and 2017 (i.e. 50 000 to 60 000 Ml/day), with maximum flows recorded in 2016 being significantly lower (i.e. ~ 14 000 ML/day) and maximum flows in 2013 and 2015 significantly larger (i.e. ~ 380 000 ML/day in 2013; and ~ 200 000 ML/day in 2015 in the Mary River).

Figure 3.3 Mean daily discharge recorded at stream flow monitoring stations on Six Mile Creek and Mary River.

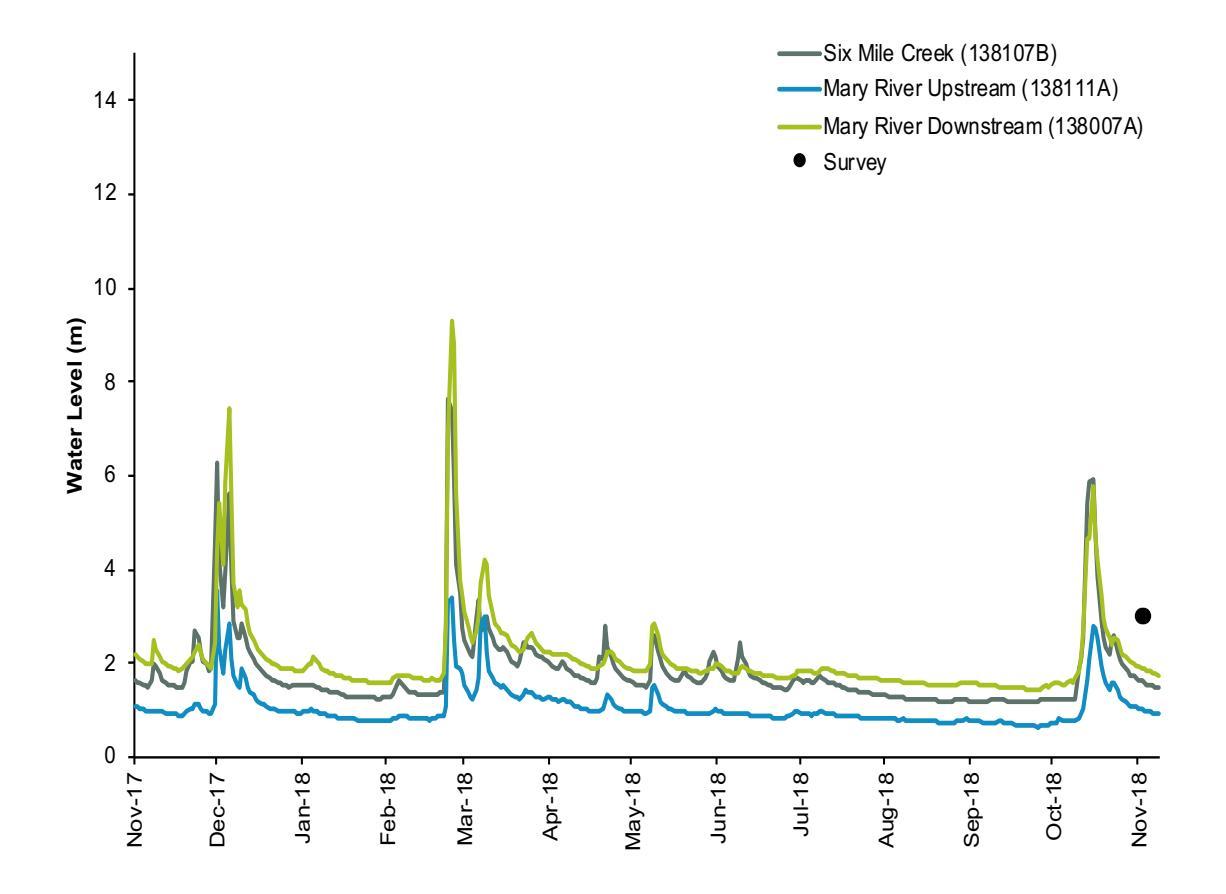
Figure 3.4 Mean daily water level recorded at stream flow monitoring stations on Six Mile Creek and Mary River.

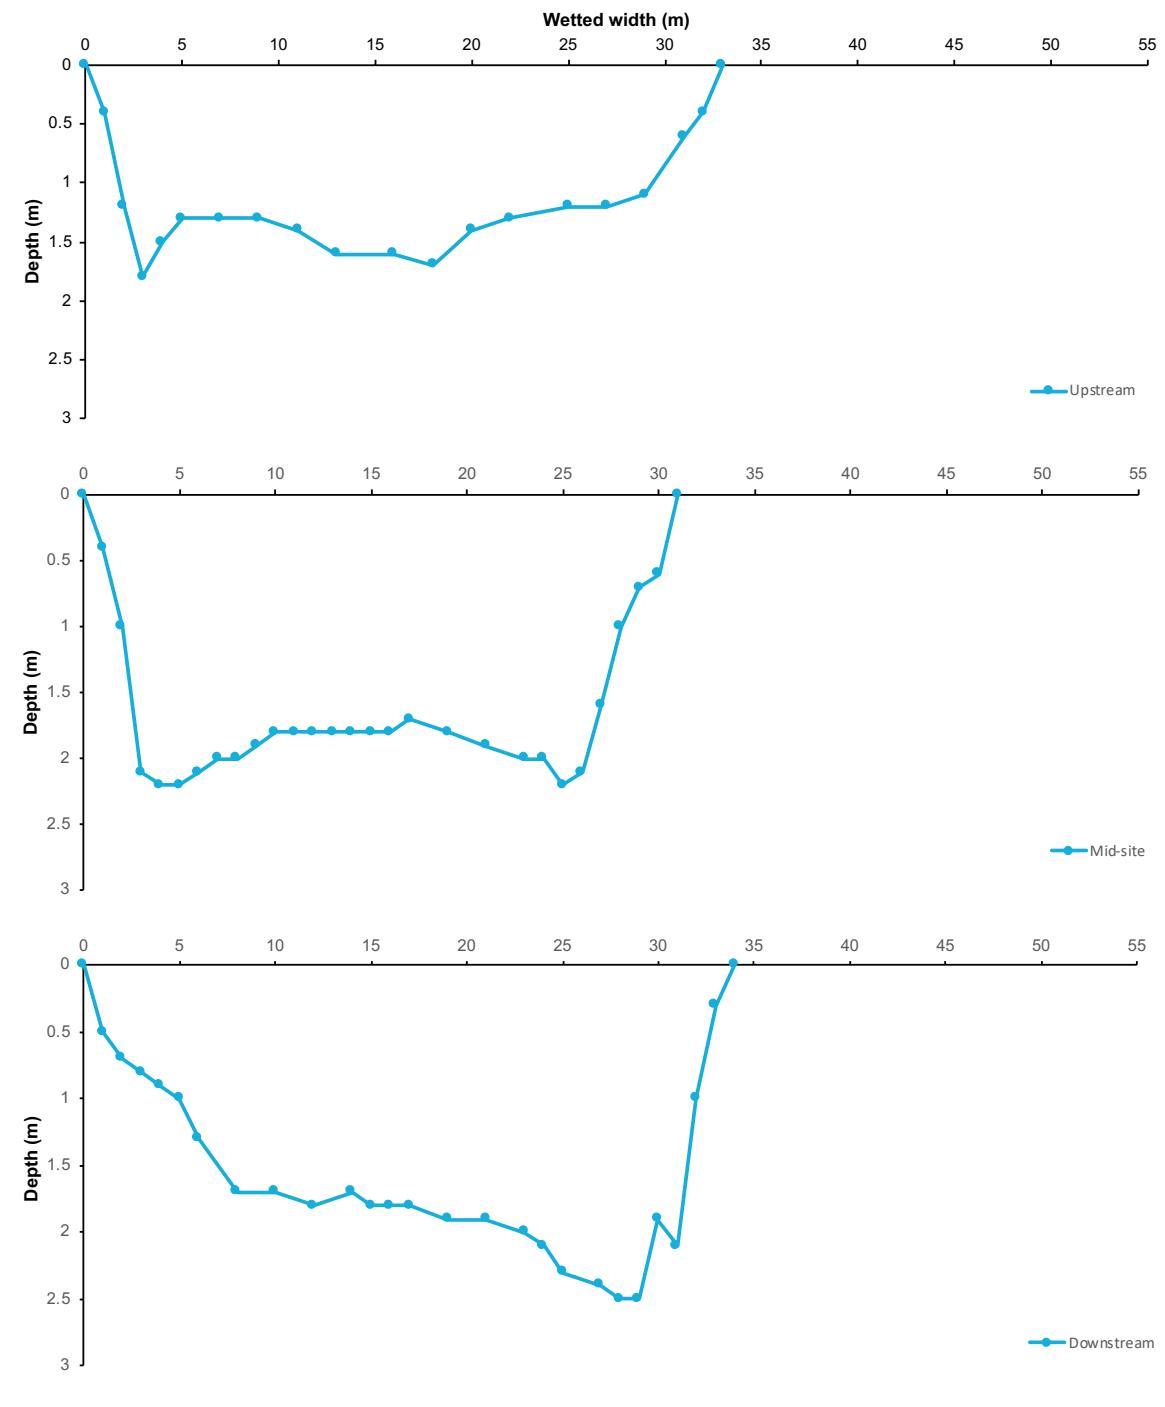
Figure B.1 Site MR1 – channel depth profiles.

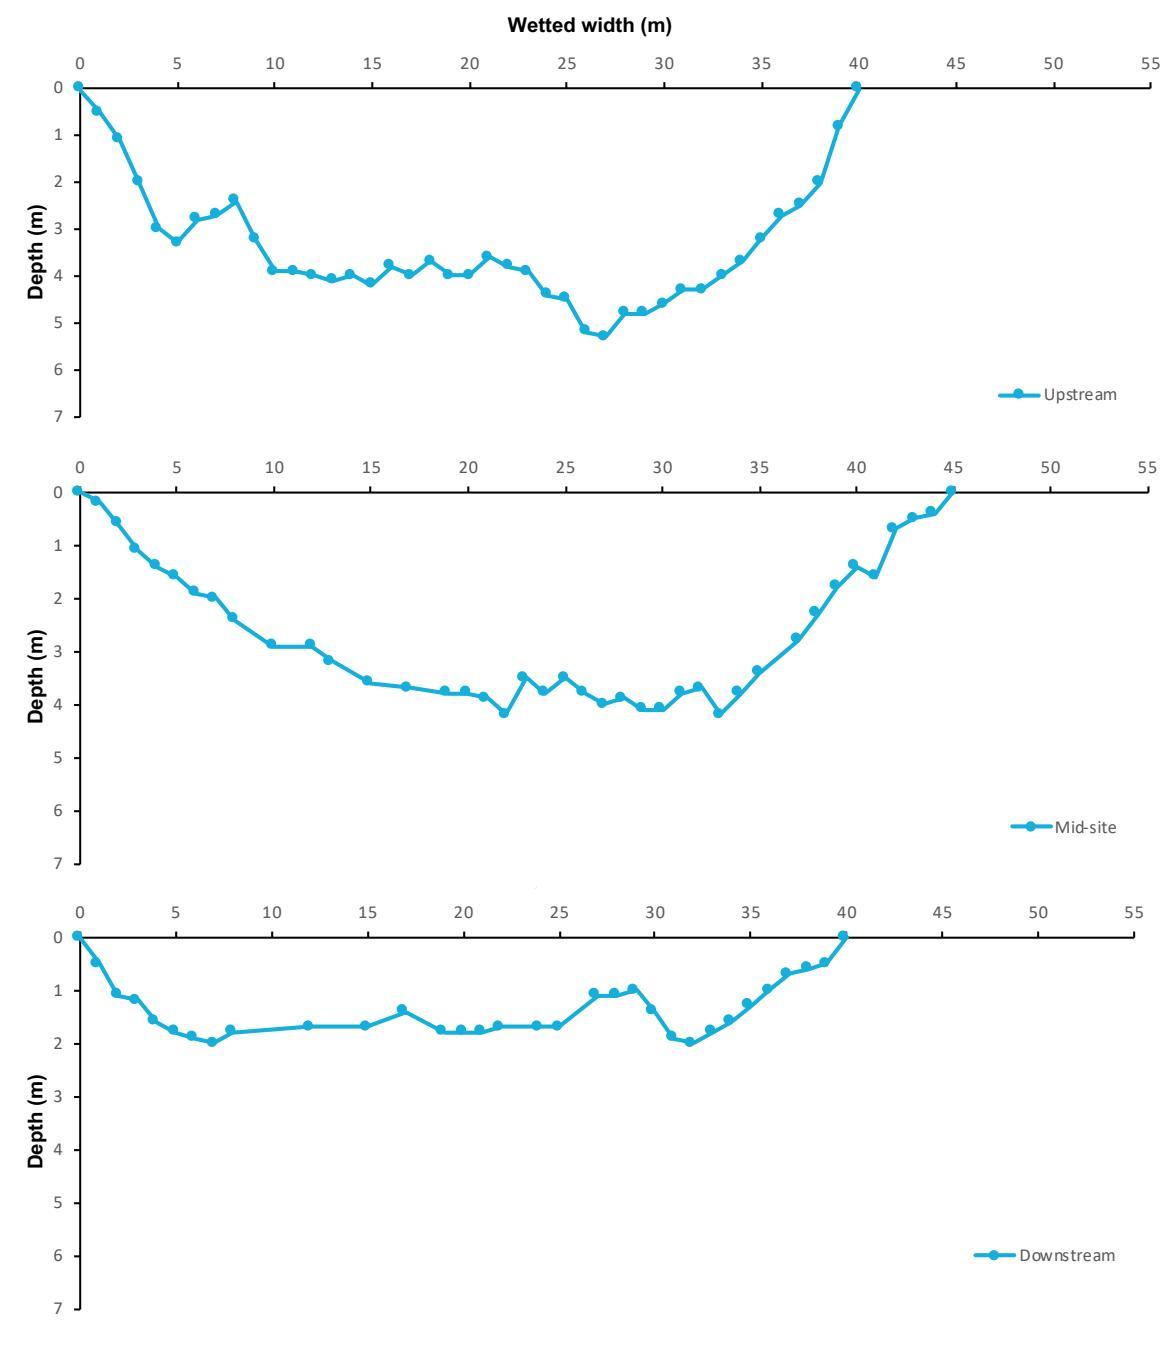
Results for site MR2 are presented in Table B.4 – B.6 and Figure B.2. Site MR2 had suitable habitat to support the MNES species (Mary River cod, Australian Lungfish, white-throated snapping turtle and Mary River turtle).

Figure B.2 Site MR2 – channel depth profiles.

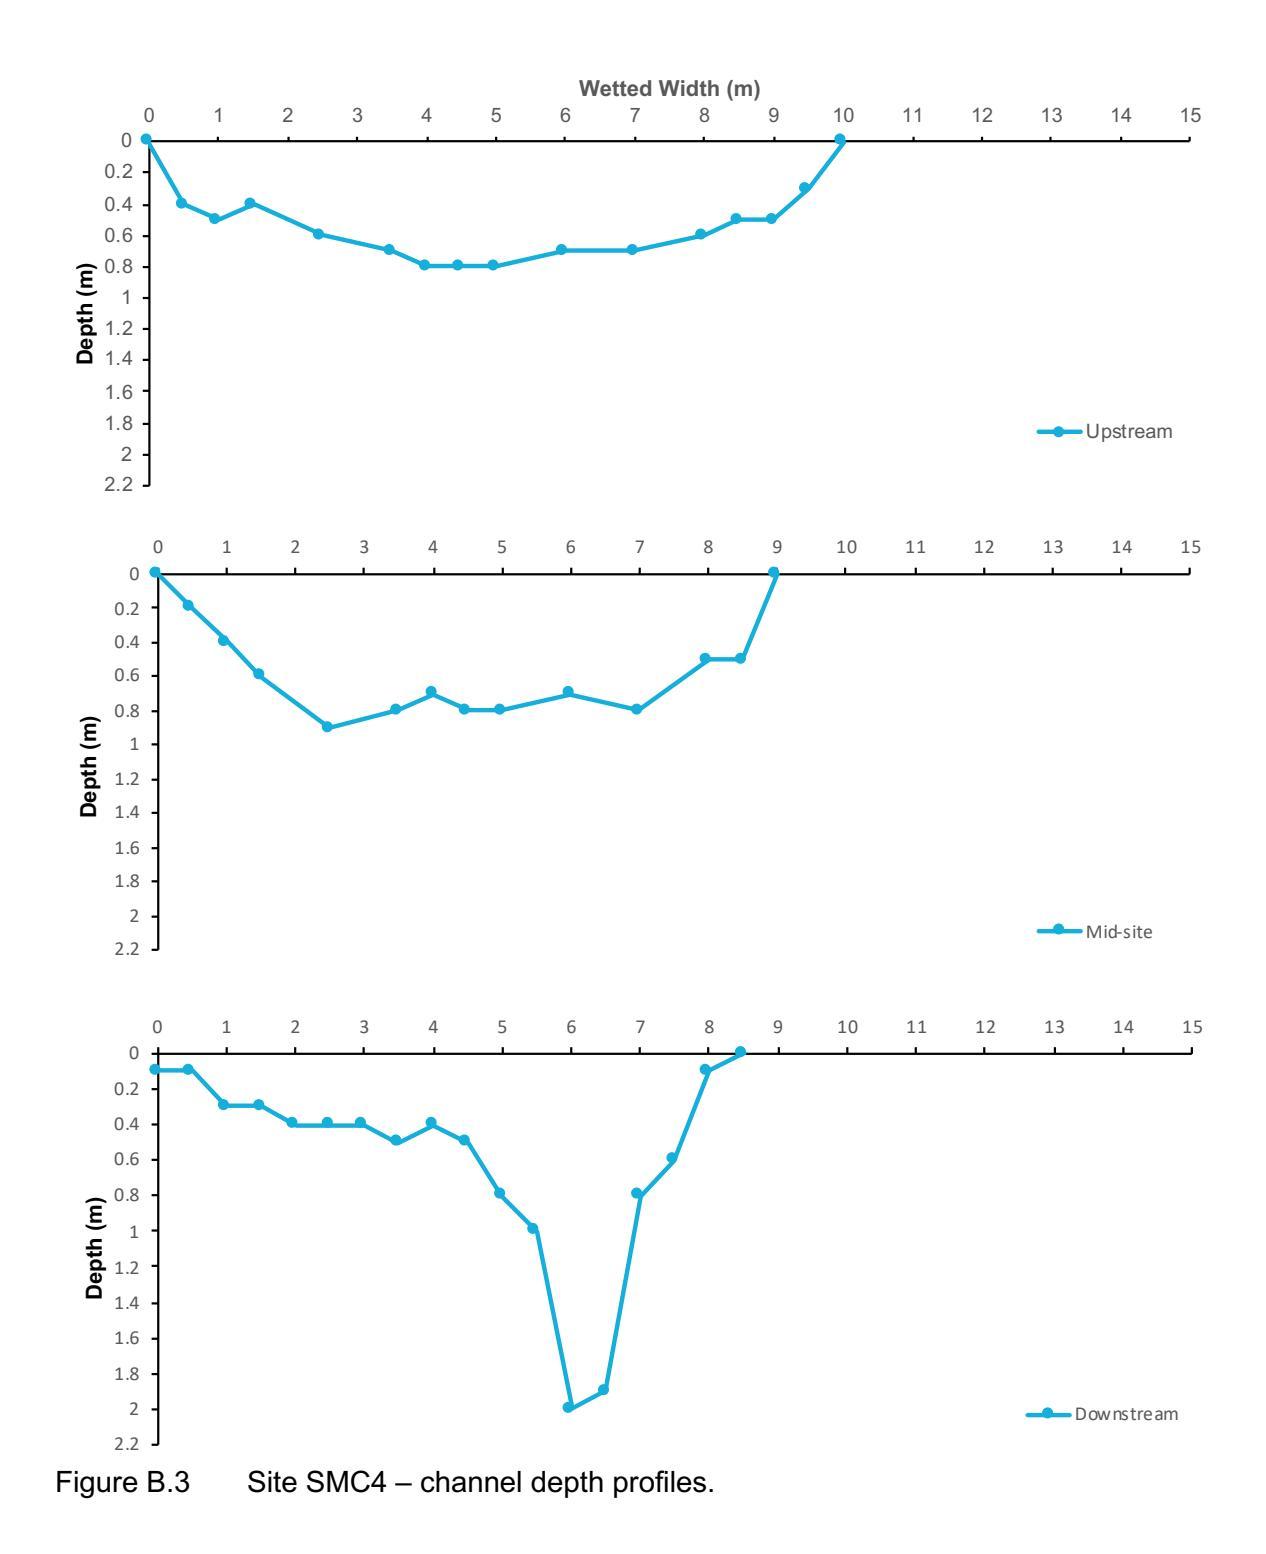
Figure B.3. Site SMC4 had suitable habitat to support white-throated snapping turtles and Mary River turtles. This site has potential habitat for Mary River cod but not Australian Lungfish.

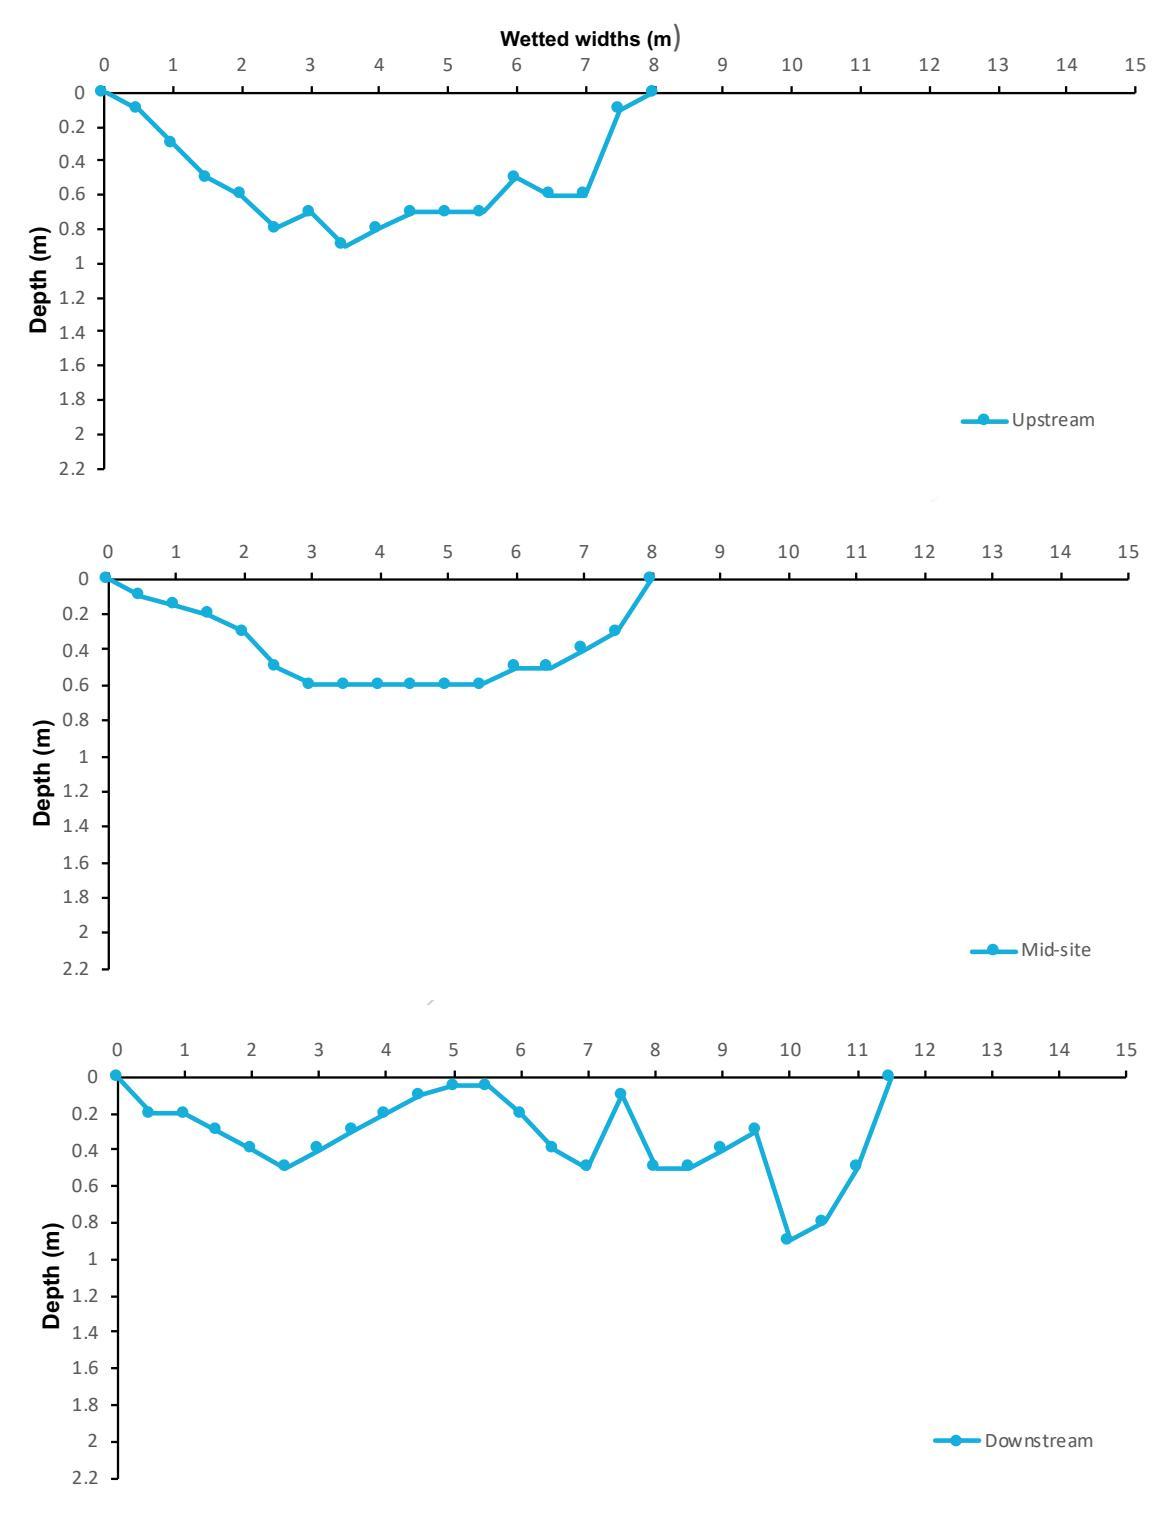
Results for site SMC5 are presented in Table B.13 – B.12 and Figure B.4. Site SMC5 had potentially suitable habitat for juvenile Mary River cod, white-throated snapping turtle and Mary River turtle, but did not have suitable habitat for Australian Lungfish.

Figure B.4 Site SMC5 – channel depth profiles.
