Wyaralong Dam Information sheet for residents downstream

December 2017

Wyaralong Dam information sheet

Ex-Tropical Cyclone Debbie – March 2017

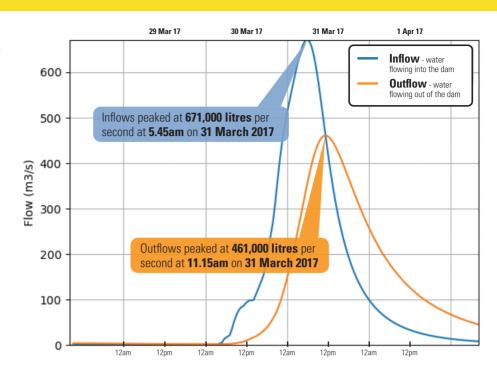
The flow hydrograph for Wyaralong Dam associated with the March event is shown above. Inflows into the dam began at 4am on Thursday 30 March 2017 and Wyaralong Dam began spilling on Tuesday 21 March 2017. The peak inflow occurred at 5.45am on Friday 31 March 2017, and the peak outflow occurred at 11.15am later that day. At the same time, the lake level reached its peak at 65.18 metres above sea level, which is 1.6 metres above the dam's full supply level.

- Ex-TC Debbie produced the largest flows in the Logan River since 1974.
- During the event, inflow into Wyaralong Dam peaked at about 671 cubic metres per second (or 671,000 litres per second) at 5.45am on 31 March 2017 - the equivalent volume of almost eight Olympic-sized swimming pools every minute.
- The water level at Wyaralong Dam peaked at 65.18 metres above sea level - about 1.6 metres above the spillway.
- This peak level was still 0.15 metres below the flood of record for Wyaralong Dam which occurred during January 2011.
- The peak outflow through the un-gated spillway at Wyaralong Dam during ex-TC Debbie was about 461 cubic metres per second (or 461,000 litres per second).
